STORMWATER MANAGEMENT FACILITIES OPERATION AND INSPECTION REPORT

Verona Subdivision
Main Street & Lawrence Avenue

Pond ID: SWP09N001
North Pond

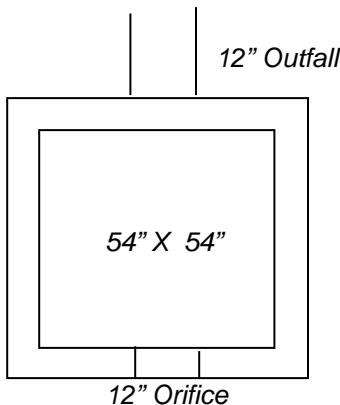
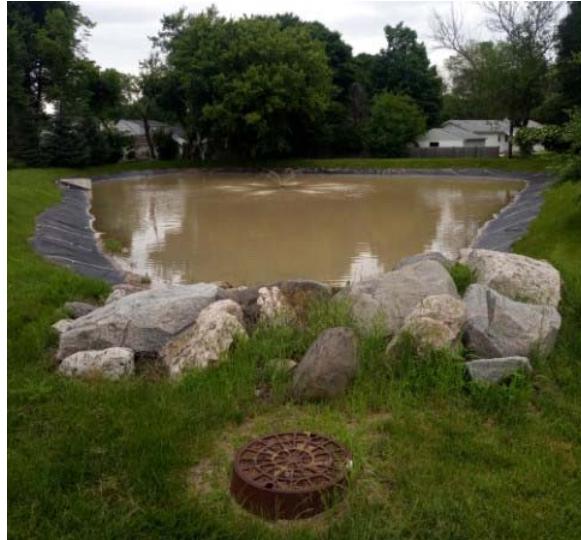
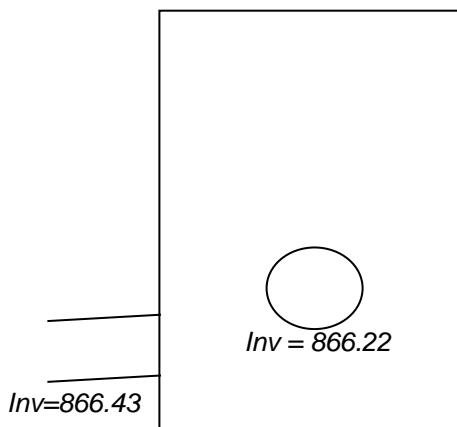
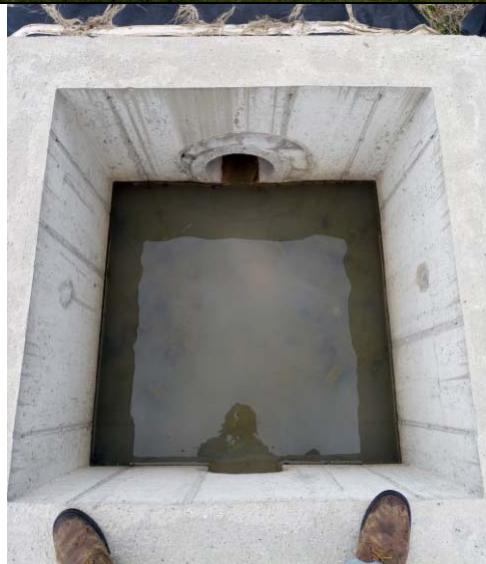
Sketch Outlet or Attach to Document

Rim = 868.86
