STORMWATER MANAGEMENT FACILITIES OPERATION AND INSPECTION REPORT

Verona Subdivision
Main Street & Lawrence Avenue

Date June 7, 2018

Dry Pond		Pond ID: SWP09N002 South Pond	Location of Pond	OUTLOT 2
Wet Pond	X			SW of Lots 6 & 7
Other				_____

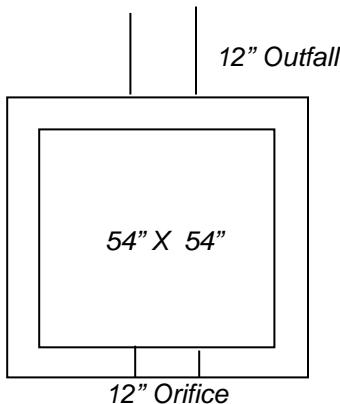
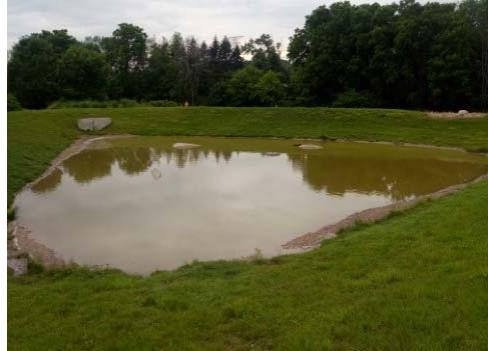
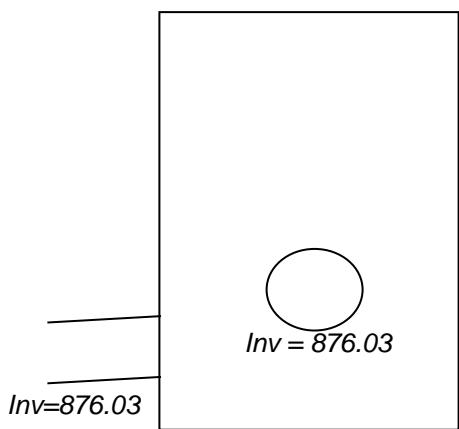
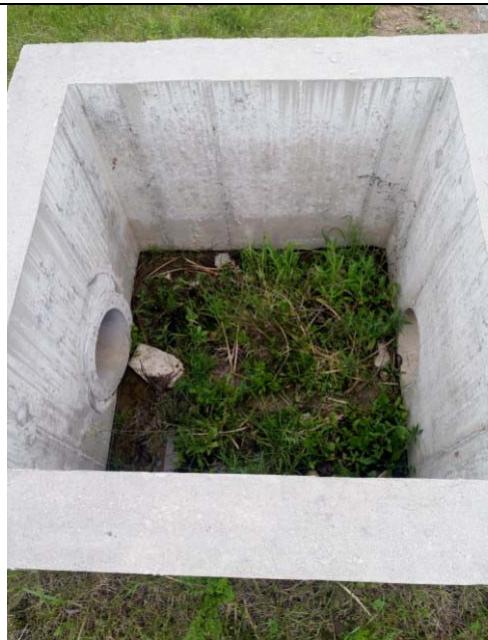
Sketch Outlet or Attach to Document

Rim = 879.12
