STORMWATER MANAGEMENT FACILITIES OPERATION AND INSPECTION REPORT

SE 1/4 S2 T8N R20E	Name of Business/Subdivision Multi-Fab Products
MNFV00089 95007	Address of Property N90 W14507 Commerce Drive
	Menomonee Falls, WI 53051

Dry Pond		Location of Pond	Southwest corner of property adjacent to Parita Drive
Wet Pond	X		
Other		Pond ID: SWP

Inspection Firm: M Squared Engineering
Phone Number: 262-376-4246
Address: W62 N215 Washington Ave
Cedarburg, WI 53012

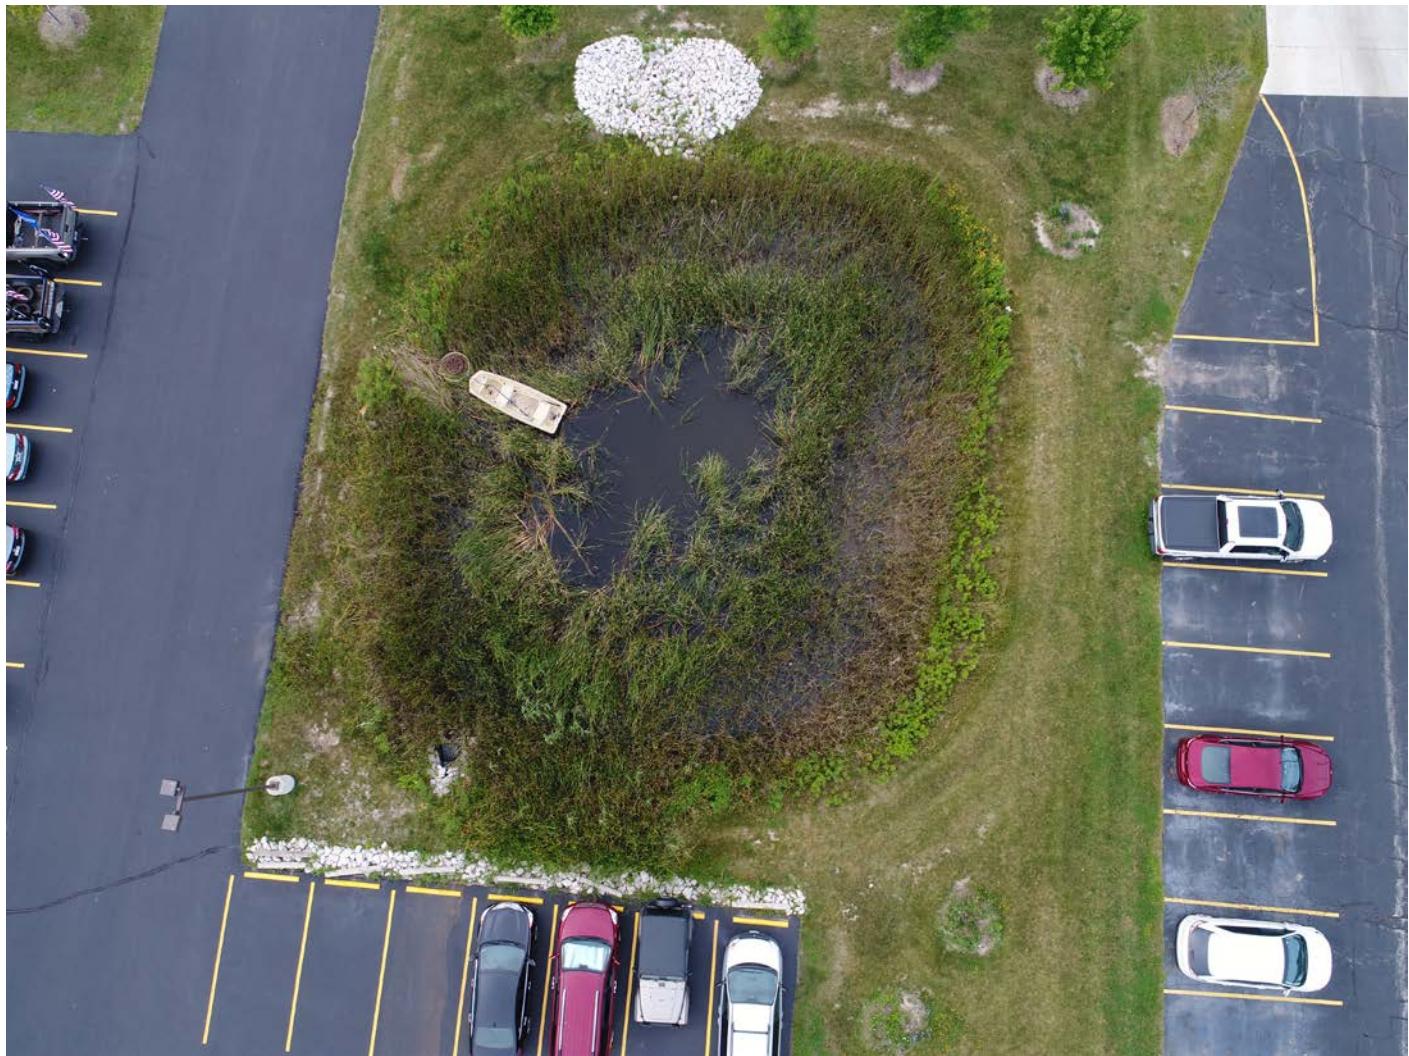
Overview of existing pond. Note extensive vegetative growth into the pond. Open water area is consistently approximately 5' deep. Cattails have encroached into the shoreline and safety shelf of the pond.

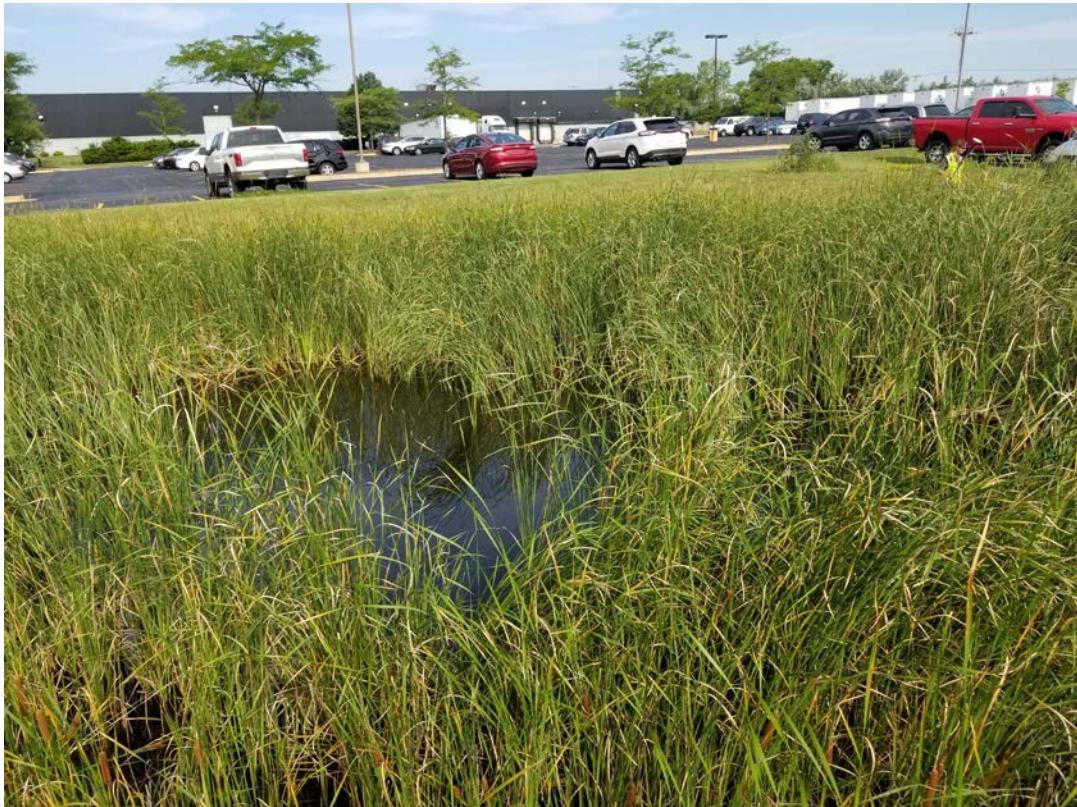
View of pond. Cattails have encroached onto all but the deepest areas of the pond. Pond depth at the center is 5 feet as designed.

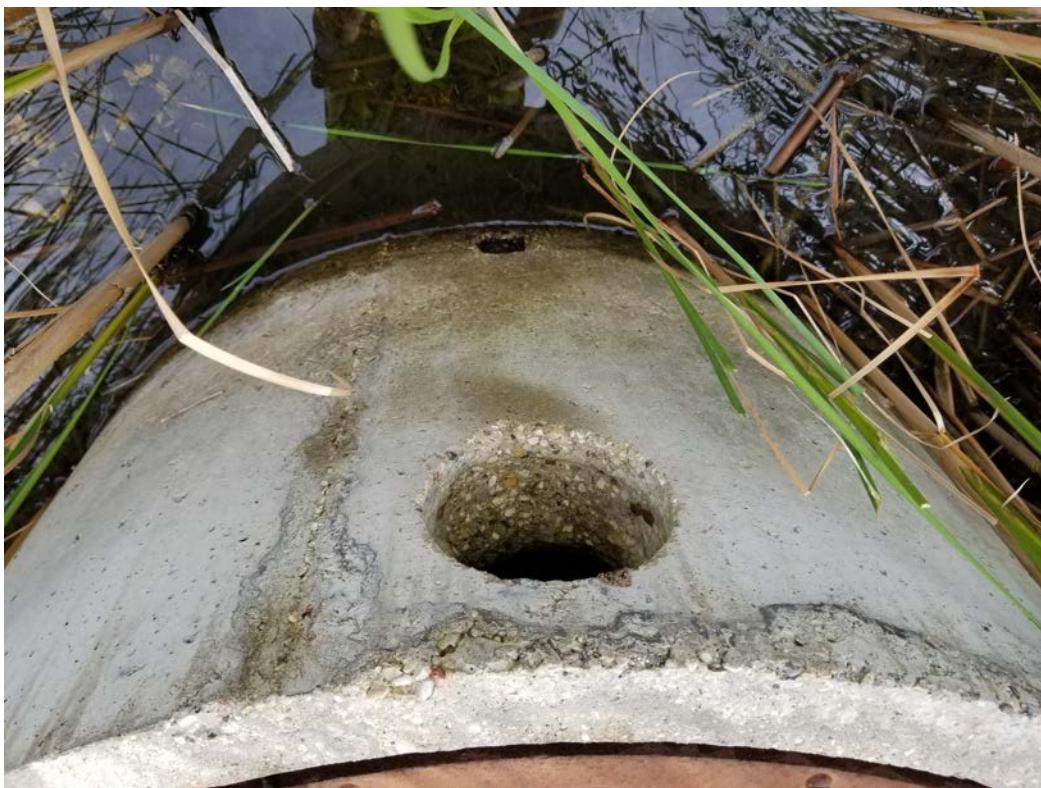
View of upper and lower orifice at control structure (from above).

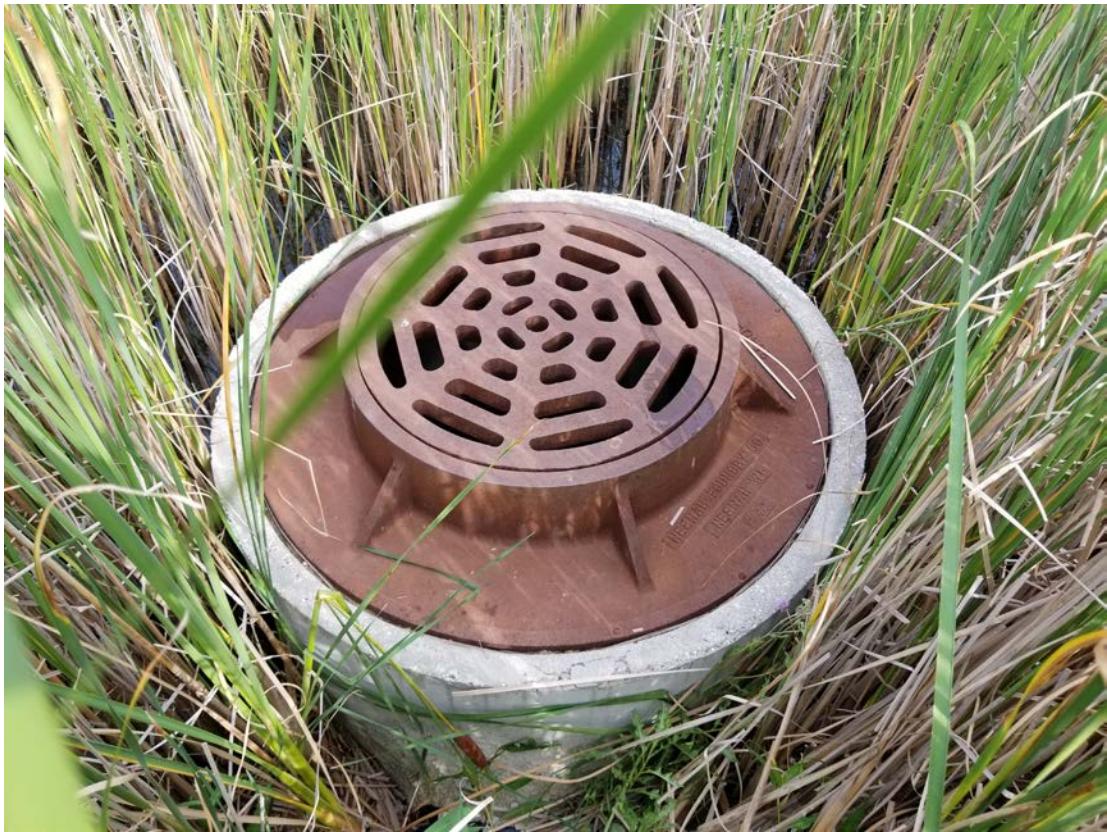
View of top of outlet control structure with Neenah casting.

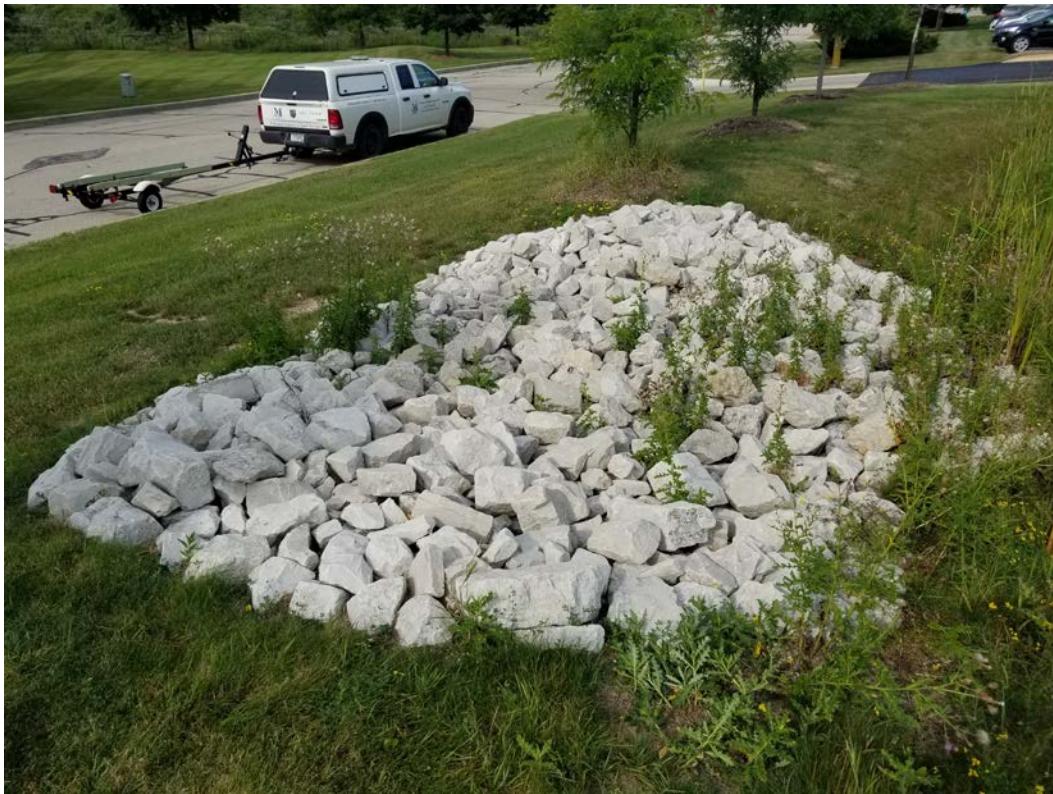
View of overflow spillway. Note minor weed encroachment into spillway. Trees on downstream side of berms are visible in the background.

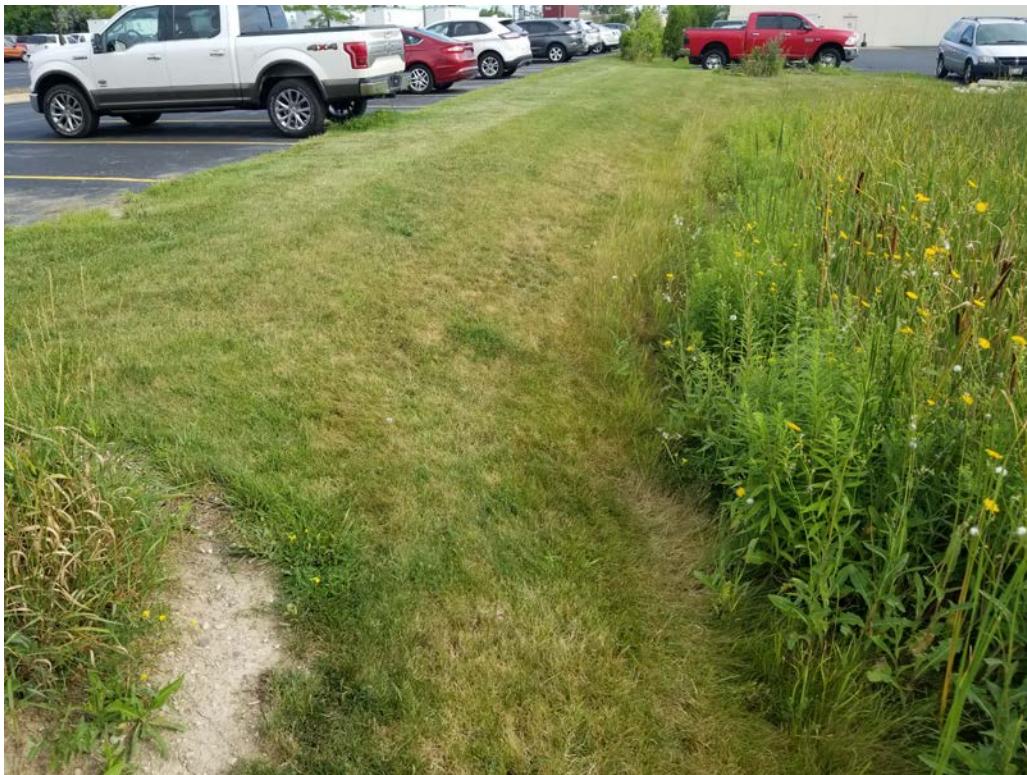
View of pond sideslope adjacent to parking lot.

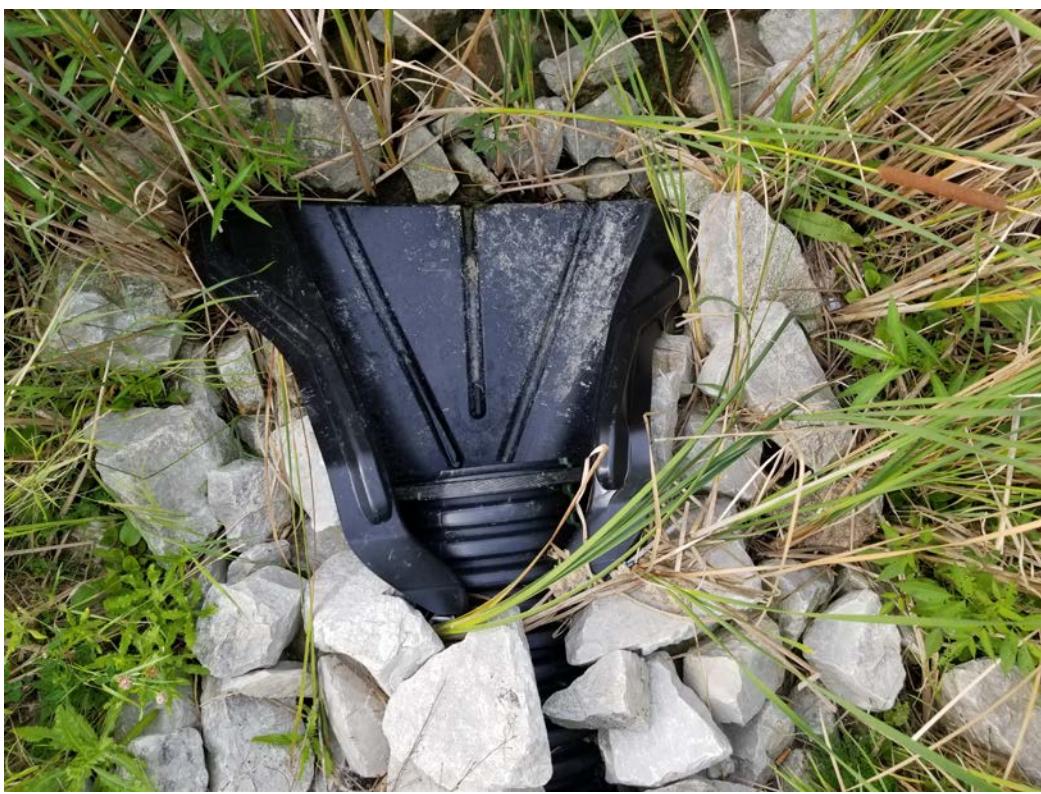
Pond inlet at NE corner. Pipe and riprap in good condition.

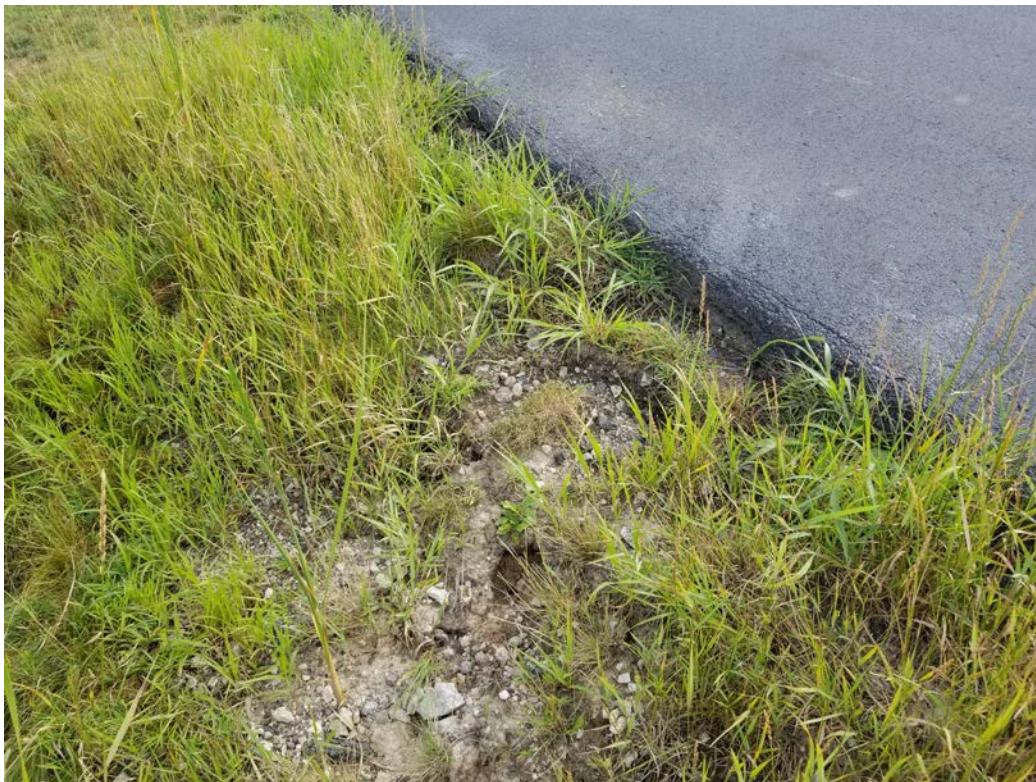
Minor erosion at edge of asphalt pavement adjacent to the pond east side.

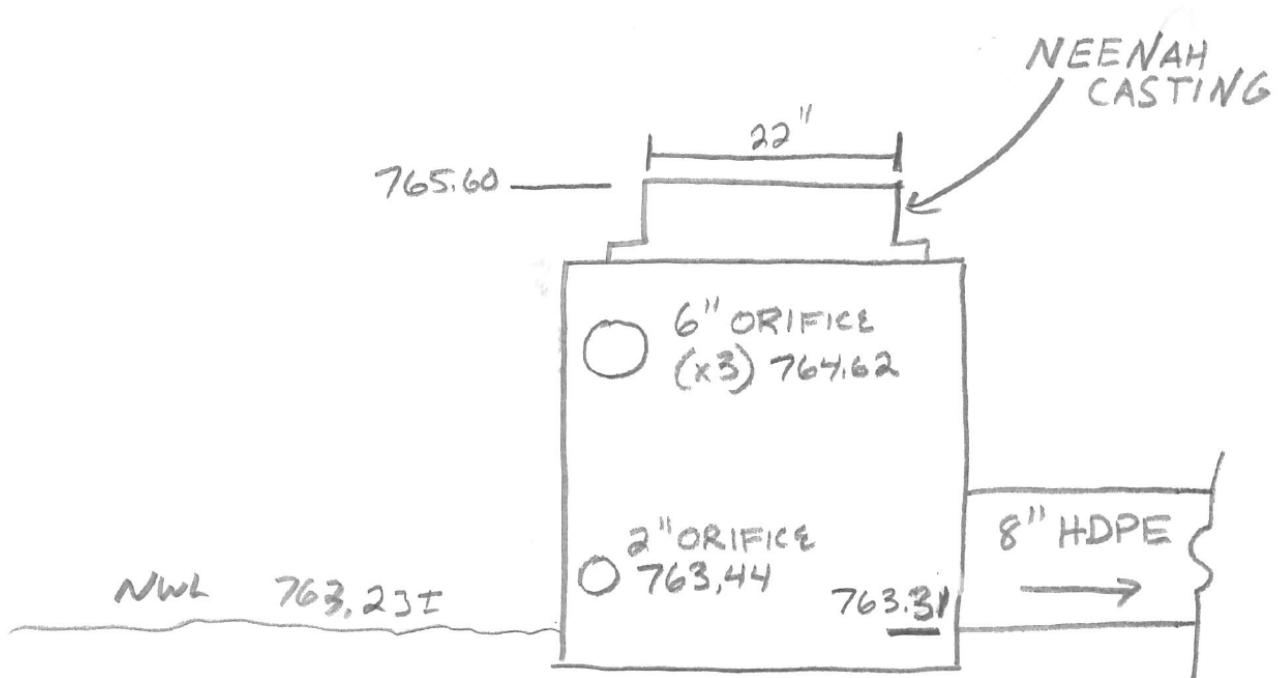
Sketch of existing outlet structure.
