## STORMWATER MANAGEMENT FACILITIES OPERATION AND INSPECTION REPORT

Quarter Section SE Name of Business/Subdivision LILLY CREEK HIGHLANDS III  
 Property Tax ID Number \_\_\_\_\_ Address of Property \_\_\_\_\_  
 Date 11-4-19 \_\_\_\_\_

Pond ID: SWP24S004  
 \_\_\_\_\_

**Re: Project No. 18-3239**  
**Storm Water Basin inspection**

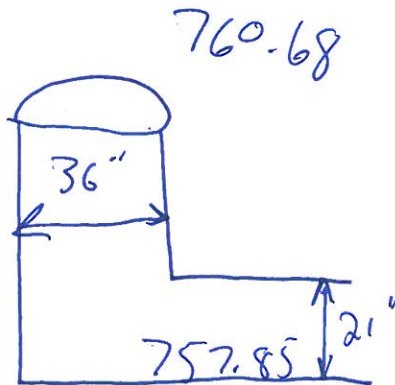
Sketch Outlet or Attach to Document

Compliance Verification	Design	Actual	Compliant Yes No		Comments ( Condition of Structure)
<b>Primary Outlet Pipe</b>					Outlet Pipe Material
Opening Diameter (inches)	21	21	X		RCP GOOD CONDITION
Upstream Invert	758.0	757.85	X		
Downstream Invert	757.65	757.49	X		
Length (feet)	47	42	X		
Slope (%)	0.74%	0.85	X		
<b>Secondary Outlet Pipe</b>	(If Applicable)				Outlet Pipe Material
Opening Diameter (inches)					
Upstream Invert					
Downstream Invert					
Length (feet)					
Slope (%)					
<b>Riser</b>	(If Applicable)				Riser Material
Opening Diameter (inches)		36	X		CMP IN GOOD CONDITION
Elevation		760.68	X		
<b>Upper Discharge Control</b>	(If Applicable)				
Opening Diameter (inches)					
Elevation
