STORMWATER MANAGEMENT FACILITIES OPERATION AND INSPECTION REPORT

Northfield Manor
--- Northfield Dr.

Pond ID: SWP24N003

SWMP Inspection Photos SWP24N003 (7/1/2019) – Village of Menomonee Falls, WI

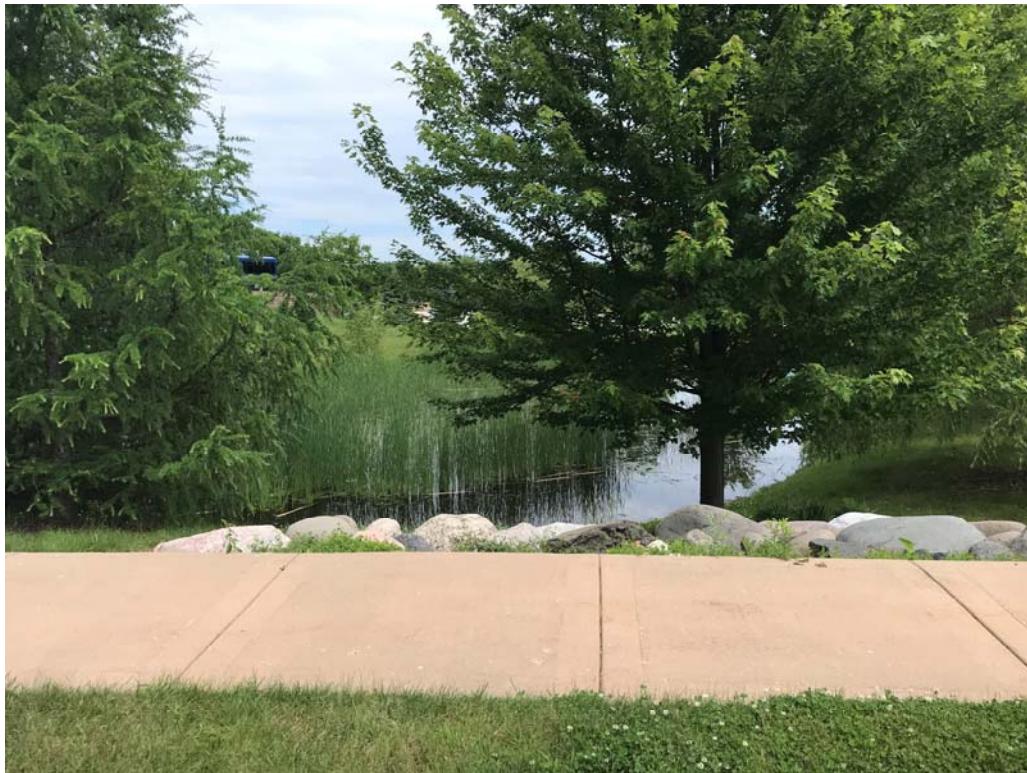
Figure 1: At east side of Northfield Drive; looking easterly

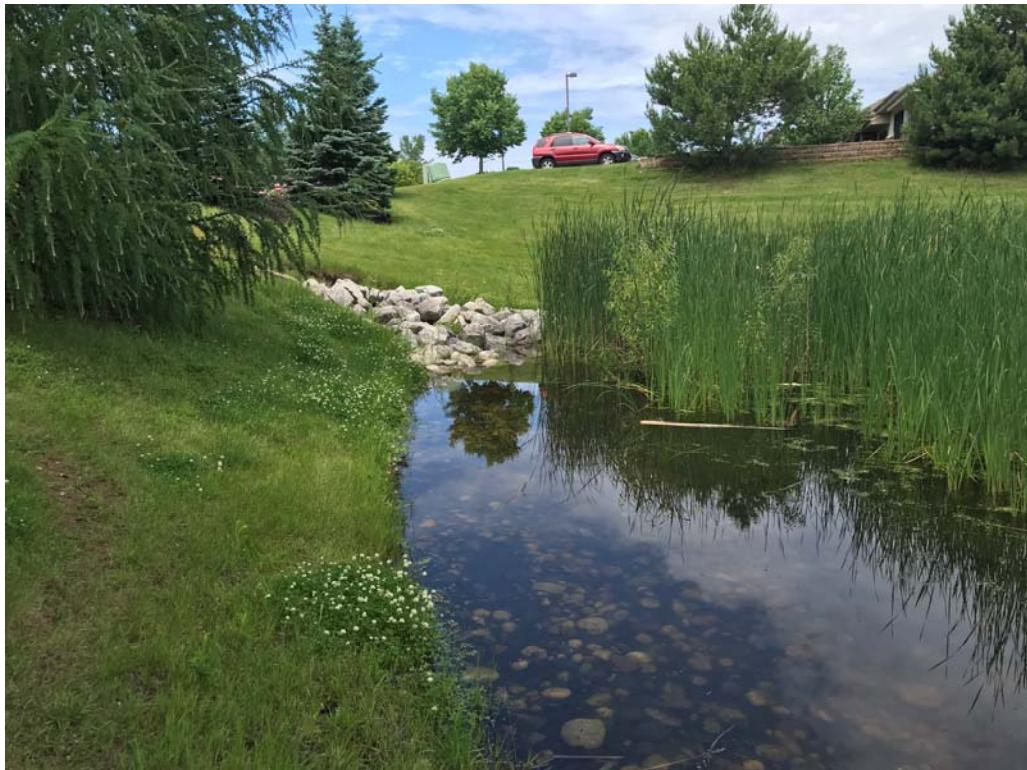
Figure 2: At SW of pond; looking northerly to storm outfall (rip rap) into pond

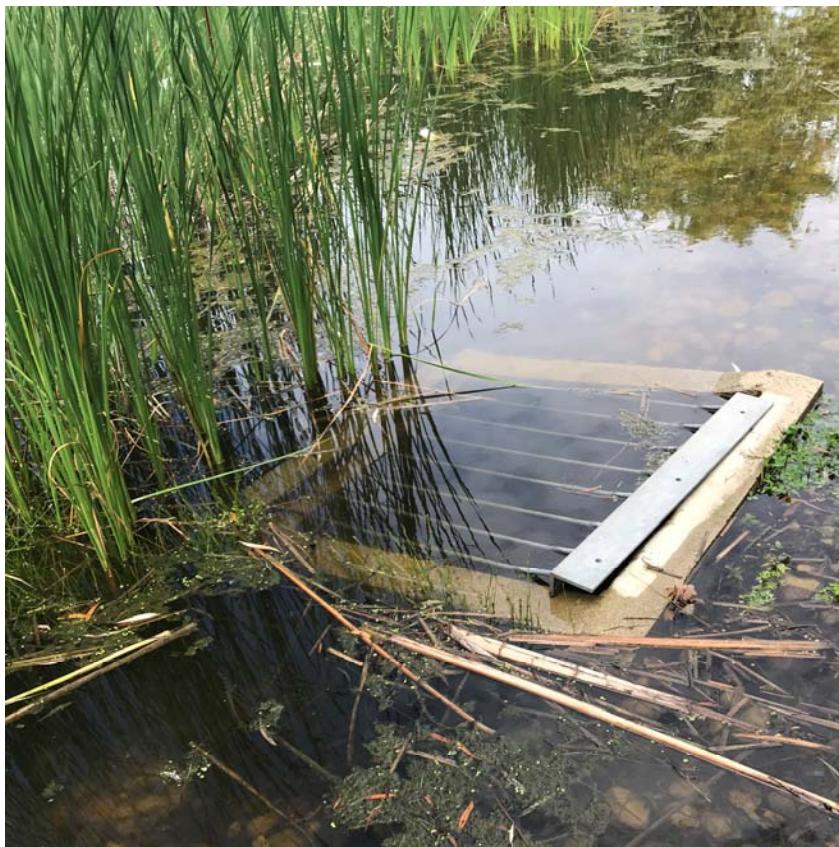
Figure 3: At SE portion of pond; looking at pond outlet structure

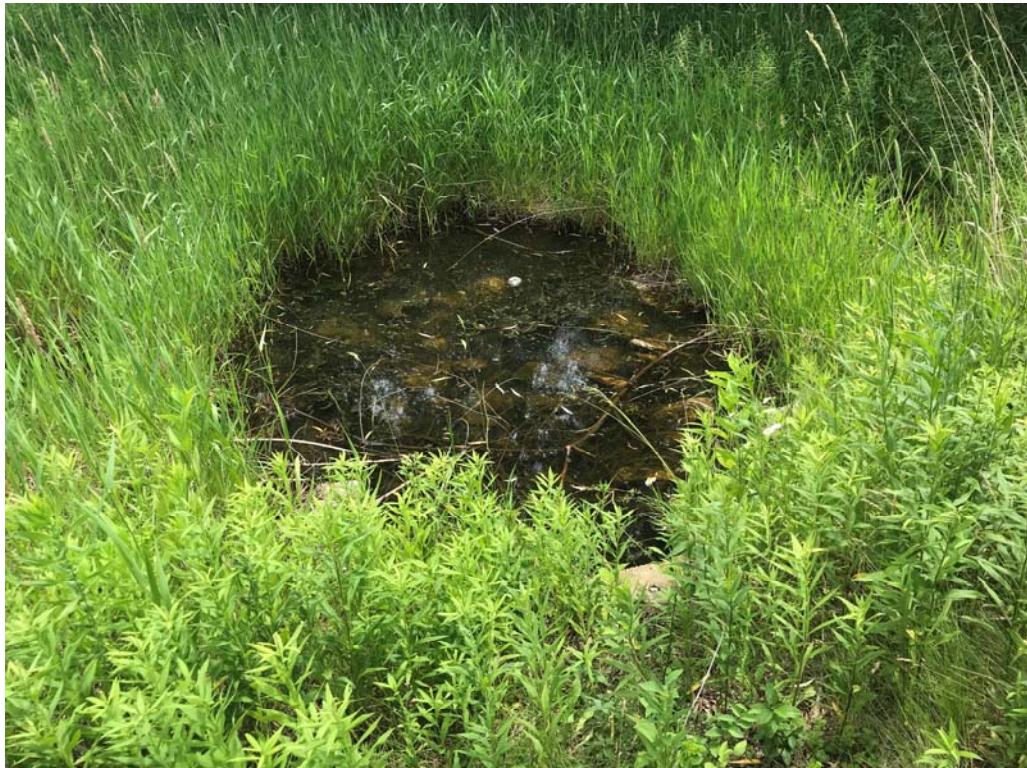
Figure 4: At SE portion of pond; looking southerly at pond 12" RCP outlet pipe

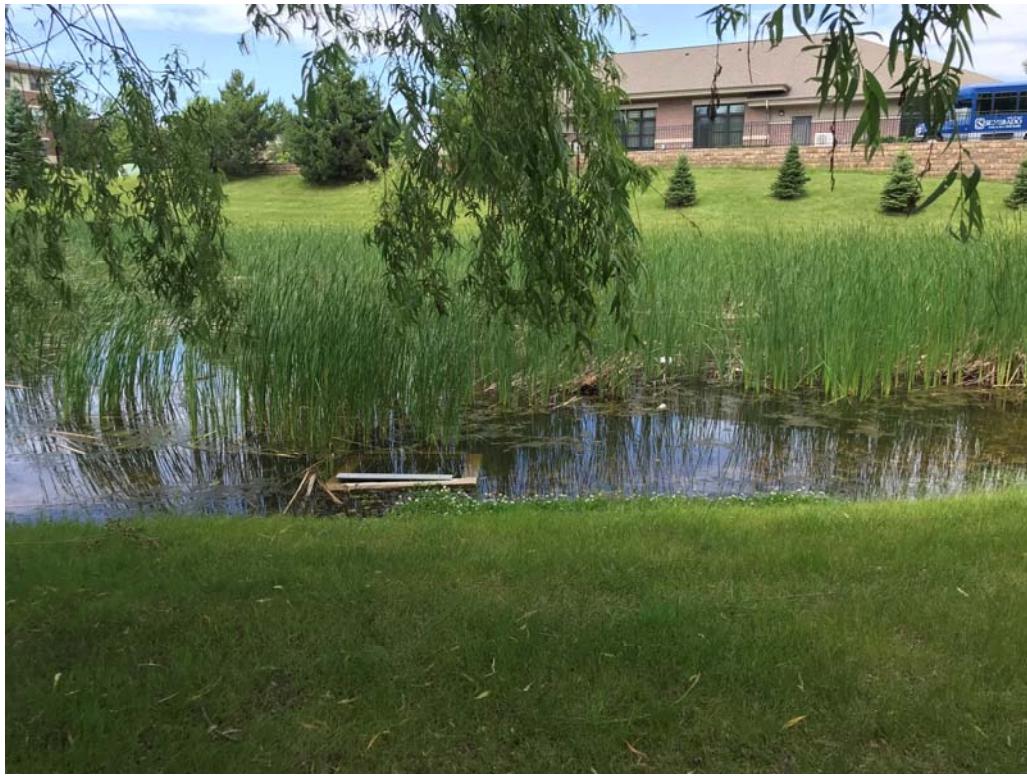
Figure 5: At SE portion of pond; looking northerly with outlet structure in foreground

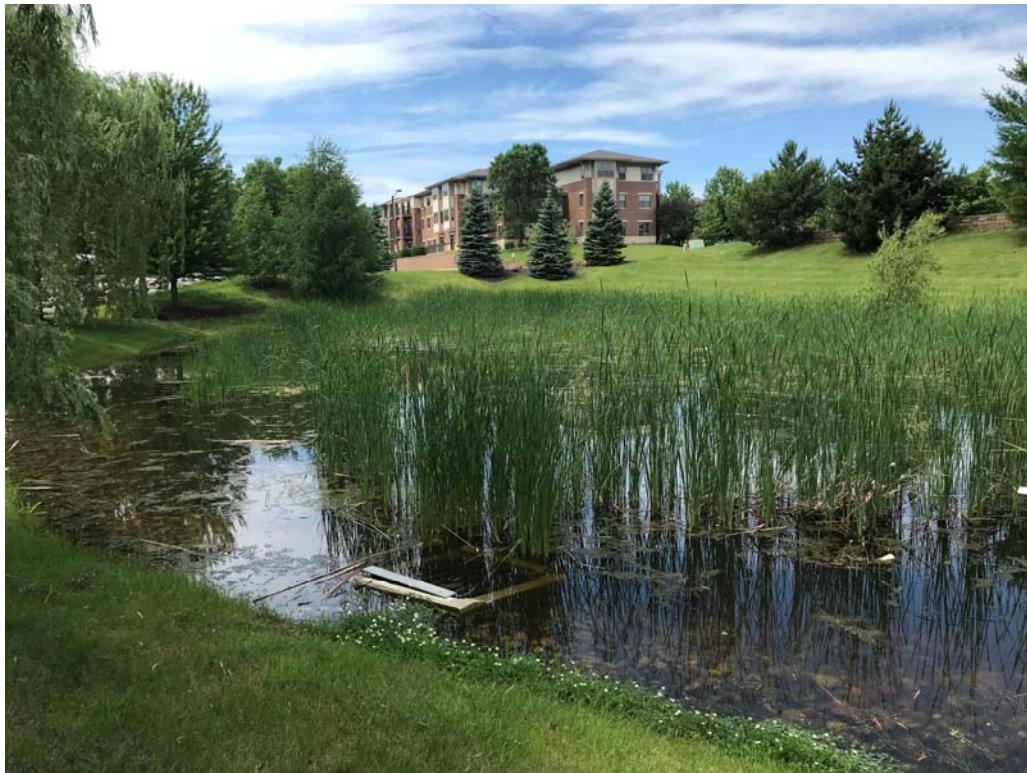
Figure 6: At SE portion of pond; looking northerly with outlet structure in foreground

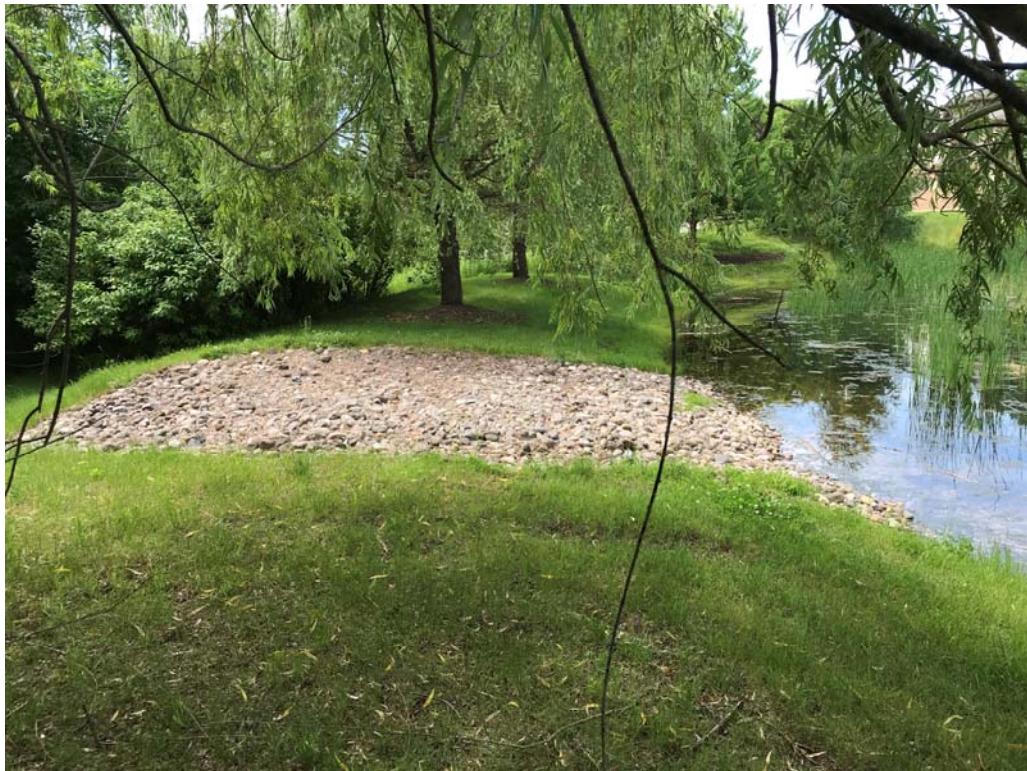
Figure 7: At SE portion of pond; looking southerly to emergency spillway

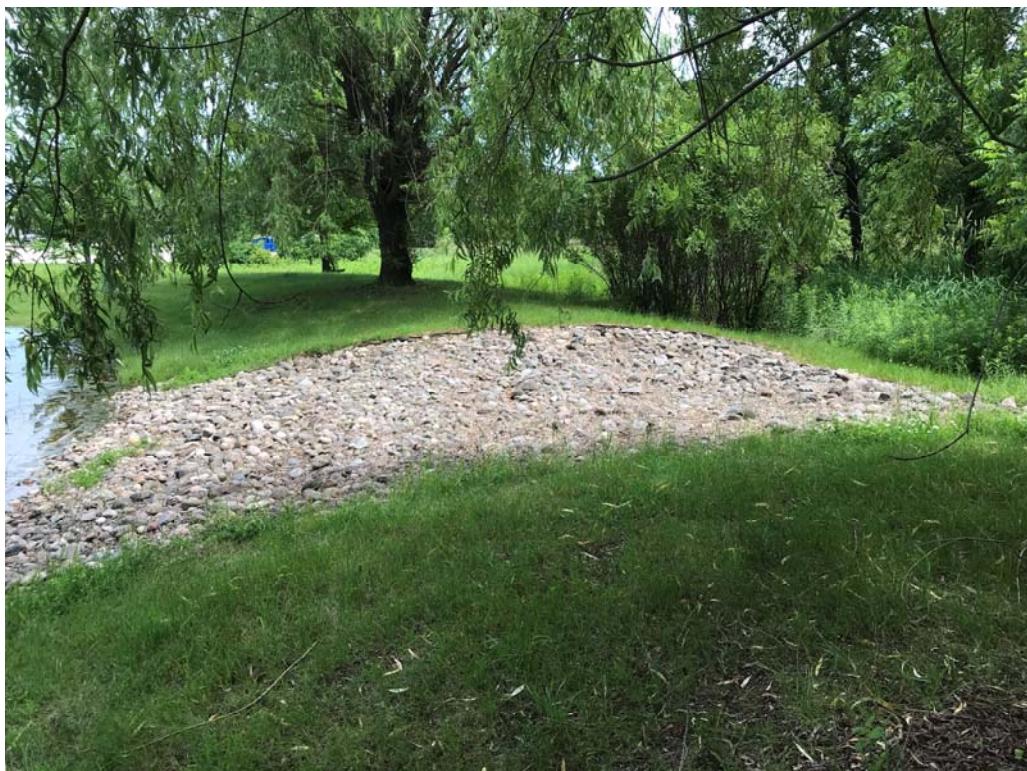
Figure 7: At SE portion of pond; looking westerly to emergency spillway
