STORMWATER MANAGEMENT FACILITIES OPERATION AND INSPECTION REPORT

Quarter Section NE1/4 24-8-20 Name of Business/Subdivision Alta Mira Apartments
Property Tax ID Number MNFV0093947 Address of Property W129N6889 Northfield Dr.
Date 08/06/19 006 Menomonee Falls, WI
53051

Pond ID: SWP24N006

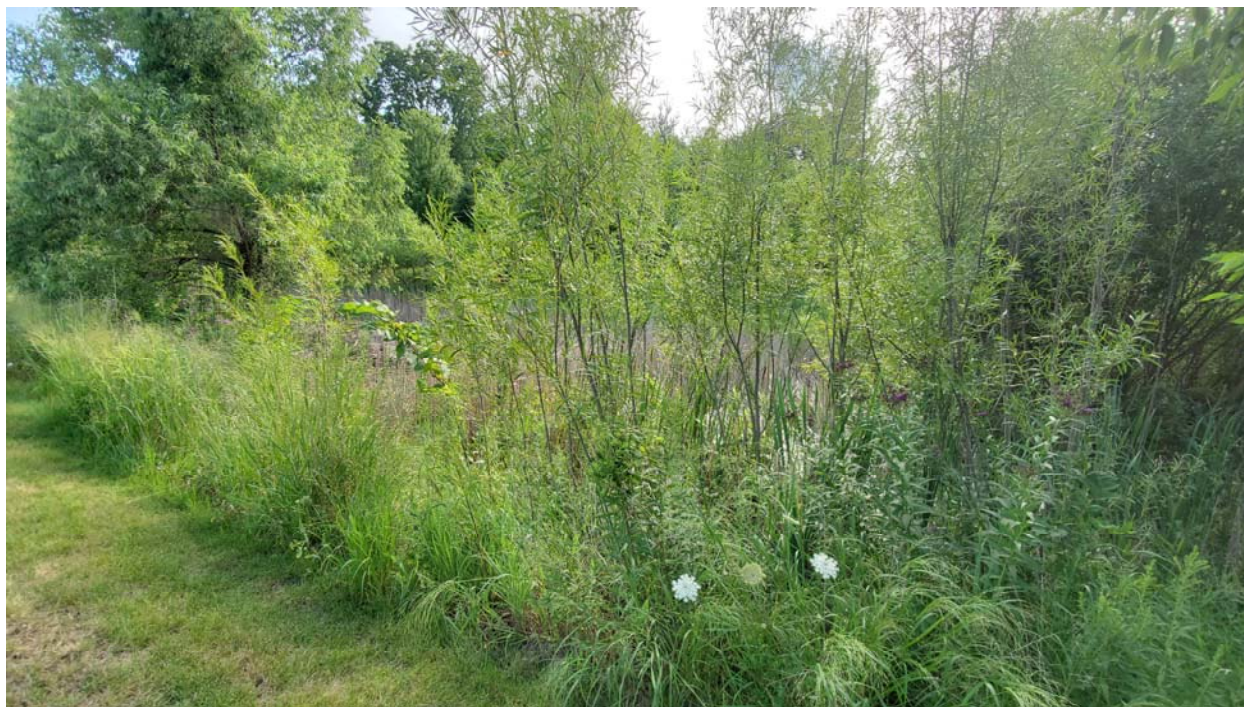
Figure 1: At north portion of pond; looking southwesterly

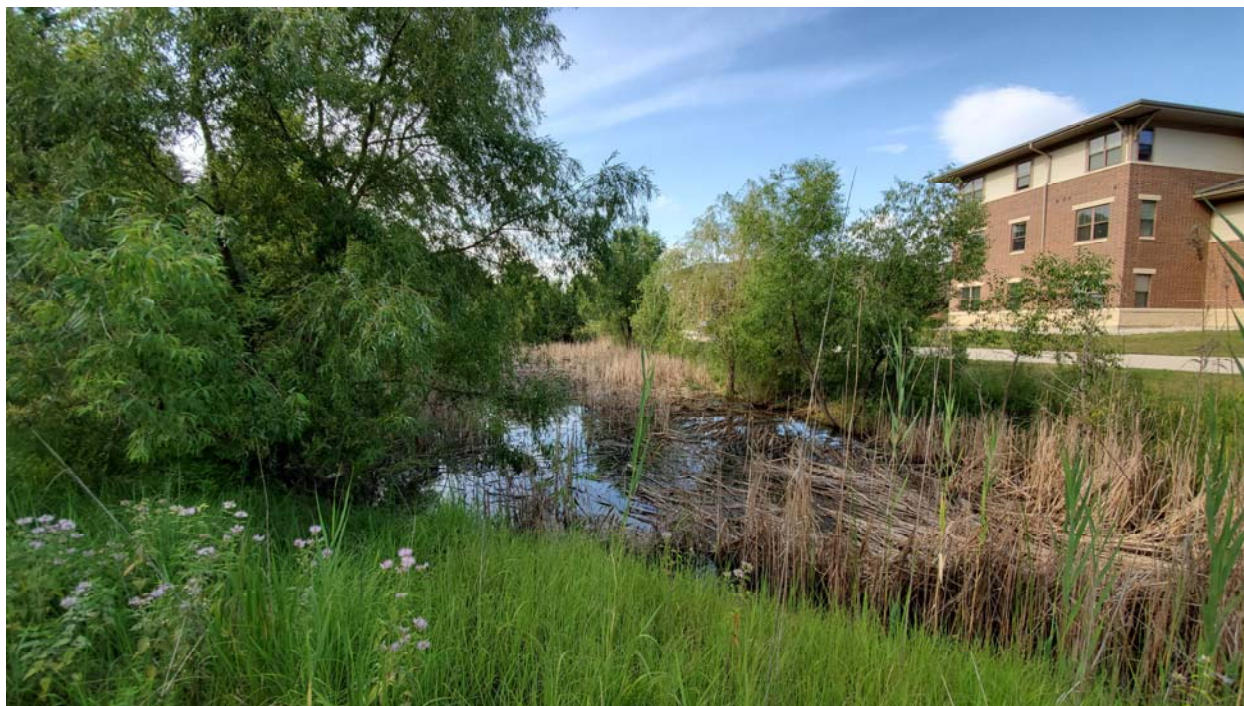
Figure 2: At south portion of pond; looking northerly (two storm outfalls)

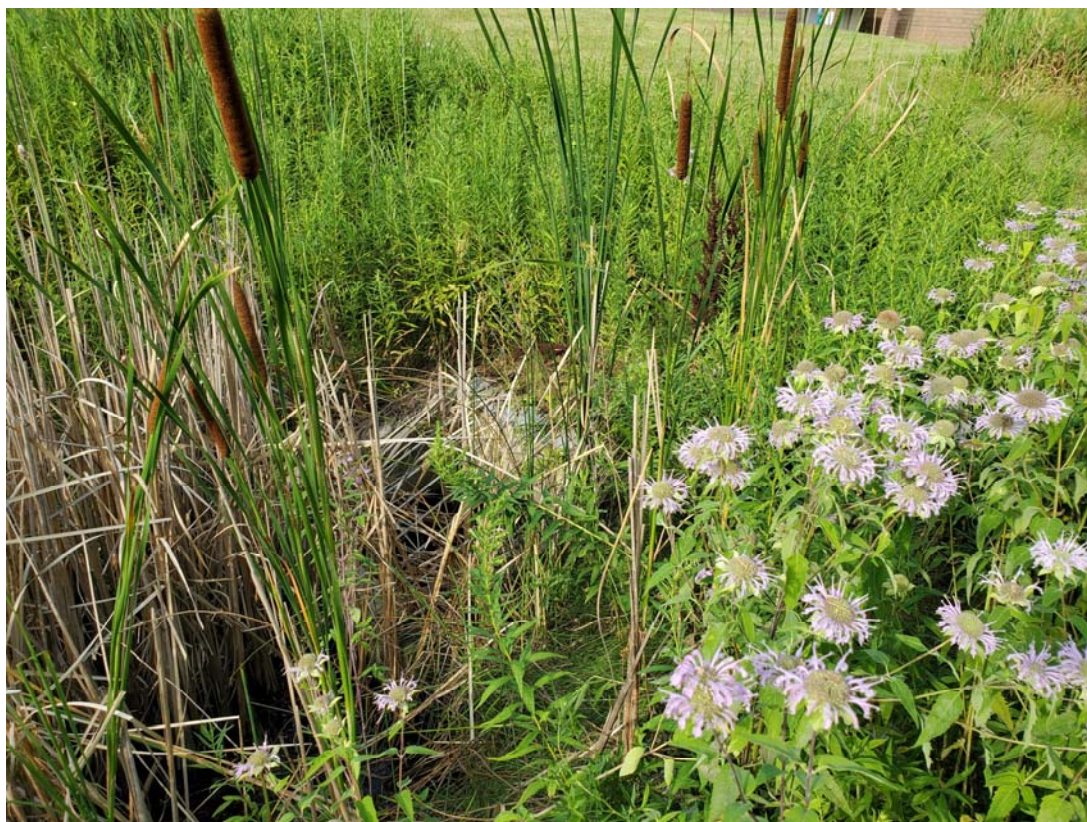
Compliance Verification	Design	Actual	Compliant Yes No	Comments (Condition of Structure)
Primary Outlet Pipe				Outlet Pipe Material
Opening Diameter (inches)	12"	12"	X	Concrete HEAVY VEGETATION AND DEBRIS SURROUNDING
Upstream Invert	790.00	789.91	X	
Downstream Invert	789.00	788.69	X	
Length (feet)	150.0'	148.35'	X	
Slope (%)	0.67%	0.82%	X	
Secondary Outlet Pipe	(If Applicable)			Outlet Pipe Material
Opening Diameter (inches)				
Upstream Invert				
Downstream Invert				
Length (feet)				
Slope (%)				
Riser	(If Applicable)			Riser Material
Opening Diameter (inches)				
Elevation				
Upper Discharge Control	(If Applicable)			
Opening Diameter (inches)				
Elevation

Figure 3: At southeast portion of pond; looking northerly (pond outlet structure)

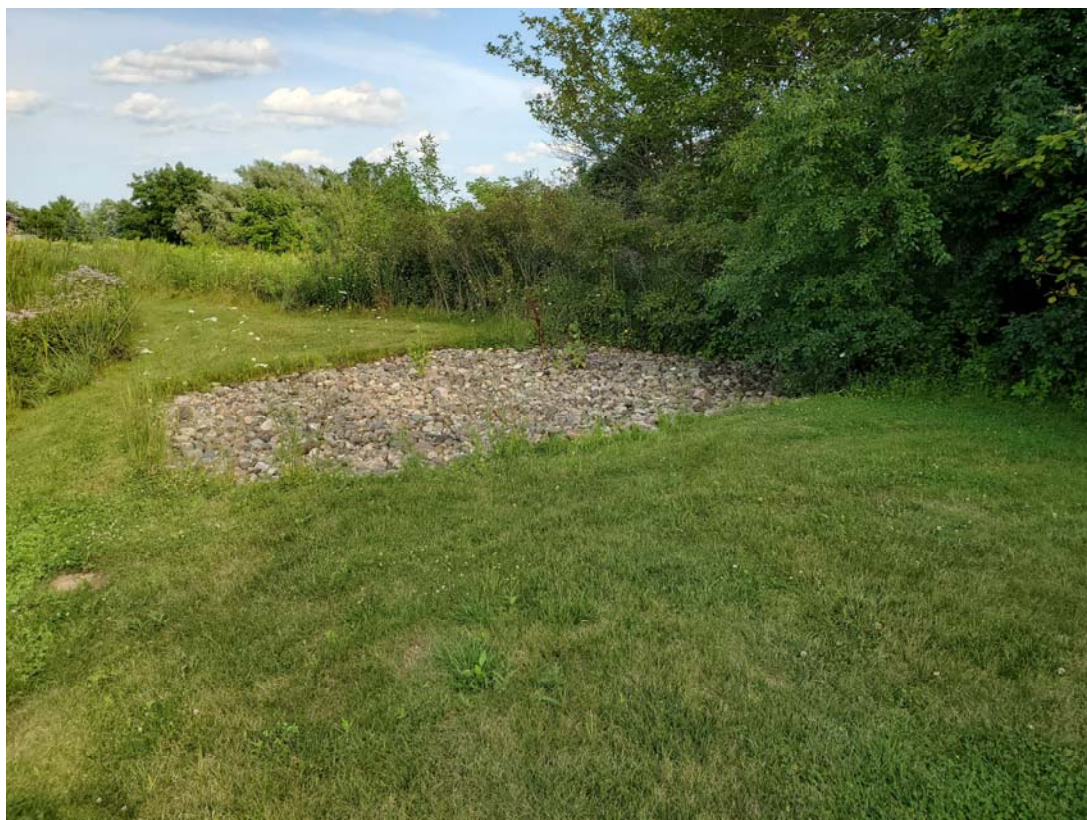
Figure 4: At southeast portion of pond; looking southeasterly (emergency spillway)
