STORMWATER MANAGEMENT FACILITIES OPERATION AND INSPECTION REPORT

SW 1/4 Sec 33 Name of Business/Subdivision
0131064 Address of Property
Cranes Crossing
N48 W18200 Lisbon Road

Pond ID: SWP 33s002
Temporary Pond P4

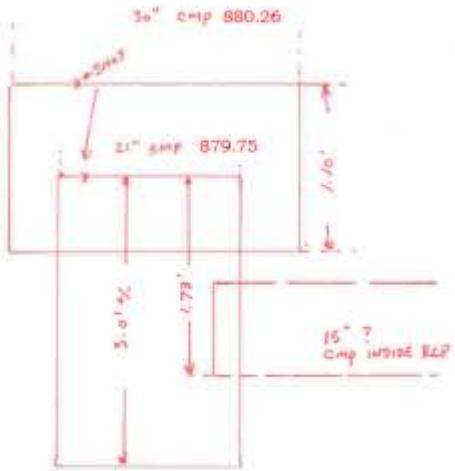
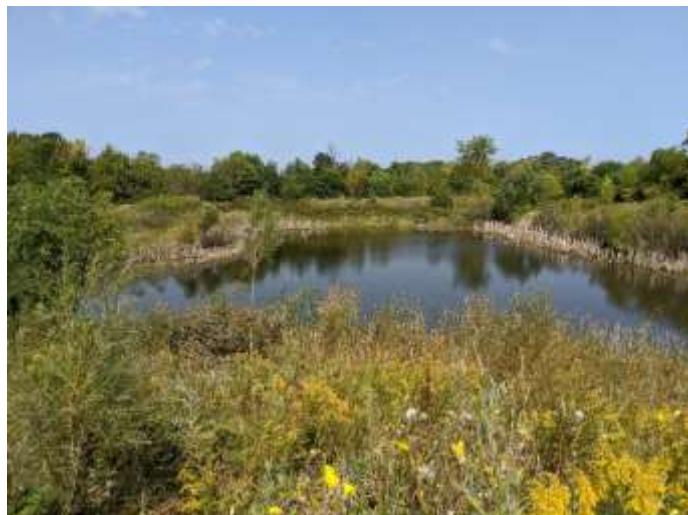
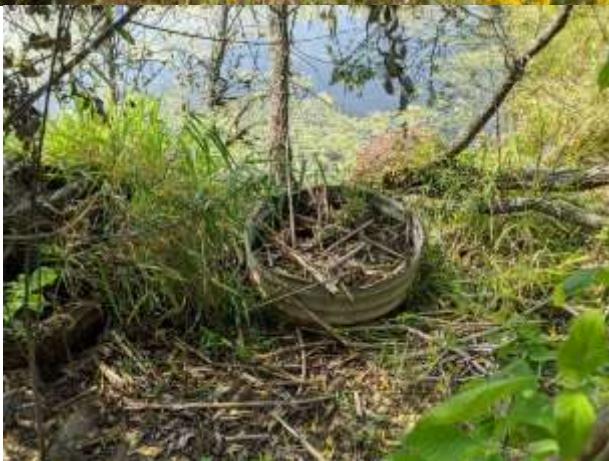
Sketch Outlet or Attach to Document

Compliance Verification	Design	Actual	Compliant Yes	No	Comments (Condition of Structure)
Primary Outlet Pipe					Outlet Pipe Material
Opening Diameter (inches)	15"	15"	X		CMP stub into RCP
Upstream Invert	878.00	877.98	X		
Downstream Invert	877.88	877.81		X	Downstream pipe appears to be blocked. Downstream MH full of water.
Length (feet)	32.03	34.9	X		
Slope (%)	0.381	0.49	X		
Secondary Outlet Pipe	(If Applicable)				Outlet Pipe Material
Opening Diameter (inches)					Not Applicable (NA)
Upstream Invert					
Downstream Invert					
Length (feet)					
Slope (%)					
Riser	(If Applicable)				Riser Material
Opening Diameter (inches)	18"	21"		X	Corrugated Metal Pipe with rebar trash grate
Elevation	879.75	879.75	X		
Upper Discharge Control	(If Applicable)				
Opening Diameter (inches)					NA
Elevation

Compliance Verification	Design	Actual	Compliant Yes	No	Comments
Lower Discharge Control	(If Applicable)				
Opening Diameter (inches)	2-4" dia.			X	Cannot determine – underwater and not visible.
Elevation	878.00			X	
Other (Description)					
Opening Type and Size (inches)					NA
Elevation					
Emergency Spillway					
Elevation	885.75	885.4±	X		
Length of spillway (feet)	12.0	17±	X		
Embankment	Present Yes		Comments/Maintenance Requirements		
Unauthorized Plantings, trees, or woody vegetation	X		Woody vegetation adjacent to outlet structure and riser structure full of debris.		
Animal burrows or slope erosion	X				
Storm Sewer Outfalls	Type & Size		Location		Comments
Outfall 1	V-channel		SW corner		Remove woody vegetation
Outfall 2	24" RCP		South side		Pipe in good condition, restore displaced riprap
Outfall 3	21" RCP		SE corner		Pipe in good condition, remove woody vegetation
Storage Properties	Design	Actual	Compliant Yes	No	Equipment Used
