## STORMWATER MANAGEMENT FACILITIES OPERATION AND INSPECTION REPORT

SW 1/4 SEC 26	Name of Business/Subdivision	First Park
V0103985	Address of Property	W156 N5384 Pilgrim Rd

Dry Pond		Location of Pond	East of Pilgrim Rd, South of Shawn Circle
Wet Pond	X		
Other			
	Pond ID: SWP Basin A <u>SWP26S003</u>

PROJECT:  
**FIRST INDUSTRIAL POND A SURVEY**

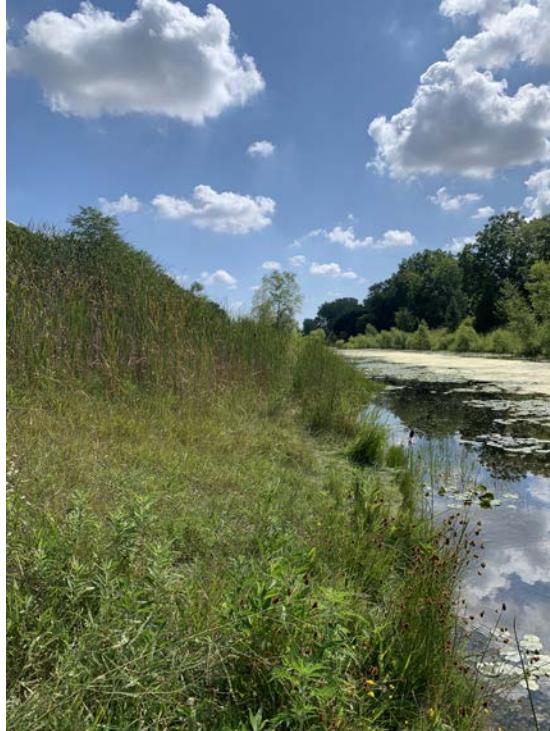
<b>Photo #</b> 1	<b>Date</b> 08/07/20	
<b>Description</b> Facing east towards Basin A. Vegetation along basin provides adequate cover.

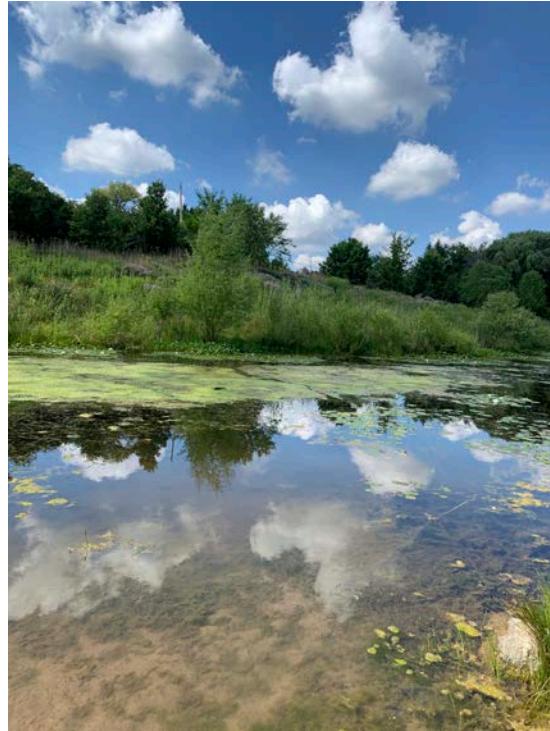
<b>Photo #</b> 2	<b>Date</b> 08/07/20	
<b>Description</b> Facing south towards Basin A.

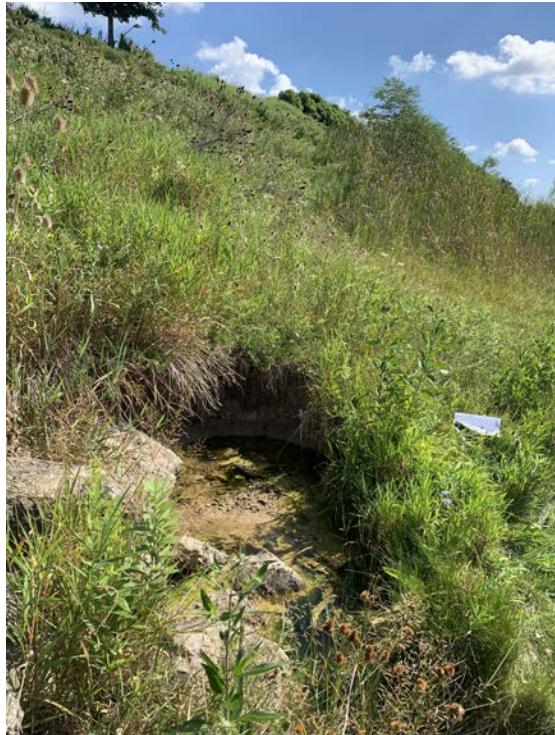
2. Presence of erosion	Annually	Yes	Yes	Some sediment accumulation near pond inlets.
3. Cracking, bulging, or sliding of slopes/ embankments	Annually	Yes	No

<b>Photo #</b> 3	<b>Date</b> 08/07/20	
<b>Description</b> Facing north east towards an area of scouring near the northern pond inlet.

4. Unauthorized addition of trees or other landscaping	Annually	Yes	No	
5. Unauthorized placement of fill material	Annually	Yes	No	
6. Riprap obstruction or failures	Annually	Yes	No	Replace areas of stone that have been displaced with high flow events at pond inlets.
<b>II. Discharge Pipes, Outlet Control Structure and Emergency Spillway</b>

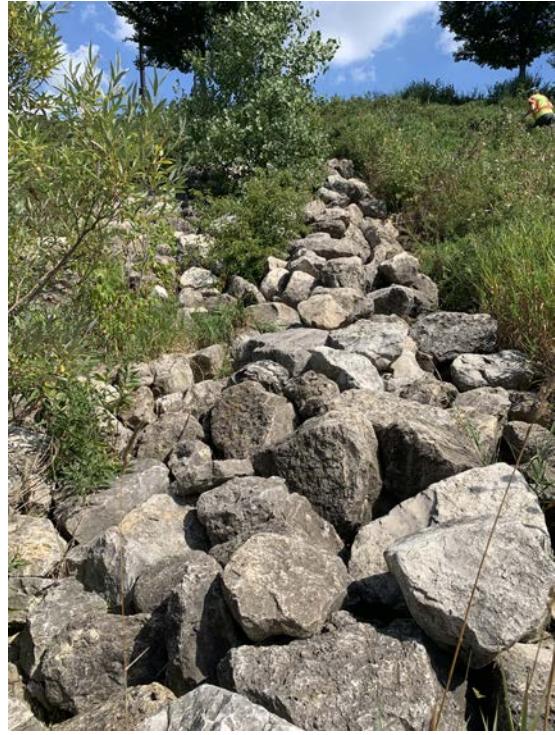
<b>Photo #</b> 4	<b>Date</b> 08/07/20	
<b>Description</b> Facing north towards the northern pond inlet adjacent to scouring.

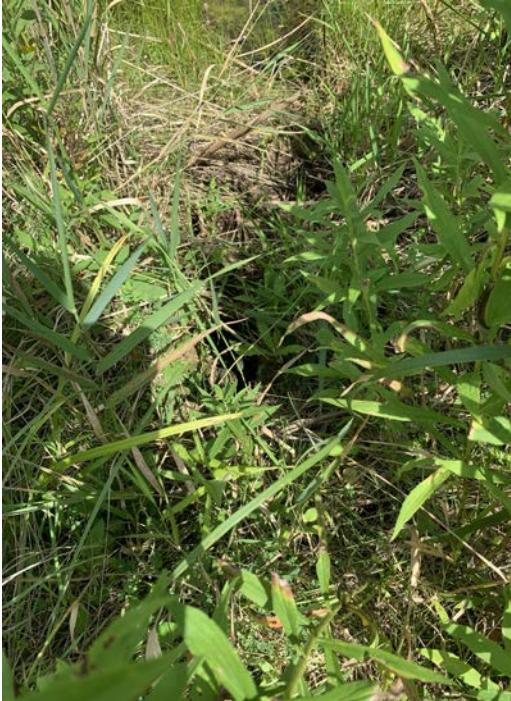
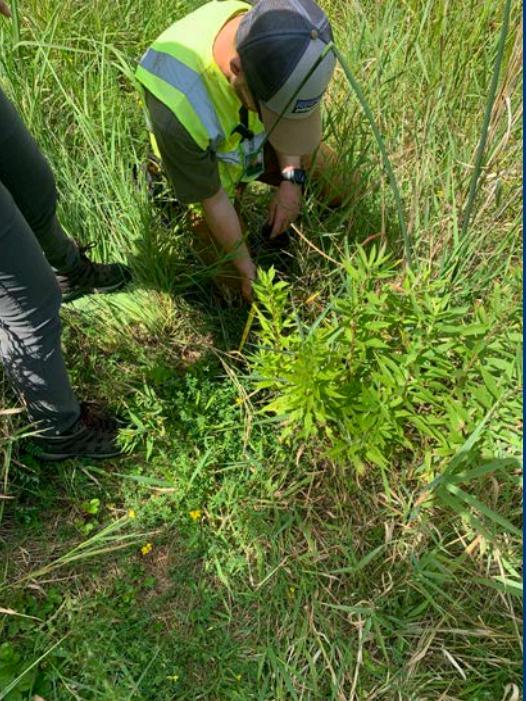
Photo # 7	Date 08/07/20

<b>Description</b> Facing north towards an area in the bank where muskrats have created burrows causing holes approximately 12" deep. Use caution walking and consider no trespass signs with any potential safety hazards.

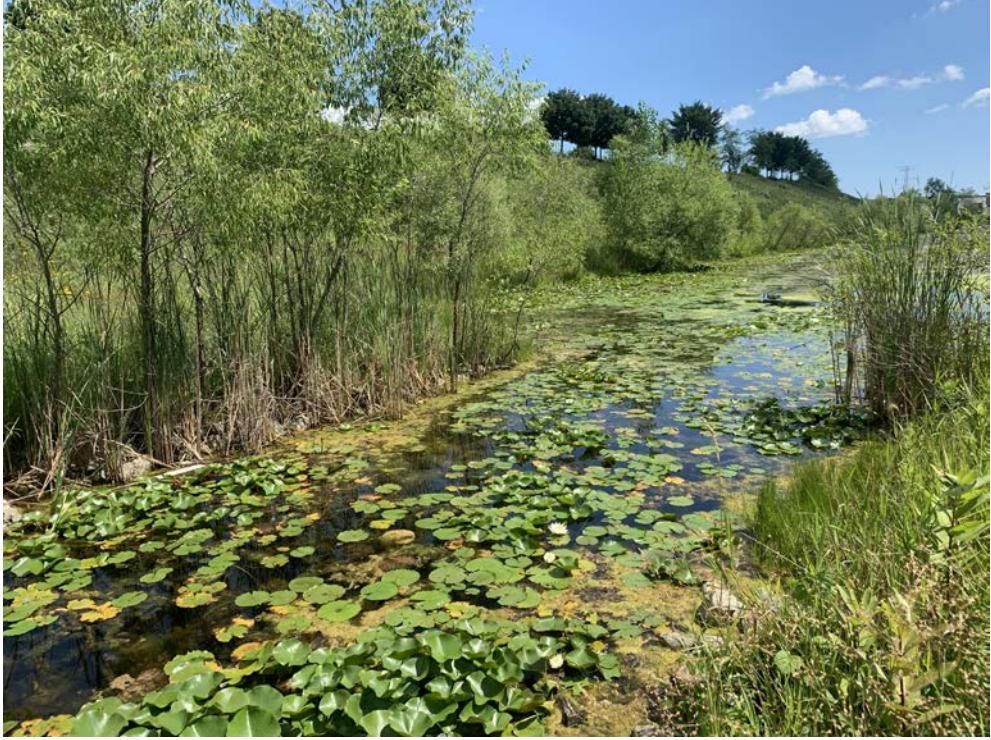
Photo # 8	Date 08/07/20

<b>Description</b> Facing northeast towards the shallow middle section of Basin A.

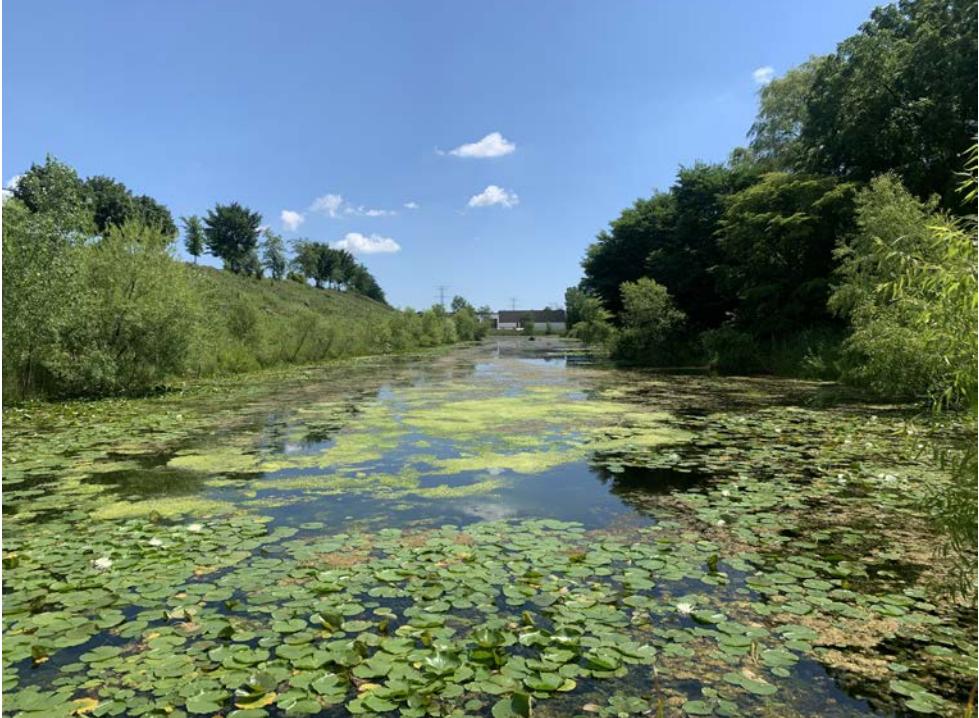
<b>Photo #</b> 9	<b>Date</b> 08/07/20

<b>Description</b> Facing east towards Basin A which has dense tree cover (a natural condition, these trees were not planted) and vegetation to the south.

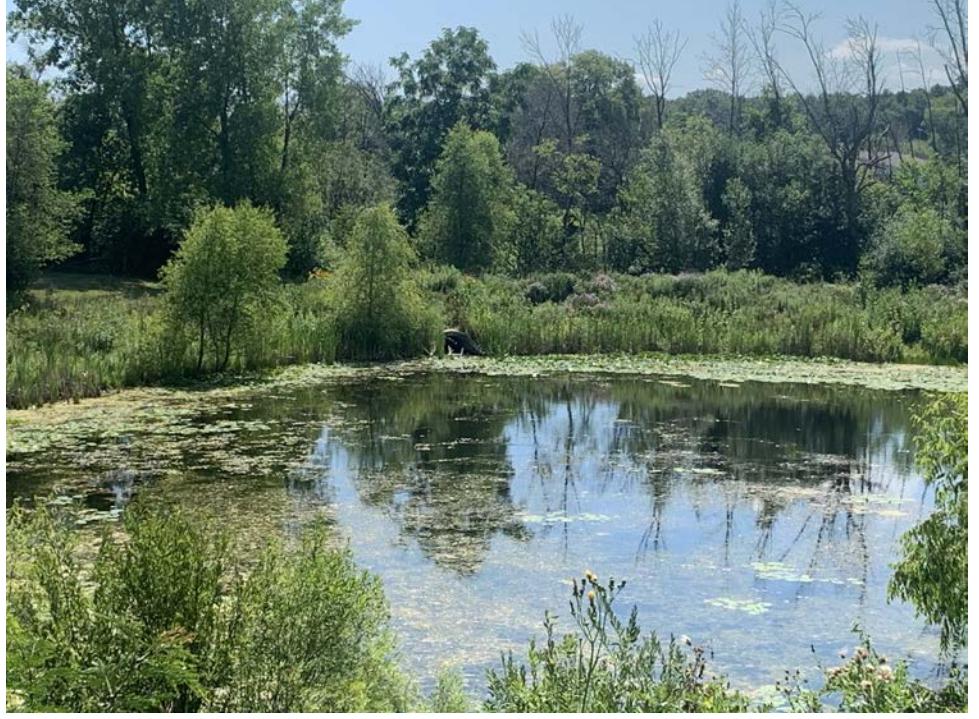
<b>Photo #</b> 10	<b>Date</b> 08/07/20

<b>Description</b> Facing southeast towards stormwater pond outlet located at southeast end of pond.

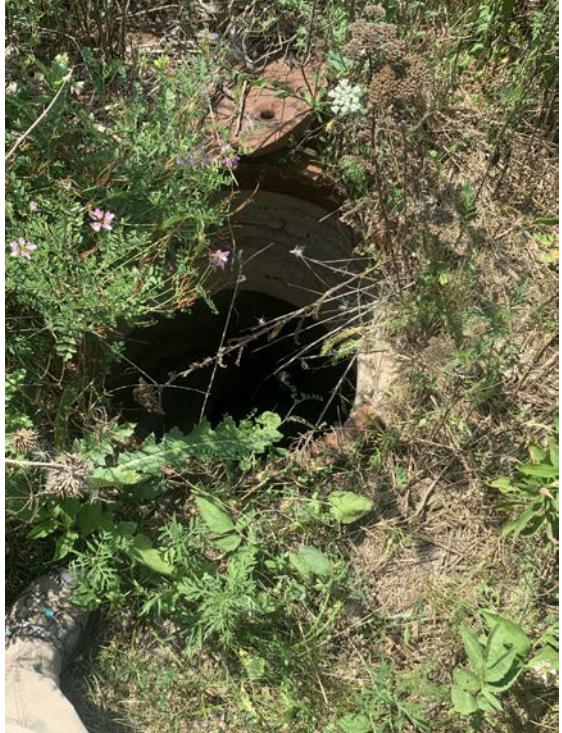
<b>Photo #</b> 11	<b>Date</b> 08/07/20

1. Condition of pipes that discharge into the basin. Presence of any obstructions.	Monthly	Yes	No	
2. Condition of pipes at outlet control structure. Presence of any obstructions.	Monthly	Yes	Yes	Silt fence downstream of outlet may be removed (note - it is not causing an obstruction at time of inspection). Open manhole cover creating safety concern.

<b>Description</b> Uncovered manhole at southeast stormwater pond outlet.

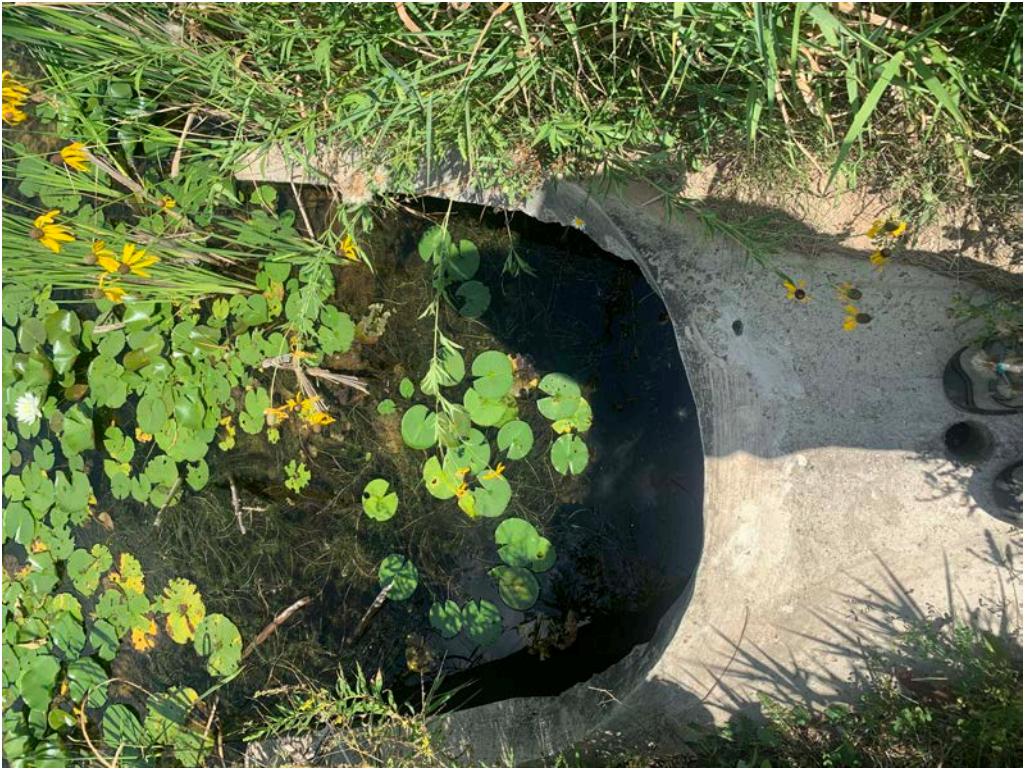
Photo # 13	Date 08/07/20

<b>Description</b> Facing southeast, view is looking down at the stormwater pond outlet structure.

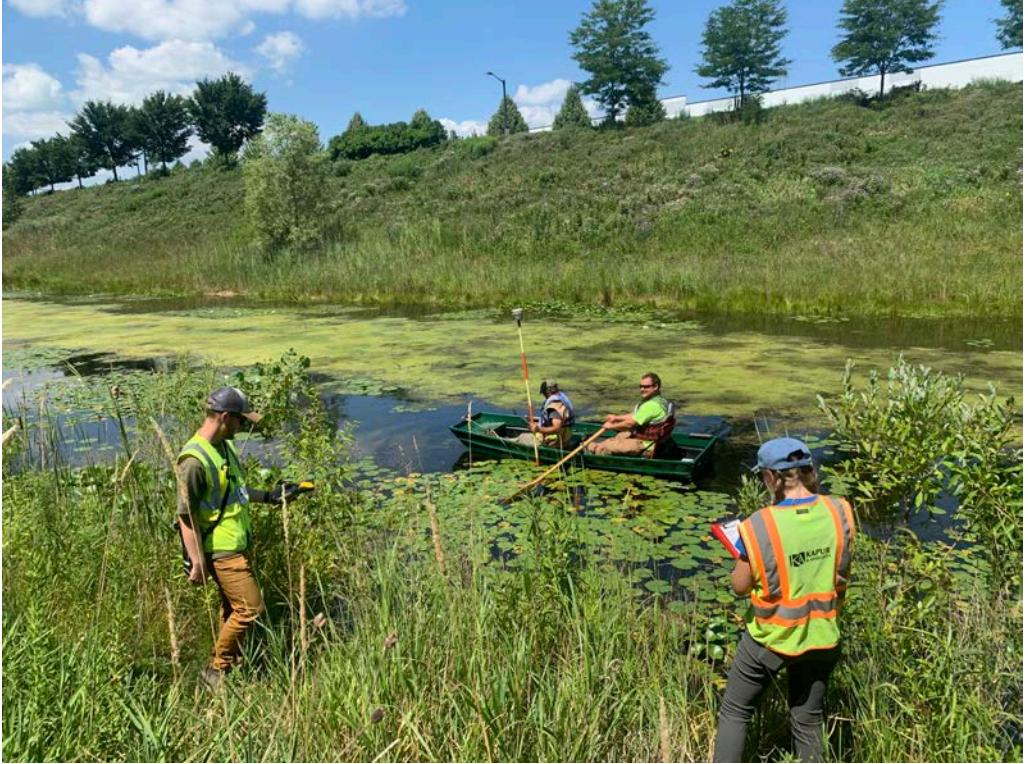
Photo # 14	Date 08/07/20

<b>Description</b> Facing north view of survey crew completing sediment survey and inspection crew.
