## STORMWATER MANAGEMENT FACILITIES OPERATION AND INSPECTION REPORT

Quarter Section NW 1/4 Sec Pilgrim Glen Condominium Plat  
 23-8-20 Name of Business/Subdivision Addendum No. 2  
 Property Tax ID Number 0090-996-126  
 thru 0090-996-167 Address of Property Amberleigh Circle  
 Date 8/31/20

Location of Pond SE Quadrant of Property  
 Pond ID: SWP23N001

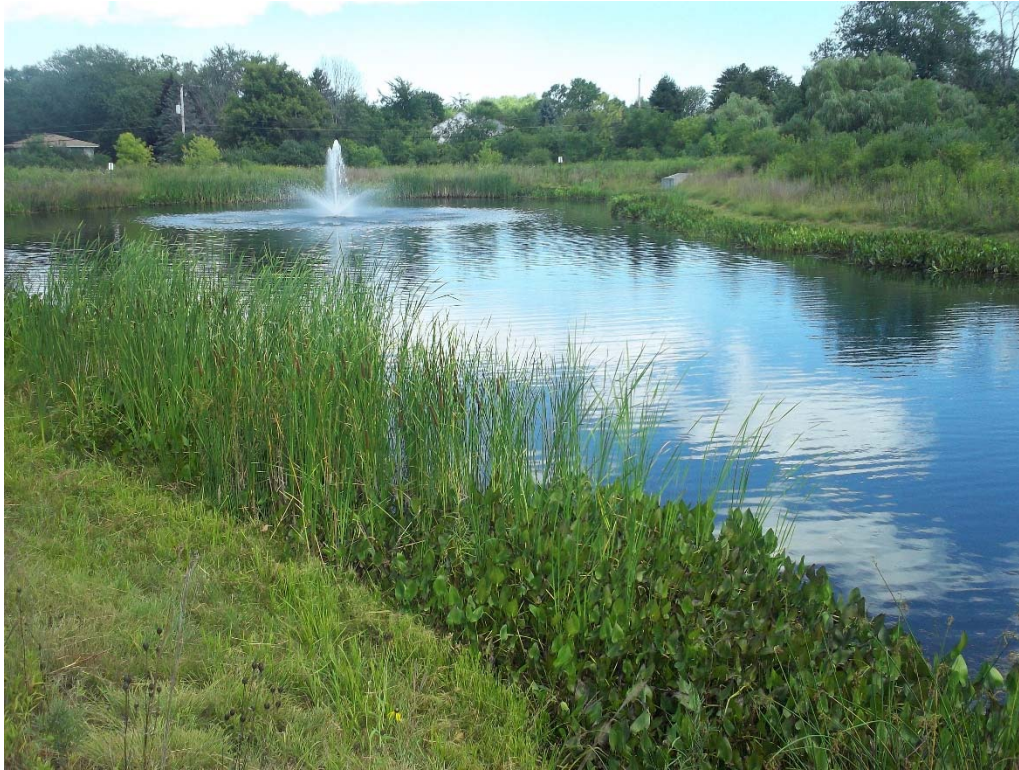
Photo 1: NW side of pond, looking southeasterly.

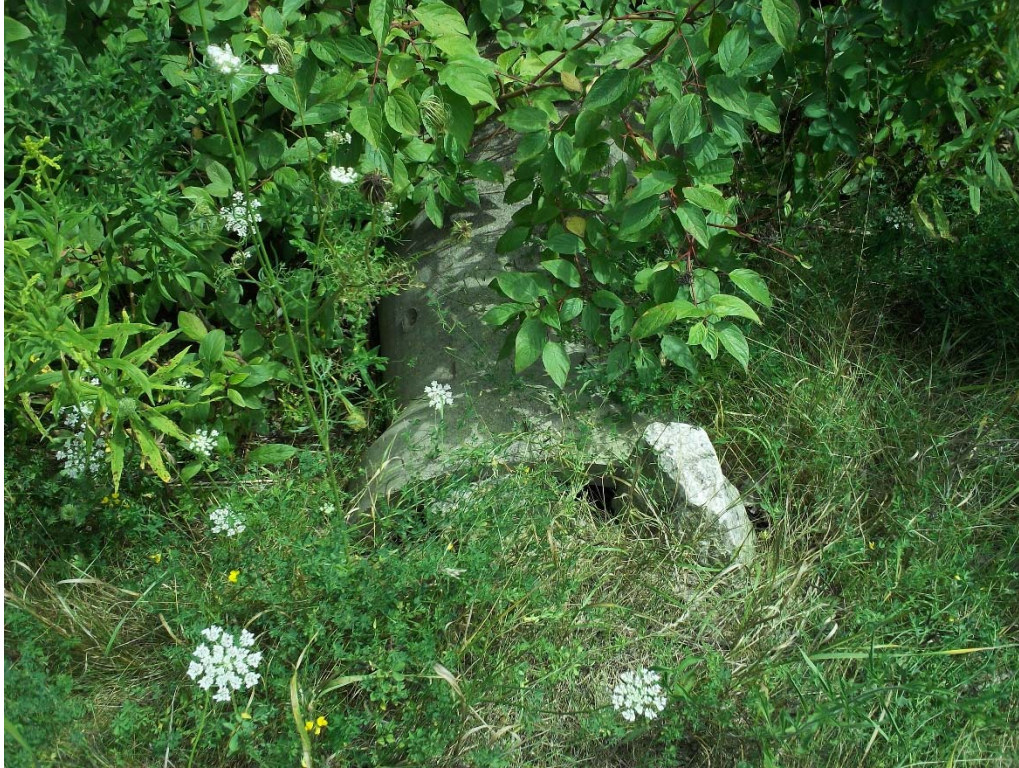
| Compliance Verification | Design | Actual | Compliant<br>Yes No | Comments | |
|---|---|---|---|---|---|
| Outfall 5 (ES-10) | RCP 12" | | W. Ditch Portion of Pond | | Heavy veg. growth and end sect. disconnected |

Photo 3: Outfall 1 (ES-10) heavy vegetation.

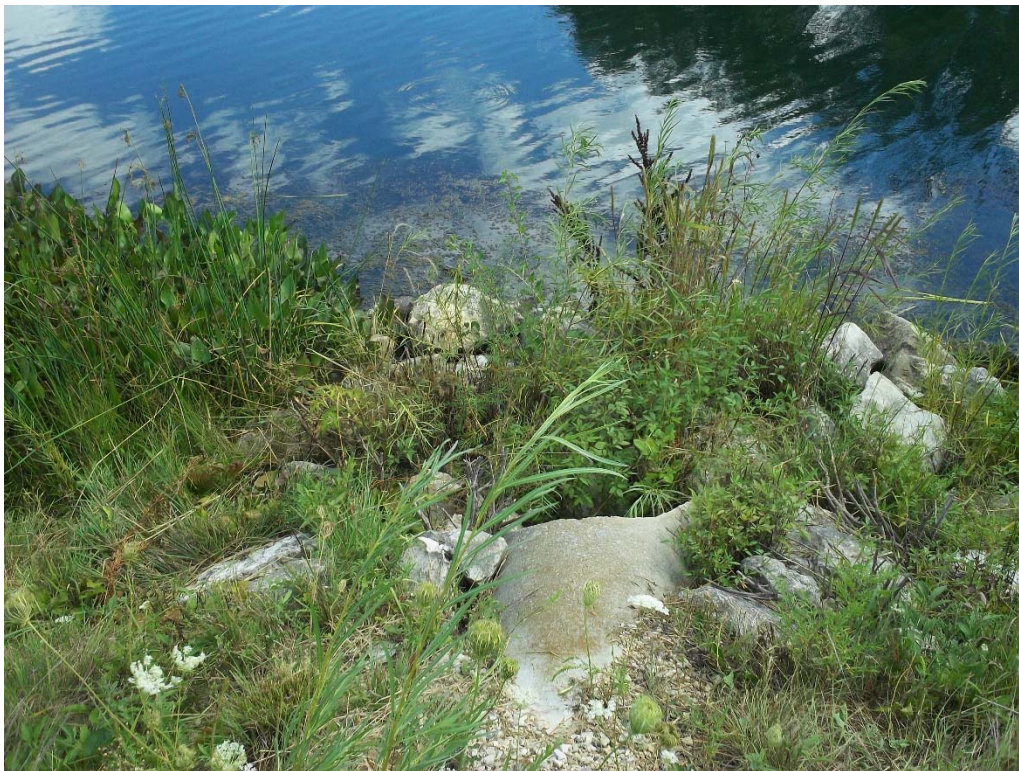
| Compliance Verification | Design | Actual | Compliant<br>Yes No | Comments | |
|---|---|---|---|---|---|
| Outfall 2 (ES-7) | RCP 18" | | North Portion of Pond | | Erosion at outfall |

Photo 4: Outfall 2 (ES-7) Erosion at rip rap and heavy vegetation.

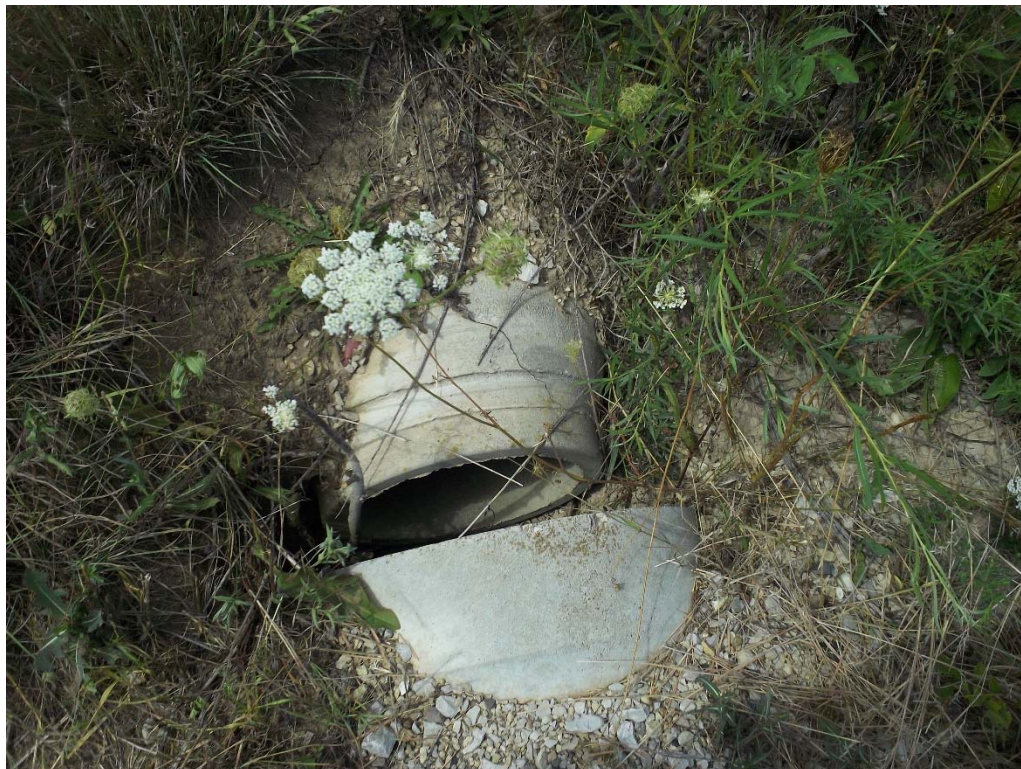
| Compliance Verification | Design | Actual | Compliant<br>Yes No | Comments | |
|---|---|---|---|---|---|
| Outfall 3 (ES-8) | RCP 12" | | NW Portion of Pond | | Erosion and end sect. disconnected |

Photo 5: Outfall 3 (ES-8) End section disconnected to pipe.

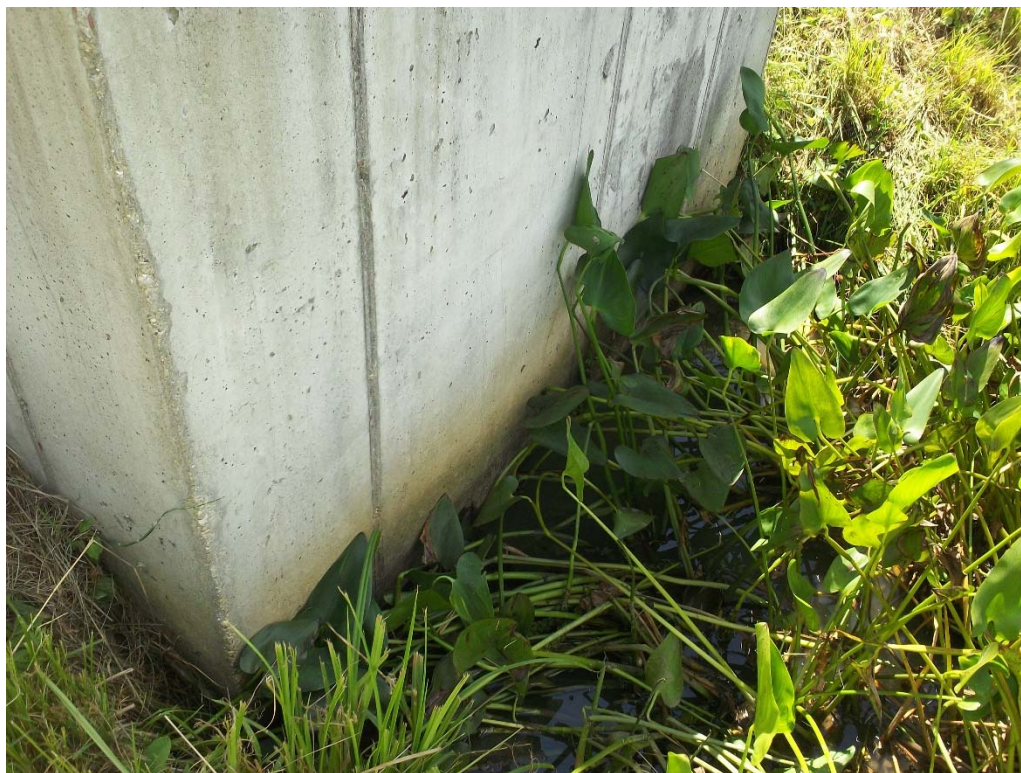
| Compliance Verification | Design | Actual | Compliant<br>Yes No | Comments<br>(Condition of Structure) |
|---|---|---|---|---|
| Opening Diameter (inches) | 12" | 12" | ✓ | Reinforced Concrete Pipe<br>Accumulative silt at opening and bottom of outlet structure<br>Recommend removal of silt. |

Photo 6: Outlet structure front intake silted.

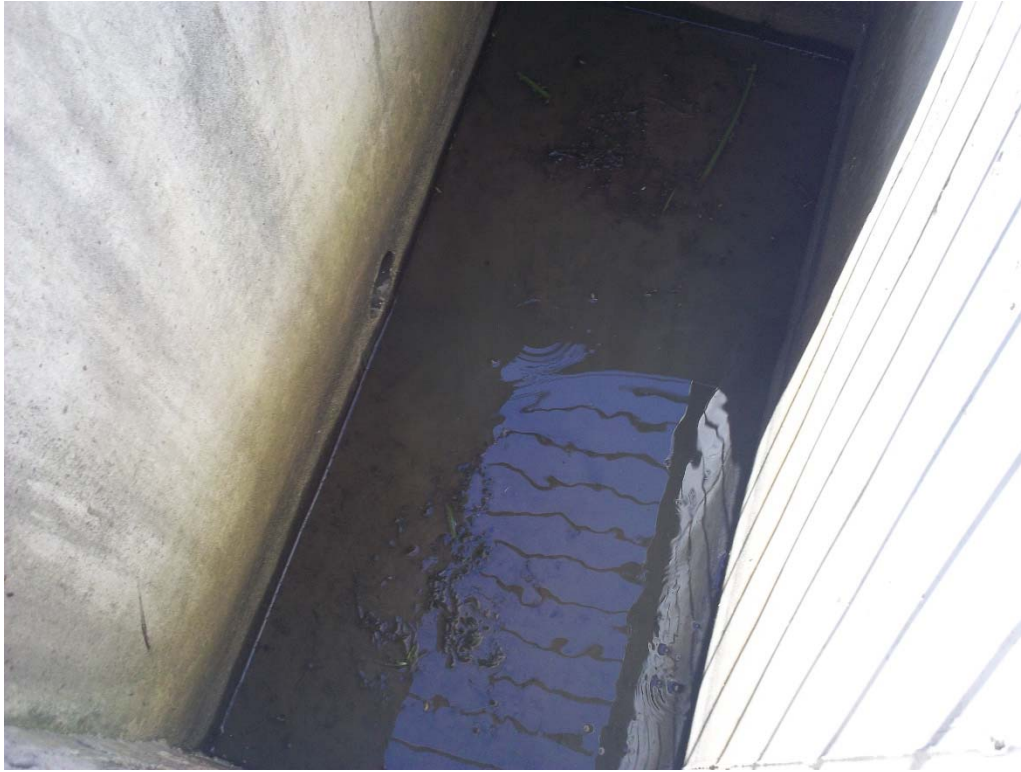
Photo 7: Outlet Structure bottom silted.

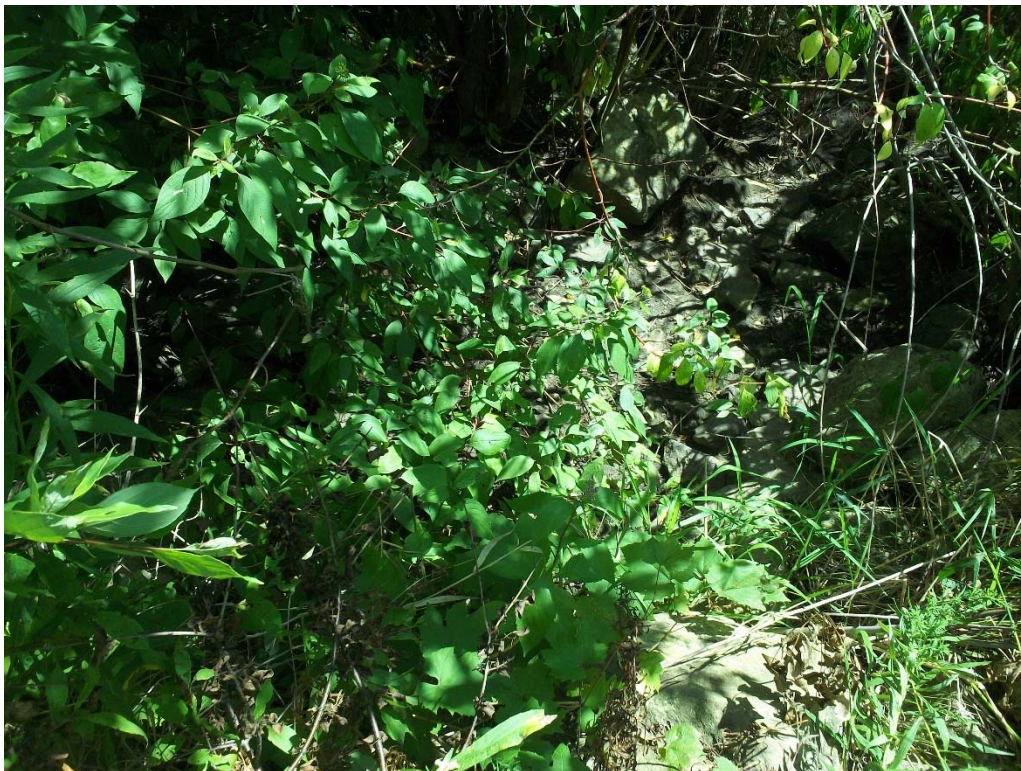
| Compliance Verification | Design | Actual | Compliant<br>Yes No | Comments | |
|---|---|---|---|---|---|
| Unauthorized Plantings, trees, or woody vegetation | ✓ | | Some vegetative growth around outlet structure and outfall. Recommend clearing for full function. | | |

Photo 8: Outlet structure discharge pipe in wooded area.
