## STORMWATER MANAGEMENT FACILITIES OPERATION AND INSPECTION REPORT

Quarter Section	NW 1/4 Sec 23-8-20	Name of Business/Subdivision	Pilgrim Glen Condominium Plat Addendum No. 2
Property Tax ID Number	0090-996-066 thru 0090-996-125	Address of Property	Macallan Court
Date	8/31/20

Pond ID: SWP23N002

Pilgrim Glen Condominium - Pond SWP23N002

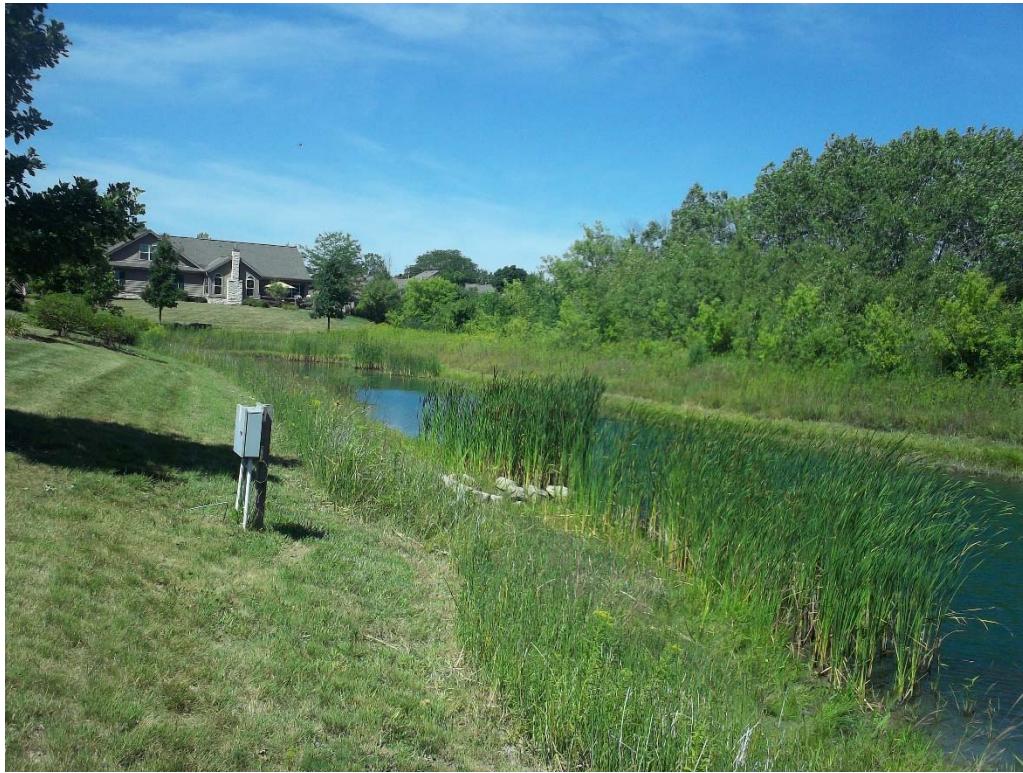
Photo 1: South side of pond, looking northwesterly.

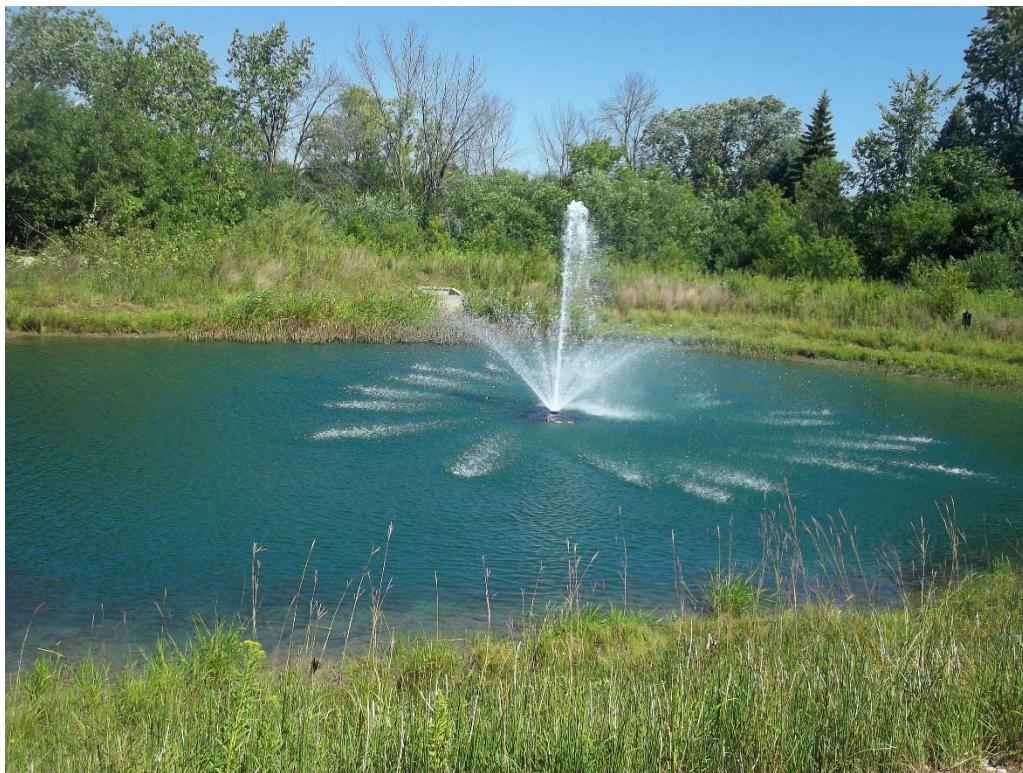
Photo 2: South side of pond, looking northeasterly.

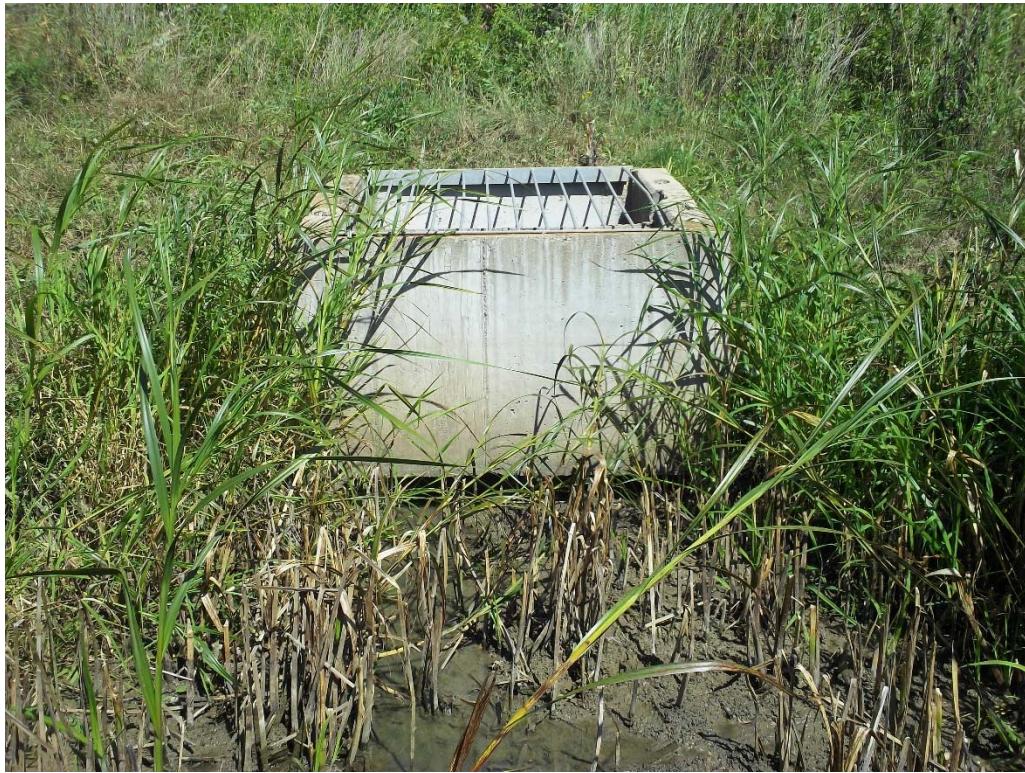
Photo 3: Outlet structure front intake silted.

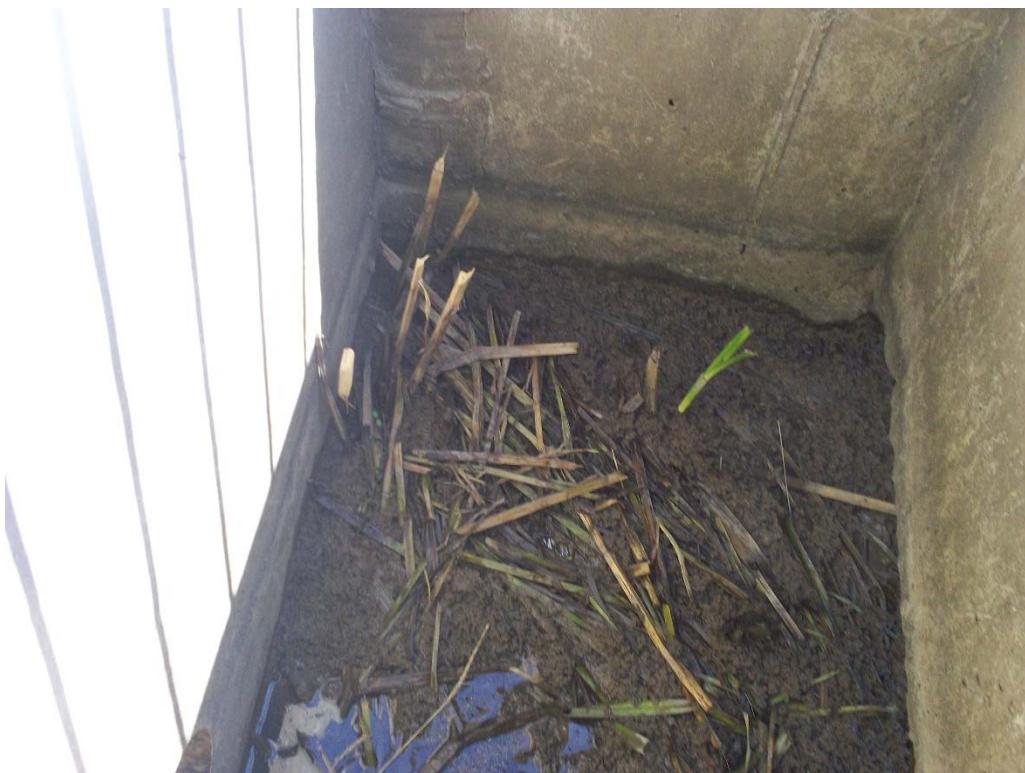
Photo 4: Outlet structure bottom silted.
