## STORMWATER MANAGEMENT FACILITIES OPERATION AND INSPECTION REPORT

Quarter Section NW 1/4 Sec.  
 36-8-20  
 Property Tax ID Number 0142999010 Name of Business/Subdivision Capital Heating and Cooling  
 Address of Property W134 N5368 Campbell Dr.

Description: SWP36N003

Inspector Name: Tyler Smith, PE  
 Inspection Date: October 14, 2020

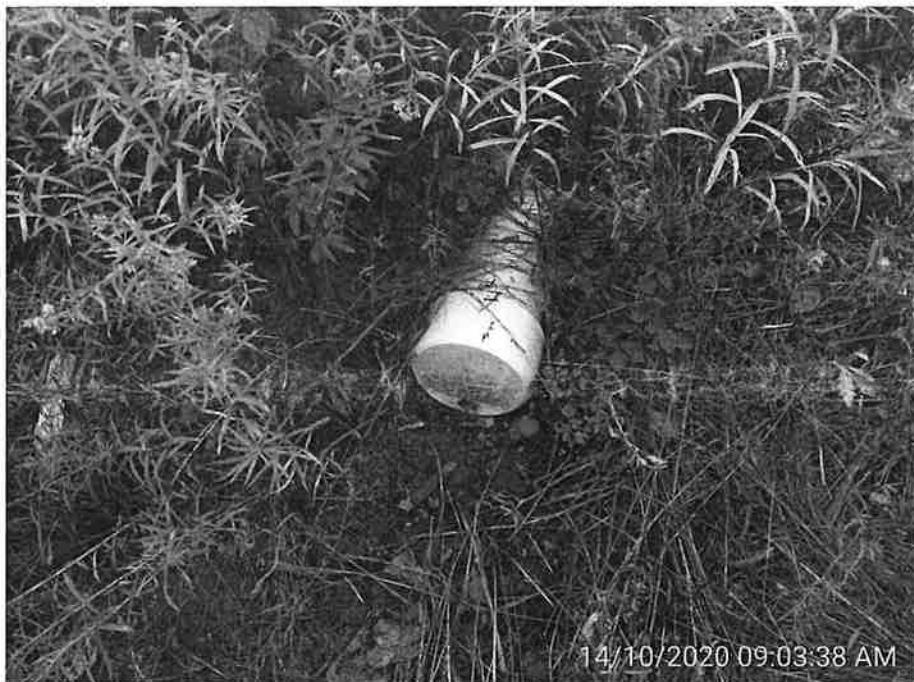
Compliance Verification	Design	Actual	Compliant Yes	Non-Compliant No	Comments (Condition of Structure)
<b>Primary Outlet Pipe</b>					
Opening Diameter (inches)	1.6"	1.6"	X		Outlet pipe is 8" in diameter, capped, with a 1.6" orifice hole drilled into cap
Upstream Invert	741.00	741.19	X		See Photo #1
Downstream Invert	740.00	740.10	X		
Length (feet)	69'	69'	X		
Slope (%)	1.45%	1.58%	X		
<b>Secondary Outlet Pipe</b>					
Opening Diameter (inches)					Not Applicable - no secondary outlet
Upstream Invert					
Downstream Invert					
Length (feet)					
Slope (%)					
<b>Riser</b>					
Opening Diameter (inches)	24"	24"	X		24" Concrete Structure w/beehive gate
Elevation	744.50	744.55	X		See Photo #2
<b>Upper Discharge Control</b>					
Opening Diameter (inches)					
Elevation

**Photo #1: Outlet pipe with 1.6" orifice**

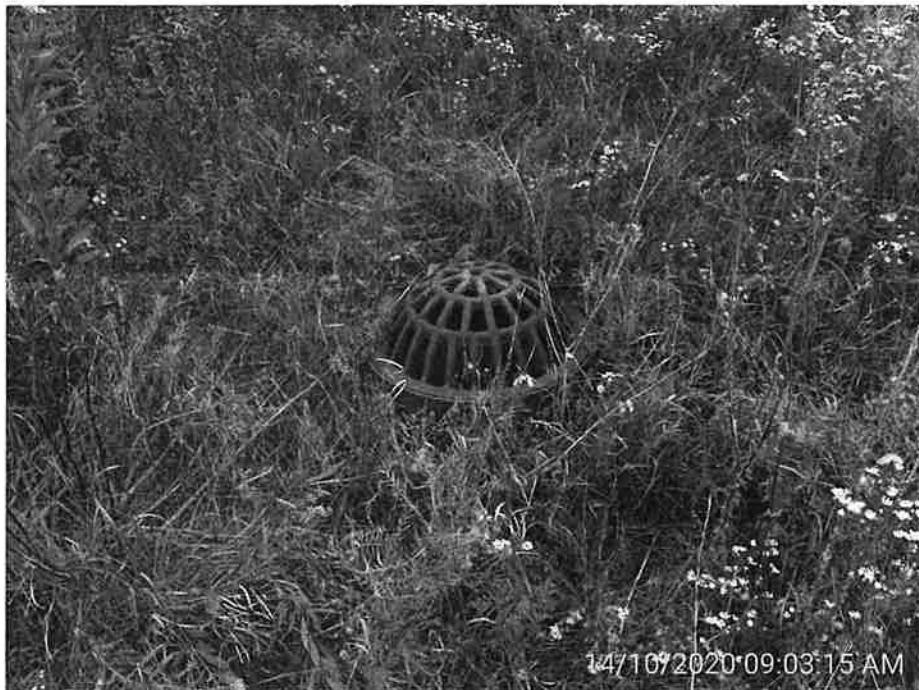
**Photo #2: Outlet structure/stand pipe**

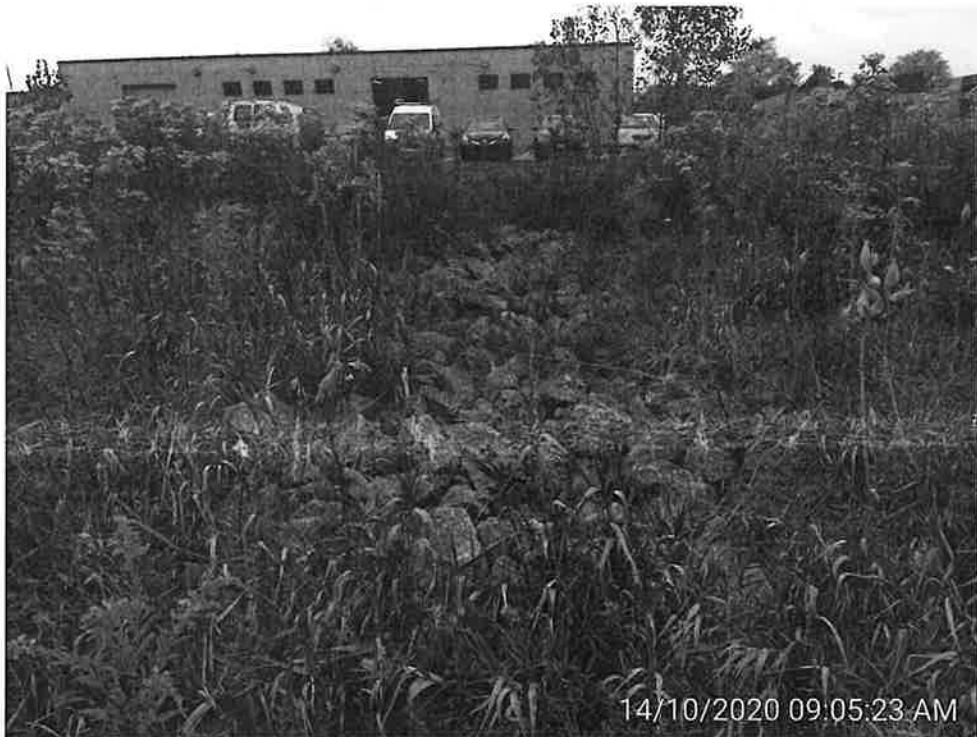
Compliance Verification	Design	Actual	Compliant Yes      No	Comments	
<b>Lower Discharge Control</b> (If Applicable)					
Opening Diameter (inches)					
Elevation					
<b>Other (Description)</b>					
Opening Type and Size (inches)					
Elevation					
<b>Emergency Spillway</b>					
Elevation	746.30	746.10	X	See Photo #3, weedy vegetation should be removed	
Length of spillway (feet)	25'	24.5'	X		
<b>Embankment</b>	Present Yes	no		Comments/Maintenance Requirements	
Unauthorized Plantings, trees, or woody vegetation	X			See Photo #4 and #5, the bottom and side slopes of the basin is recommended to be mowed twice per year to a 6"-8" height, all woody vegetation and trees shall be removed	
Animal burrows or slope erosion		X			
<b>Storm Sewer Outfalls</b>	Type & Size		Location	Comments	
Outfall 1	6" PVC		West slope of basin	Significant erosion, recommend restoring riprap outfall, see Photo #6	
Outfall 2					
Outfall 3

Photo #3: Emergency Spillway

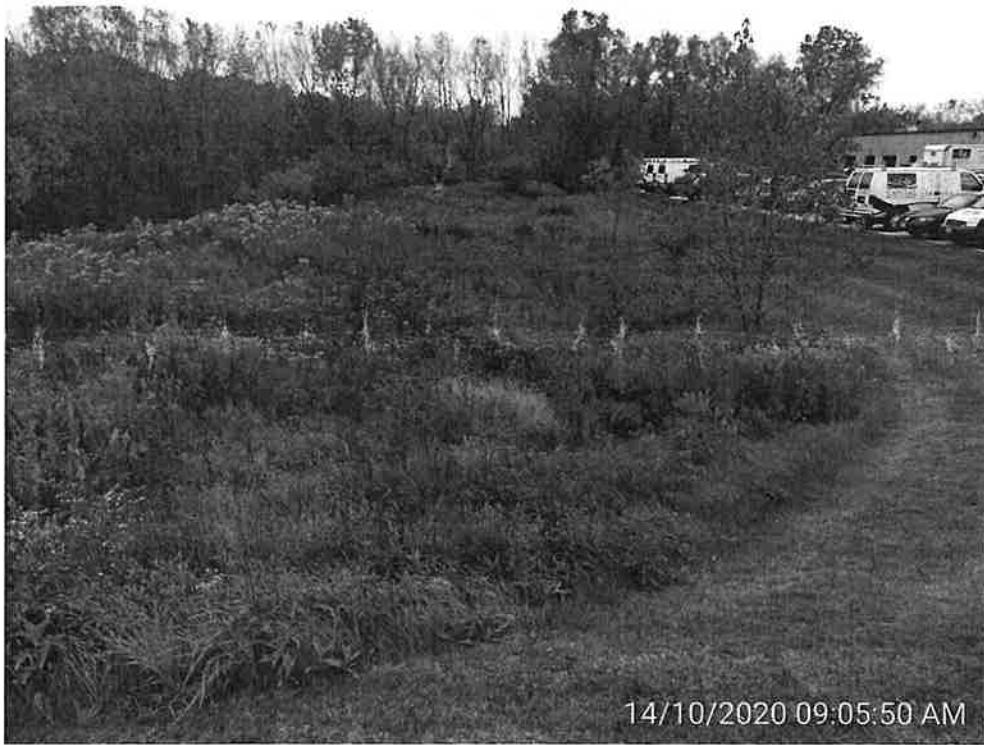
Photo #4: Overall basin looking south

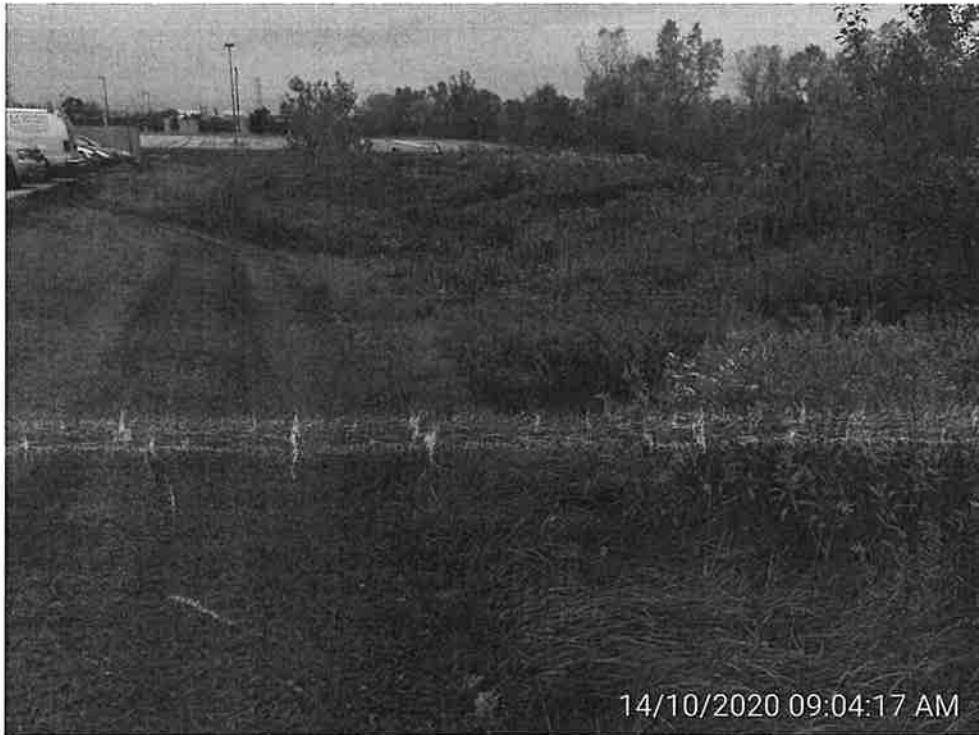
Photo #5: Overall basin, looking north

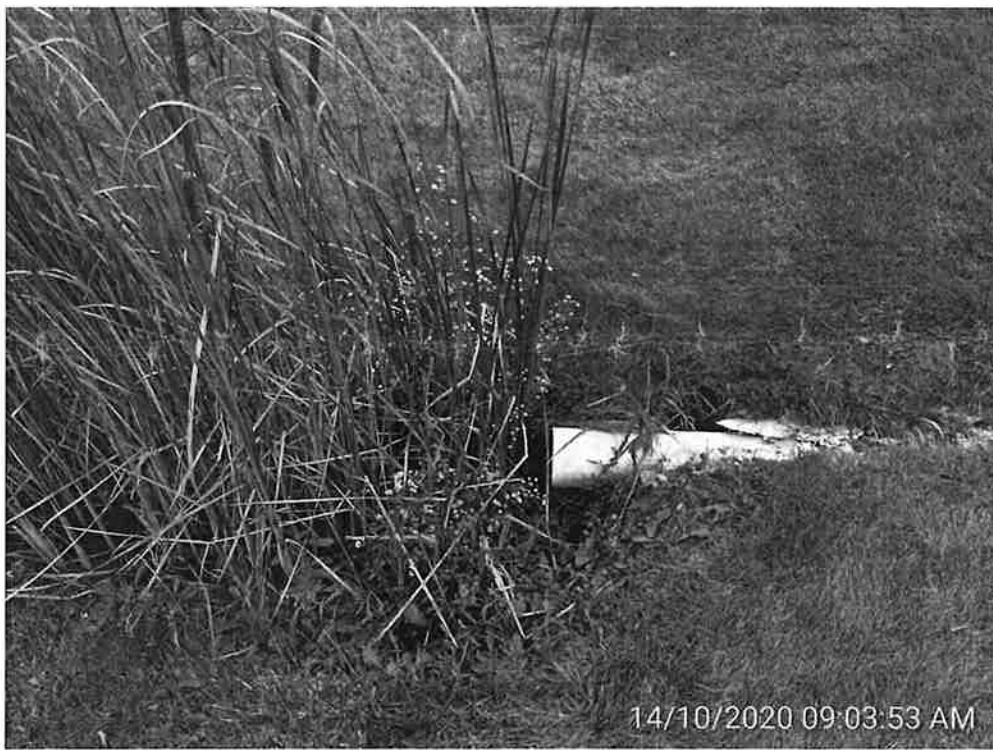
Photo #6: Erosion at 6" outfall pipe

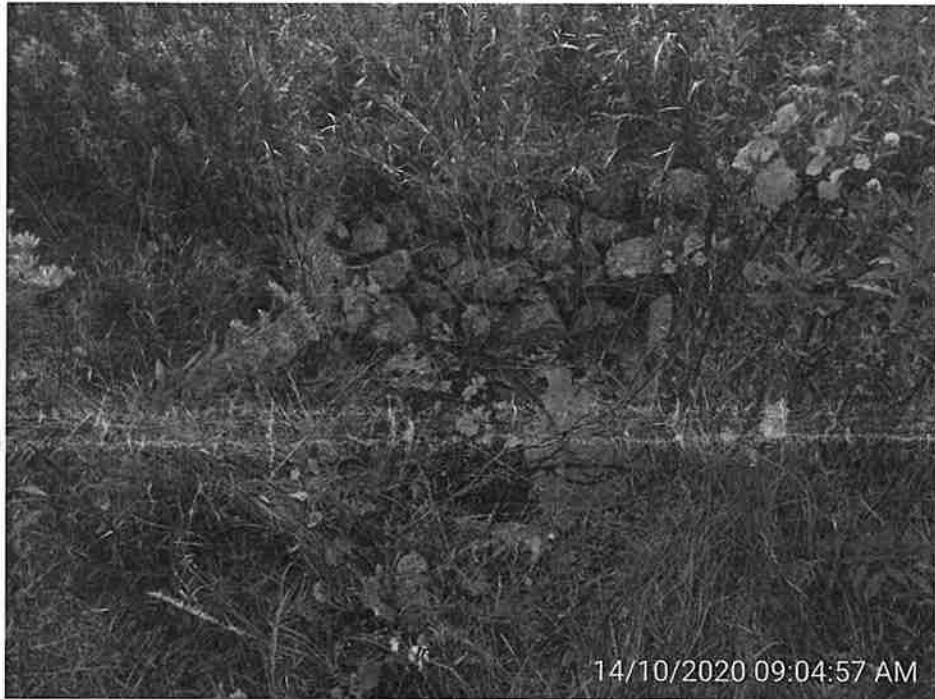
**Photo #7: Basin outfall pipe**
