## STORMWATER MANAGEMENT FACILITIES OPERATION AND INSPECTION REPORT

Quarter Section Property Tax ID Number	SE1/4-SEC2 & NW1/4- SEC 11 MNFV00089 91001	Name of Business/Subdivision Address of Property	Ascension N88W14275 Main Street Menomonee Falls, WI 53051
Date	06-15-2021

Pond ID: SWP11N007

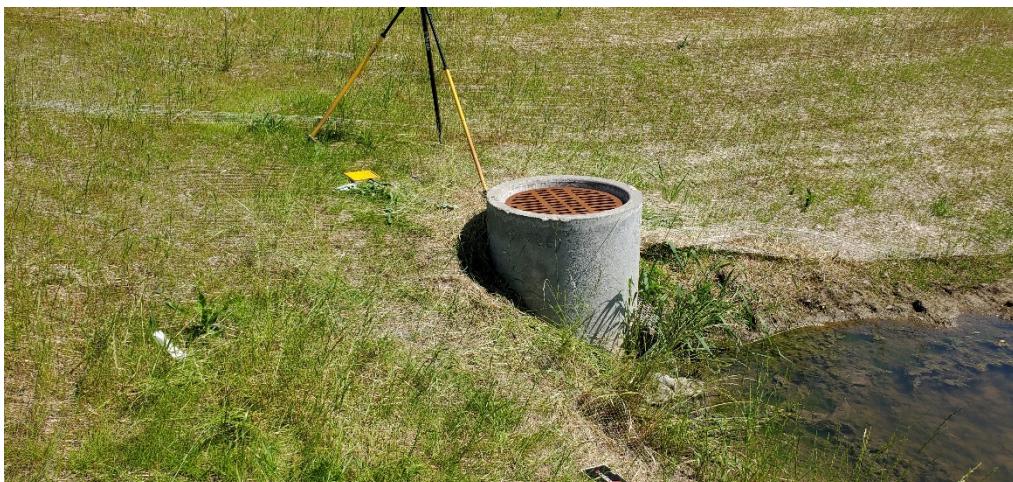
Figure 5: Pond Outlet Structure, Looking South

Compliance Verification	Design	Actual	Compliant Yes No		Comments
<b>Lower Discharge Control</b>	(If Applicable)				
Opening Diameter (inches)	3"	3"	X		PVC Cap w/ 3" orifice in great condition.  Pond Outlet Structure verified by JSD w/ Trimble S6
Elevation	751.00	750.80	X		
<b>Other (Description)</b>					
Opening Type and Size (inches)	NA	NA			
Elevation	NA	NA			
<b>Emergency Spillway</b>					
Elevation	757.00	756.91	X		No comments
Length of spillway (feet)	13'	12'	X		No comments
<b>Embankment</b>	Present Yes no		Comments/Maintenance Requirements		
Unauthorized Plantings, trees, or woody vegetation		X			
Animal burrows or slope erosion		X			
<b>Storm Sewer Outfalls</b>	Type & Size		Location		Comments
Outfall 1	HDPE 24"		SW Corner of pond		No comments
Outfall 2	HDPE 18"		NW Corner of Pond		No comments
Outfall 3					
Storage Properties	Design	Actual	Compliant Yes No	Not Applicable	Equipment Used
Normal Water Elevation (Wet Ponds)	751.00	750.65	X		Pond Topographic Survey Provided By Others. Per HydroCAD

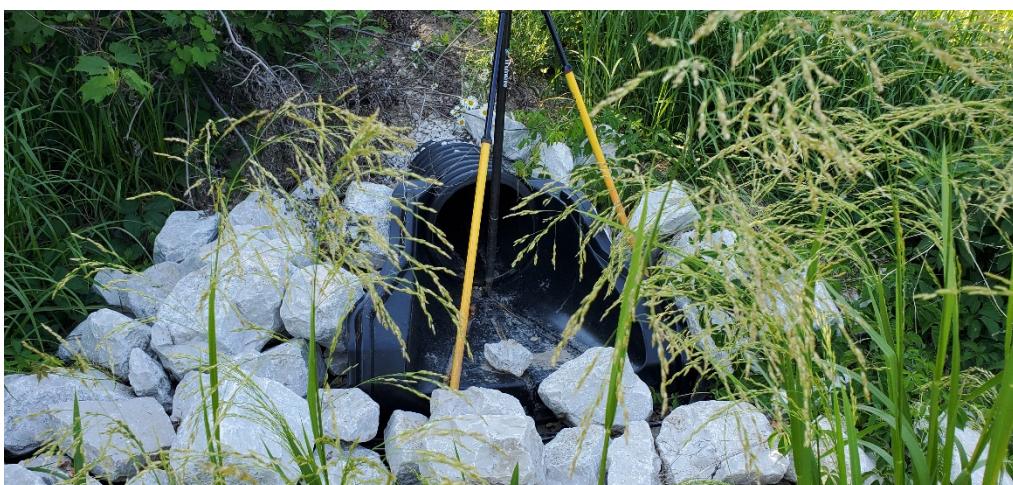
Figure 6: 15" HDPE Pond Outfall, Looking North

Compliance Verification	Design	Actual	Compliant Yes	Comments (Condition of Structure)
<b>Primary Outlet Pipe</b>				Outlet Pipe Material
Opening Diameter (inches)	15"	15"	X	HDPE Pipe in great condition.
Upstream Invert	751.00	750.80	X	Pond Outlet Structure verified by JSD w/ Trimble S6
Downstream Invert	750.00	750.05	X	
Length (feet)	60	60.1	X	
Slope (%)	1.67%	1.25%	X	
<b>Secondary Outlet Pipe</b>	(If Applicable)			Outlet Pipe Material
Opening Diameter (inches)	NA	NA		Not Applicable
Upstream Invert	NA	NA		
Downstream Invert	NA	NA		
Length (feet)	NA	NA		
Slope (%)	NA	NA		
<b>Riser</b>	(If Applicable)			Riser Material
Opening Diameter (inches)	24"	24"	X	Concrete Standpipe w/ concrete base in great condition.
Elevation	754.00	753.68	X	
<b>Upper Discharge Control</b>	(If Applicable)			
Opening Diameter (inches)	NA	NA		Not Applicable
Elevation	NA	NA		Pond Outlet Structure verified by JSD w/ Trimble S6
