## STORMWATER MANAGEMENT FACILITIES OPERATION AND INSPECTION REPORT

Quarter Section SE ¼ SEC 22 Name of Business/Subdivision FOX MEADOW  
Property Tax ID Number \_\_\_\_\_ Address of Property \_\_\_\_\_  
Date 12-03-2021 \_\_\_\_\_

Location of Pond OUTLOT 3  
Pond ID: SWP22S007

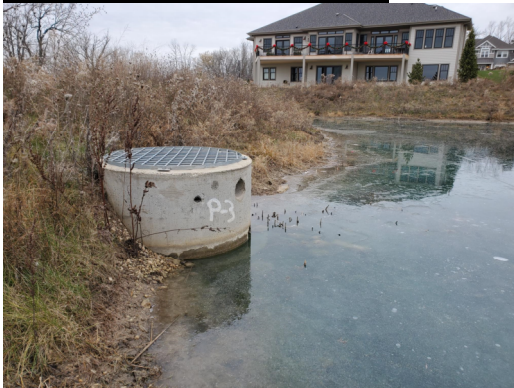
**Figure 2: Pond 3 Outlet Structure**

Compliance Verification	Design	Actual	Compliant Yes No	Comments ( Condition of Structure)
<b>Primary Outlet Pipe</b>				Outlet Pipe Material
Opening Diameter (inches)	18	18	X	Reinforced concrete pipe
Upstream Invert	843.50	843.48	X	Good Condition
Downstream Invert	843.20	843.26	X	
Length (feet)	59.8	59.8	X	
Slope (%)	0.50	0.37	X	
<b>Secondary Outlet Pipe</b>	(If Applicable)			Outlet Pipe Material
Opening Diameter (inches)	NA			NA
Upstream Invert	NA			
Downstream Invert	NA			
Length (feet)	NA			
Slope (%)	NA			
<b>Riser</b>	(If Applicable)			Riser Material
Opening Diameter (inches)	48	48	X	Precast concrete structure
Elevation	846.20	846.14	X	Good Condition
<b>Upper Discharge Control</b>	(If Applicable)			
Opening Diameter (inches)	6 (2)	6 (2)	X	Concrete orifice
Elevation	845.10	845.06	X	Good Condition

Compliance Verification	Design	Actual	Compliant Yes No		Comments	
<b>Lower Discharge Control</b>	(If Applicable)					
Opening Diameter (inches)	6	6	X		Concrete orifice	
Elevation	843.50	843.44	X		Good Condition	
<b>Other (Description)</b>						
Opening Type and Size (inches)	NA	NA				
Elevation	NA	NA				
<b>Emergency Spillway</b>						
Elevation	848.60	848.62	X		Good Condition	
Length of spillway (feet)	20	20	X		Good Condition	
<b>Embankment</b>	Present Yes No		Comments/Maintenance Requirements			
Unauthorized Plantings, trees, or woody vegetation		X	Several locations of minor slope erosion and animal burrow. Recommend filling and stabilizing eroded areas.			
Animal burrows or slope erosion	X					
<b>Storm Sewer Outfalls</b>	Type & Size		Location		Comments	
Outfall 1	30" RCP FES		SE corner		Good Condition	
Outfall 2	15" RCP FES		NE corner		Good Condition	
Outfall 3						
<b>Storage Properties</b>	Design	Actual	Compliant Yes No		Not Applicable	Equipment Used
