## STORMWATER MANAGEMENT FACILITIES OPERATION AND INSPECTION REPORT

SE 1/4 SEC 22 Name of Business/Subdivision FOX MEADOW  
Address of Property \_\_\_\_\_  
\_\_\_\_\_

SWP22S008

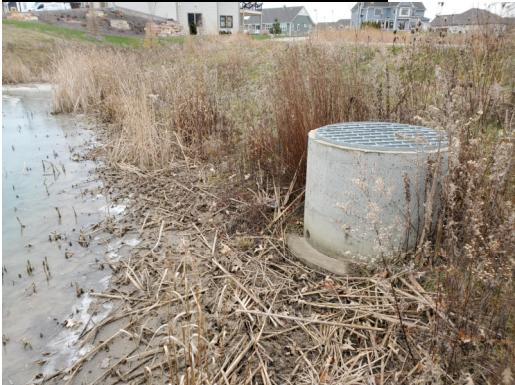
**Figure 2: Pond 2 Outlet Structure**

Compliance Verification	Design	Actual	Compliant Yes      No		Comments
<b>Lower Discharge Control</b>	(If Applicable)				
Opening Diameter (inches)	3	3	X		Concrete orifice Good Condition
Elevation	843.00	842.92	X		
<b>Other (Description)</b>					
Opening Type and Size (inches)	NA	NA			
Elevation	NA	NA			
<b>Emergency Spillway</b>					
Elevation	847.10	847.14	X		Good Condition
Length of spillway (feet)	15	15	X		Good Condition
<b>Embankment</b>	Present Yes      No		Comments/Maintenance Requirements		
Unauthorized Plantings, trees, or woody vegetation		X			
Animal burrows or slope erosion		X			
<b>Storm Sewer Outfalls</b>	Type & Size		Location		Comments
Outfall 1	12" RCP FES		SE corner		Poor Condition – End Section undermined. Recommend filling under end section.
Outfall 2	15" RCP FES		NE corner		Good Condition
Outfall 3					
<b>Storage Properties</b>	Design	Actual	Compliant Yes      No	Not Applicable	Equipment Used
