STORMWATER MANAGEMENT FACILITIES OPERATION AND INSPECTION REPORT

Home2Suites
N91W15851 Falls Pkwy
Menomonee Falls, WI 53051

Date 11/1/2021

Pond ID: SWP03S004
P-0154

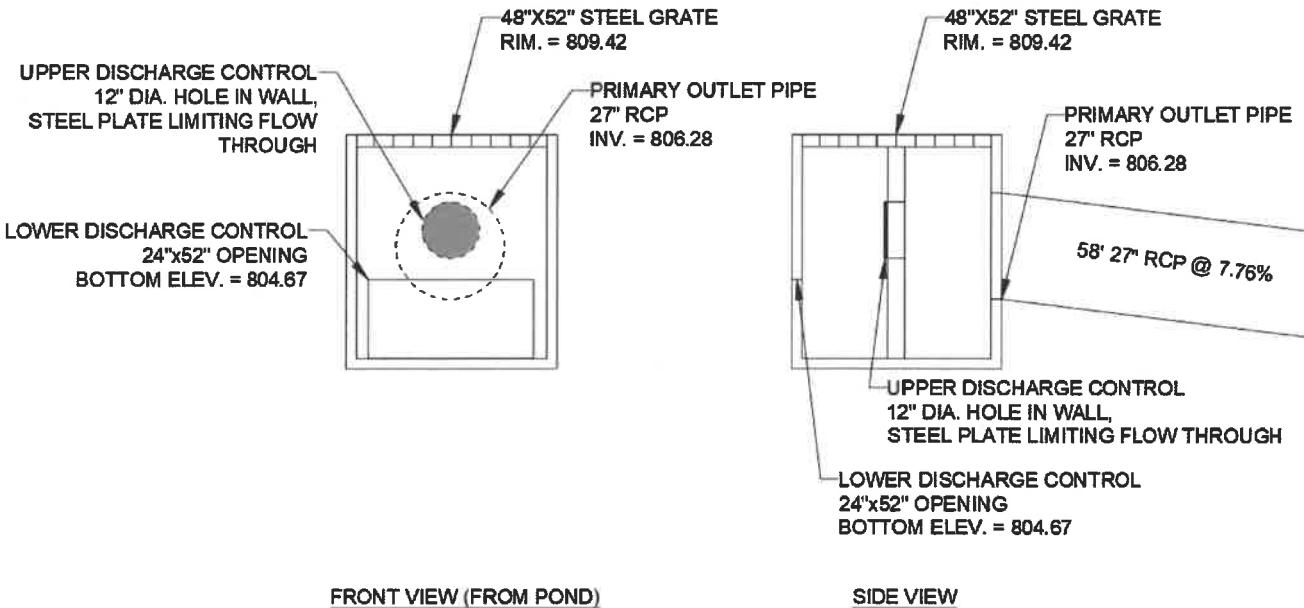
Sketch Outlet or Attach to Document

Compliance Verification	Design	Actual	Compliant Yes	No	Comments
Lower Discharge Control	(If Applicable)				
Opening Diameter (inches)	24"x52"	24"x52"	X		Actual size is approx. Opening was completely submerged during site inspection.
Elevation	804.68	804.67	X		Opening is at pond side of structure, see detail on next page
Other (Description)					
Opening Type and Size (inches)					
Elevation					
Emergency Spillway					
Elevation	811.00	811.16	X		
Length of spillway (feet)	10'	13'	X		
Embankment	Present Yes	no	Comments/Maintenance Requirements		
Unauthorized Plantings, trees, or woody vegetation		X			
Animal burrows or slope erosion		X			
Storm Sewer Outfalls	Type & Size		Location		Comments
Outfall 1	12" RCP		East side of pond		Good condition
Outfall 2	30" RCP		Northeast side of pond		Good condition
Outfall 3	12" RCP		North side of pond		Good condition
Outfall 4	30" CPCP		West side of pond		Good condition
Storage Properties	Design	Actual	Compliant Yes	No	Equipment Used

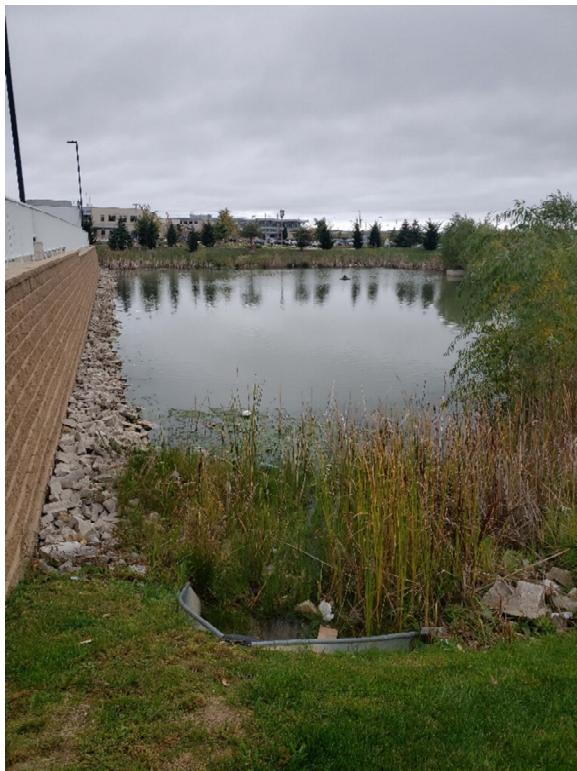
Stormwater pond looking east

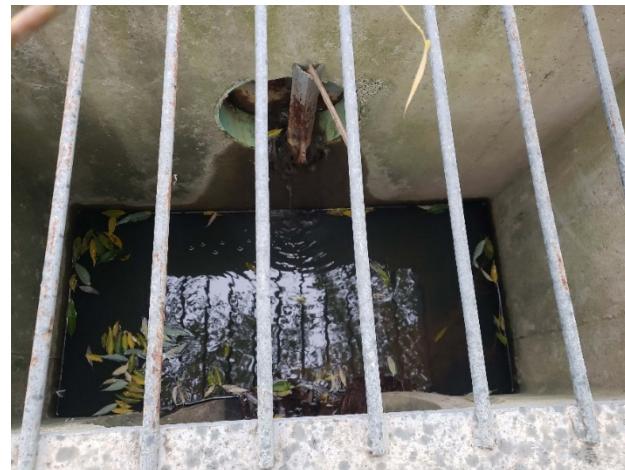
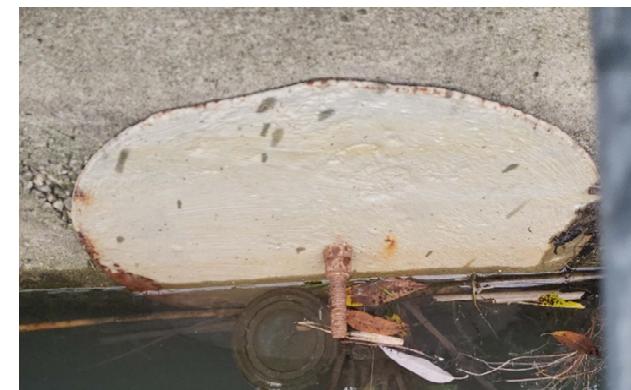
Compliance Verification	Design	Actual	Compliant Yes	No	Comments (Condition of Structure)
Primary Outlet Pipe					
Opening Diameter (inches)	27"	27"	X		RCP
Upstream Invert	806.26	806.28	X		All actual elevations are based on vertical datum NGVD83.
Downstream Invert	802.28	801.78		X	
Length (feet)	58.0'	58.0'	X		
Slope (%)	6.86%	7.76%		X	
Secondary Outlet Pipe	(If Applicable)			Outlet Pipe Material	
Opening Diameter (inches)					
Upstream Invert					
Downstream Invert					
Length (feet)					
Slope (%)					
Riser	(If Applicable)			Riser Material	
Opening Diameter (inches)	48"x52" Grate	48"x52" Grate	X		
Elevation	809.40	809.42	X		
Upper Discharge Control	(If Applicable)				
Opening Diameter (inches)	12" PVC	12" PVC		X	Steel plate in front of 12" PVC pipe opening limiting water passing through.
Elevation	807.66	807.66	X

Stormwater pond outlet structure, steel plate in front of 12" PVC pipe opening.

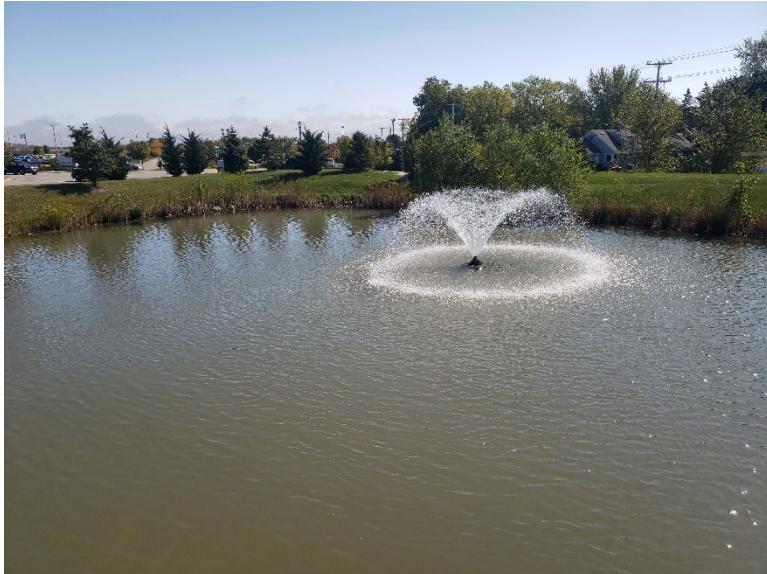
Stormwater pond looking south

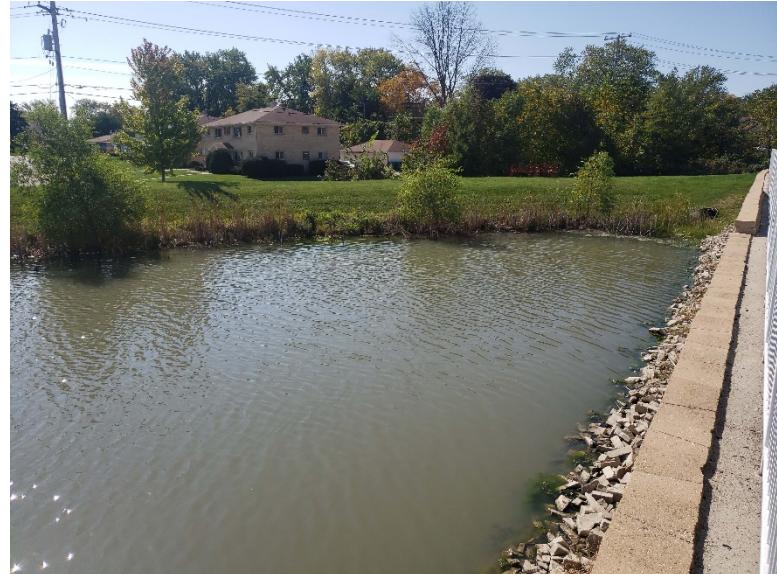
Stormwater pond looking west
