Willow Springs School Stormwater Facilities Inspection and Recertification
W220 N6660 Town Line Road
Menomonee Falls, Wisconsin 53051

STORMWATER MANAGEMENT FACILITIES OPERATION AND INSPECTION REPORT

Pond ID: SWP19S001

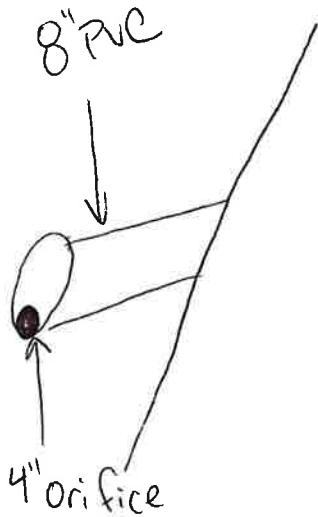
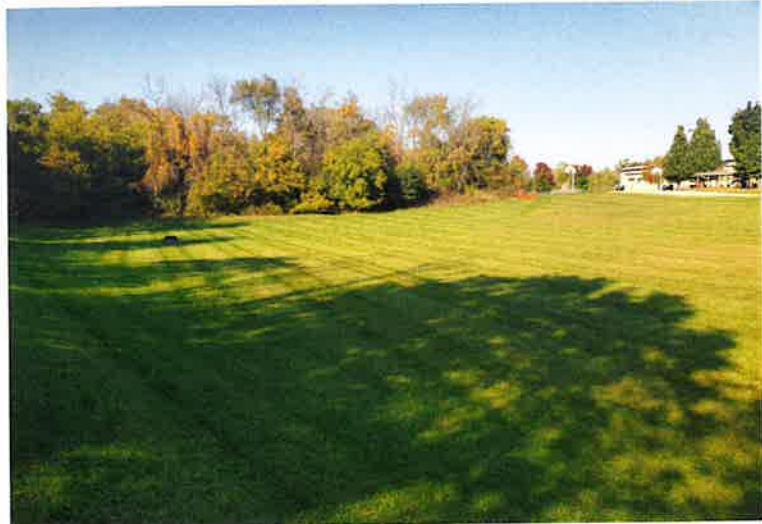
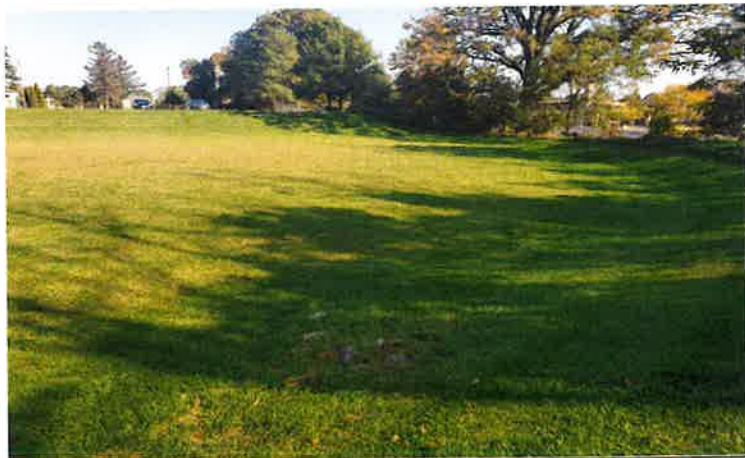
Sketch Outlet or Attach to Document

| Compliance Verification | | Design | Actual | Compliant Yes | No | Comments (Condition of Structure) |
|---|---|---|---|---|---|---|
| Opening Diameter (inches) | 4" | 4" | X | | | -PVC Cap with 4" orifice over 8" PVC Pipe |
