STORMWATER MANAGEMENT FACILITIES OPERATION AND INSPECTION REPORT

Quarter Section SE1/4, Sec 24 Name of Business/Subdivision Lilly Creek Highlands IV
Property Tax ID Number 0096131 Address of Property _____
Date: 8/17/2021 _____

Pond ID: SWP24s012

Location of Pond Outlot 11 – Pond #1

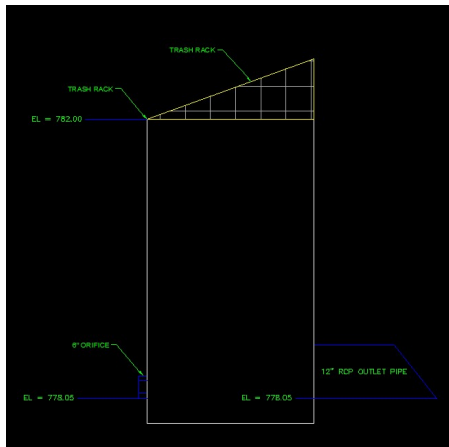
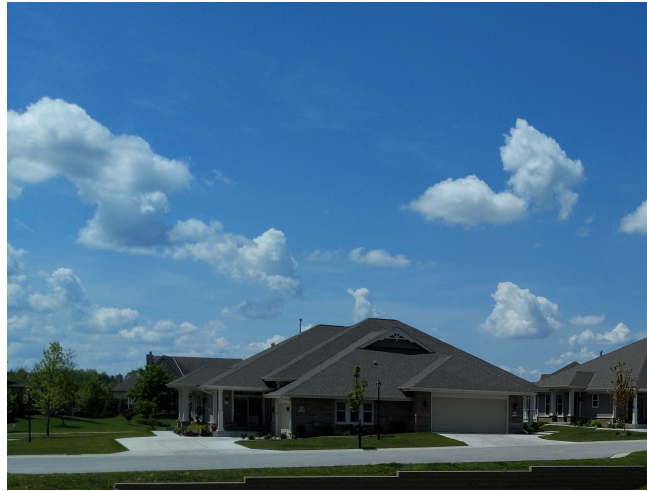
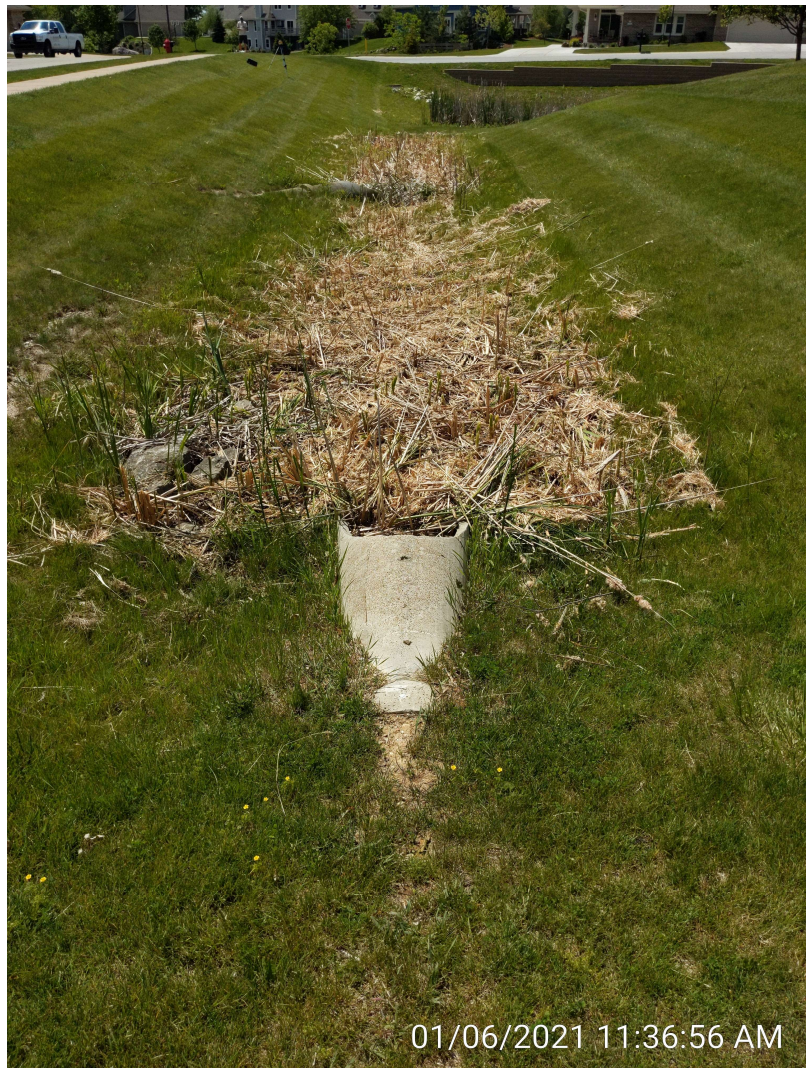
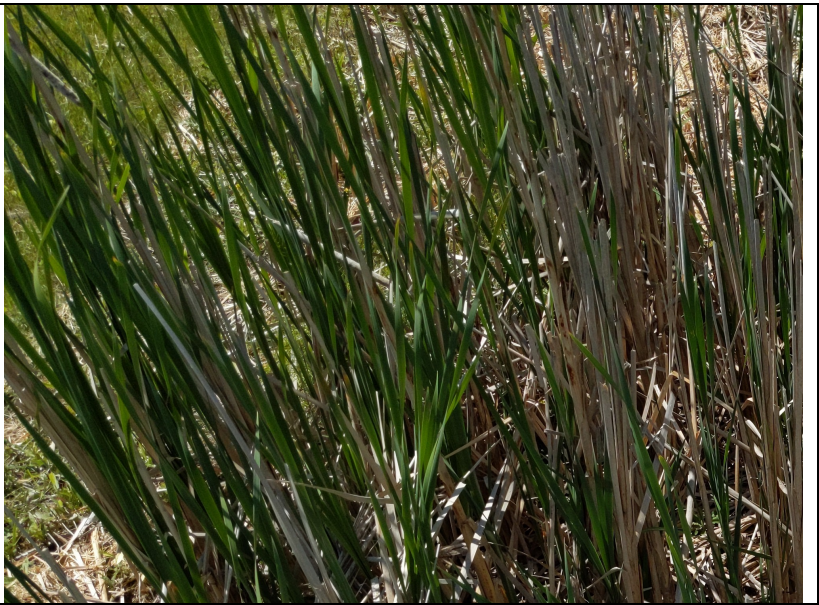
Sketch Outlet or Attach to Document

Compliance Verification	Design	Actual	Compliant Yes No	Comments (Condition of Structure)
Primary Outlet Pipe				Outlet Pipe Material
Opening Diameter (inches)	15"	15"	X	Outlet pipe material is RCP. RCP is in good condition and no evidence of sediment accumulation within pipe, appears to be operating as originally intended. End of pipe is infall into Wet Pond in Outlot 9.
Upstream Invert	777.00	777.00	X	
Downstream Invert	775.50	775.14	X	
Length (feet)	184	186	X	
Slope (%)	0.82%	1.0%	X	
Secondary Outlet Pipe	(If Applicable)			Outlet Pipe Material
Opening Diameter (inches)				
Upstream Invert				
Downstream Invert				
Length (feet)				
Slope (%)				
Riser	(If Applicable)			Riser Material
Opening Diameter (inches)	24"x36"	24"x36"	X	Riser is a concrete structure with a metal trash grate, good condition, operating as intended
Elevation	782.50	782.55	X	
Upper Discharge Control	(If Applicable)			
Opening Diameter (inches)

Compliance Verification	Design	Actual	Compliant Yes No		Comments	
Lower Discharge Control	(If Applicable)					
Opening Diameter (inches)	10" cmp	10" cmp	X		Cattails are growing around the orifice and may be hindering the flow of water through the system. These cattails should be removed and any sediment that these cattails may be allowing to accumulate at the opening.	
Elevation	777.00	777.02	X			
Other (Description)						
Opening Type and Size (inches)						
Elevation						
Emergency Spillway						
Elevation	785.1	785.10	X			
Length of spillway (feet)	15'	16'	X			
Embankment	Present Yes no		Comments/Maintenance Requirements			
Unauthorized Plantings, trees, or woody vegetation		X	The presence of water on the bottom of the basin create a situation where cattails thrive and will not allow stormwater runoff to flow through the system as intended. As a Dry Pond, water is not intended to pool in the bottom of the basin.

Animal burrows or slope erosion		X				
Storm Sewer Outfalls	Type & Size		Location		Comments	
Outfall 1	RCP, 12"		North End		Cattails to be removed and replaced with riprap stone to protect outfall	
Outfall 2	RCP, 15"		Near North End		Cattails to be removed, endwall section is starting to fall off of main pipe line, this will lead to major erosion issues under the pipe, causing it to fail	
Outfall 3	RCP, 15"		SW corner		Good condition	
Storage Properties	Design	Actual	Compliant Yes No		Not Applicable	Equipment Used
Normal Water Elevation (Wet Ponds)					X	Drone technology and laser level To determine elevations and contours
Design High Water Elevation	786.00	786.00	X			
Area at Normal Water Elevation (Ac) (Wet Ponds)					X	HydroCAD 10.0 to determine areas and pond volumes
Area at Design High Water Elevation (Ac)	0.38 ac	0.30 ac	X			
Active Storage Available (Ac-Ft)*	1.6	1.22	X			
Lowest Elevation at Top of Embankment (If Applicable)
