Village of Menomonee Falls
W156 N8480 Pilgrim Road
Menomonee Falls, WI 53051-3140
Telephone: (262) 532-4200

STORMWATER MANAGEMENT FACILITIES OPERATION AND INSPECTION REPORT

NW1/4, Sec 25 Name of Business/Subdivision Harmony Hills II
N0098090 Address of Property _____

Dry Pond		Location of Pond	Outlet 2 – Pond #1
Wet Pond	X		_____
Other			_____

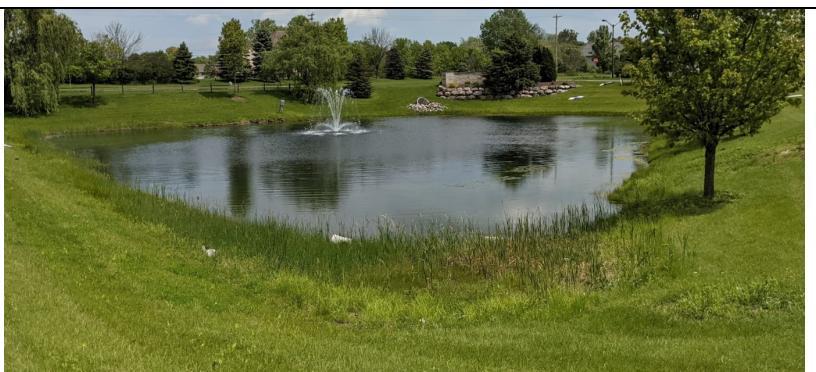
Overall view of pond

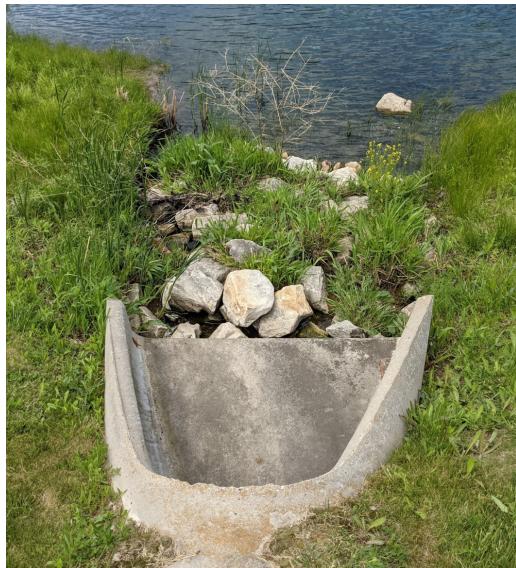
Infall pipe at southeast corner

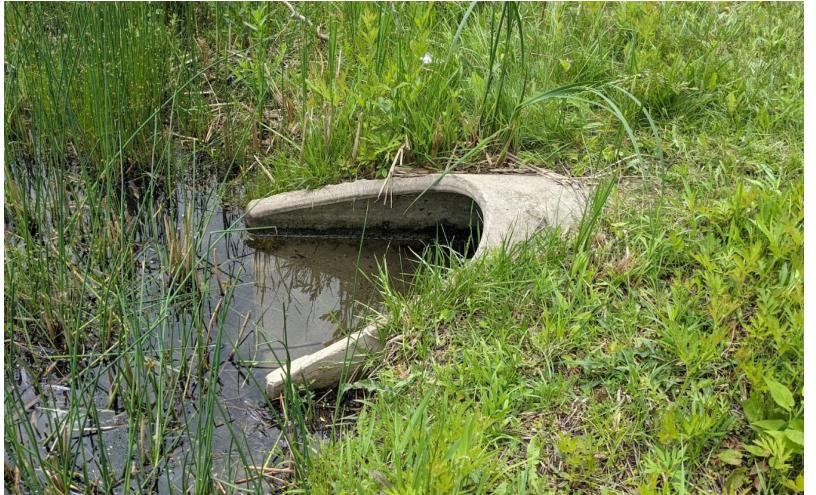
12" RCP outlet pipe to structure

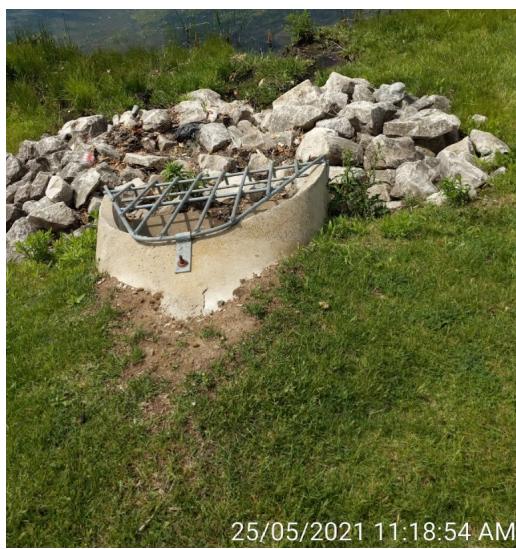
*25/05/2021 11:18:54 AM
Infall pipe at northeast corner*

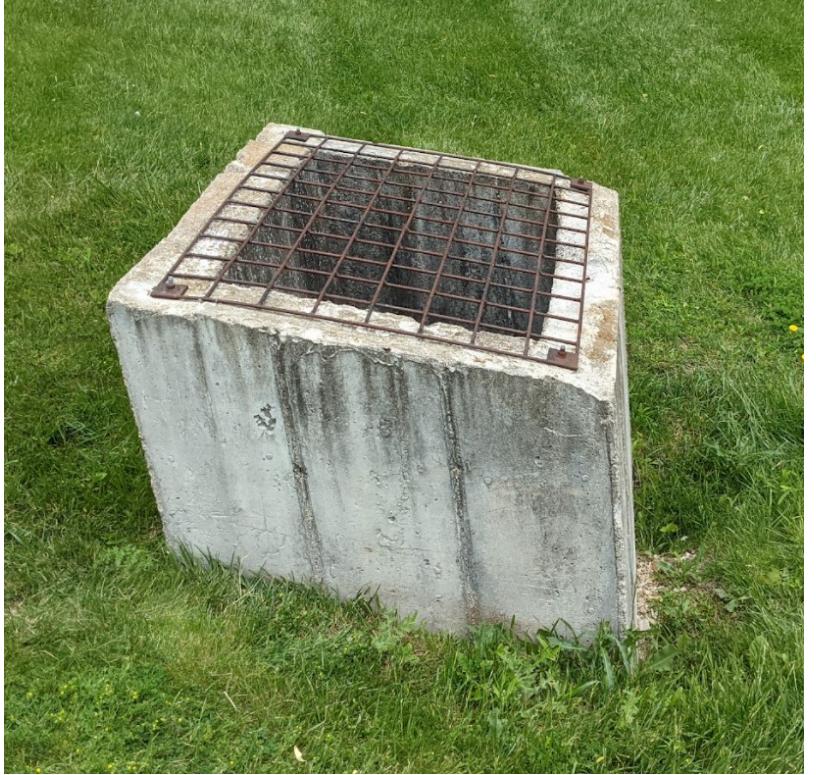
Outlet structure with rebar grate bolted down

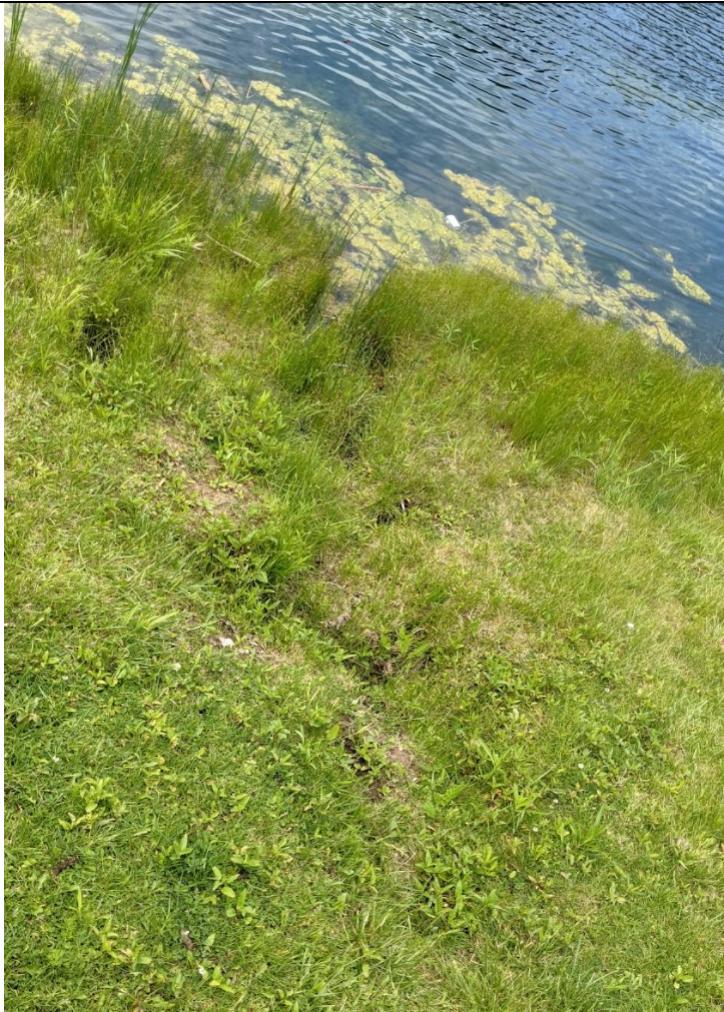
Erosion in side slope near electrical pedestal
