STORMWATER MANAGEMENT FACILITIES OPERATION AND INSPECTION REPORT

NW1/4, Sec 25 Name of Business/Subdivision Harmony Hills II
N0098090 Address of Property _____

Pond ID: SWP25n002 _____

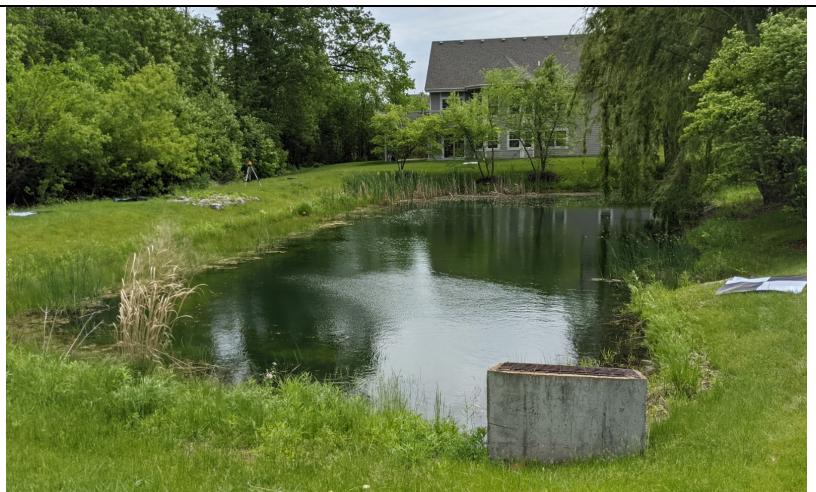
Overall view of pond with trees at SE corner

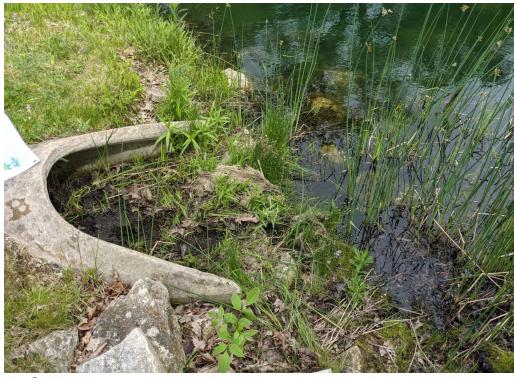
Infall pipe at south edge, showing sediment

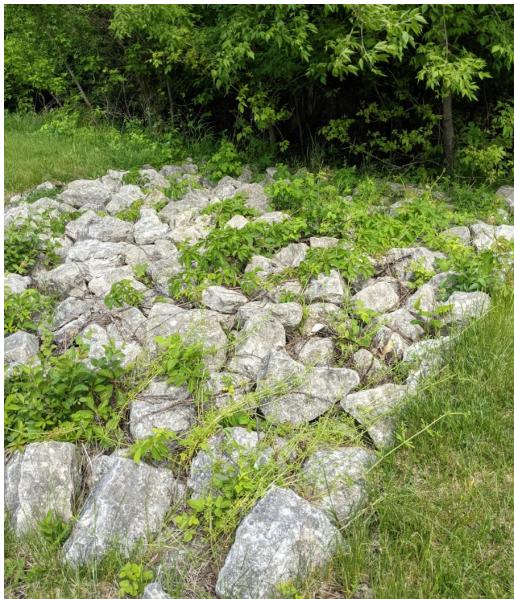
Emergency riprap outflow weir

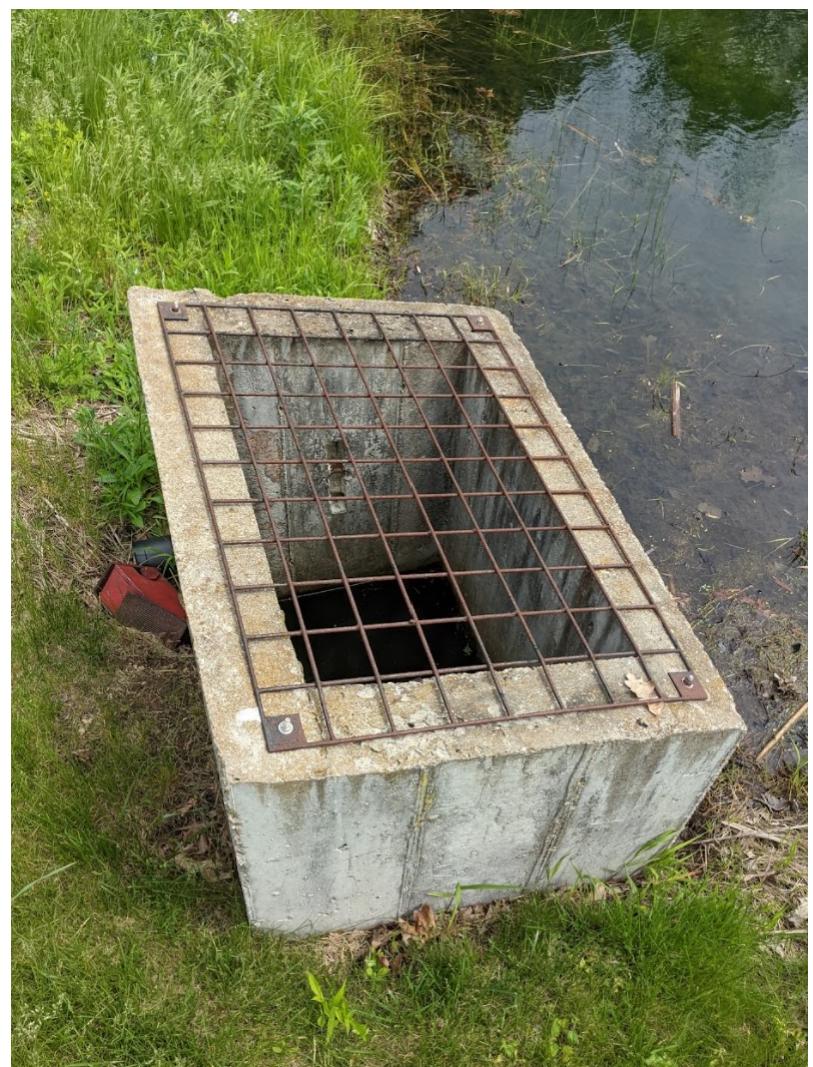
Compliance Verification	Design	Actual	Compliant Yes	Comments (Condition of Structure)
Primary Outlet Pipe				Outlet Pipe Material
Opening Diameter (inches)	12"	12"	X	Outlet pipe material is RCP.
Upstream Invert	784.00	784.00	X	RCP is in good condition and no evidence of sediment accumulation within pipe, appears to be operating as originally intended.
Downstream Invert	783.80	783.75	X	There is sediment accumulating at the end of the pipe that may be hindering water flow out of the wet pond. Remove sediment accumulation to allow water flow.
Length (feet)	84	83	X	
Slope (%)	0.24%	0.30%	X	
Secondary Outlet Pipe	(If Applicable)			Outlet Pipe Material
Opening Diameter (inches)				
Upstream Invert				
Downstream Invert				
Length (feet)				
Slope (%)				
Riser	(If Applicable)			Riser Material
Opening Diameter (inches)	24"x36"	24"x36"	X	Riser is a concrete structure with a metal rebar grate bolted to concrete structure. There is some slight erosion around the west side of the structure.

Outlet structure with rebar grate bolted down

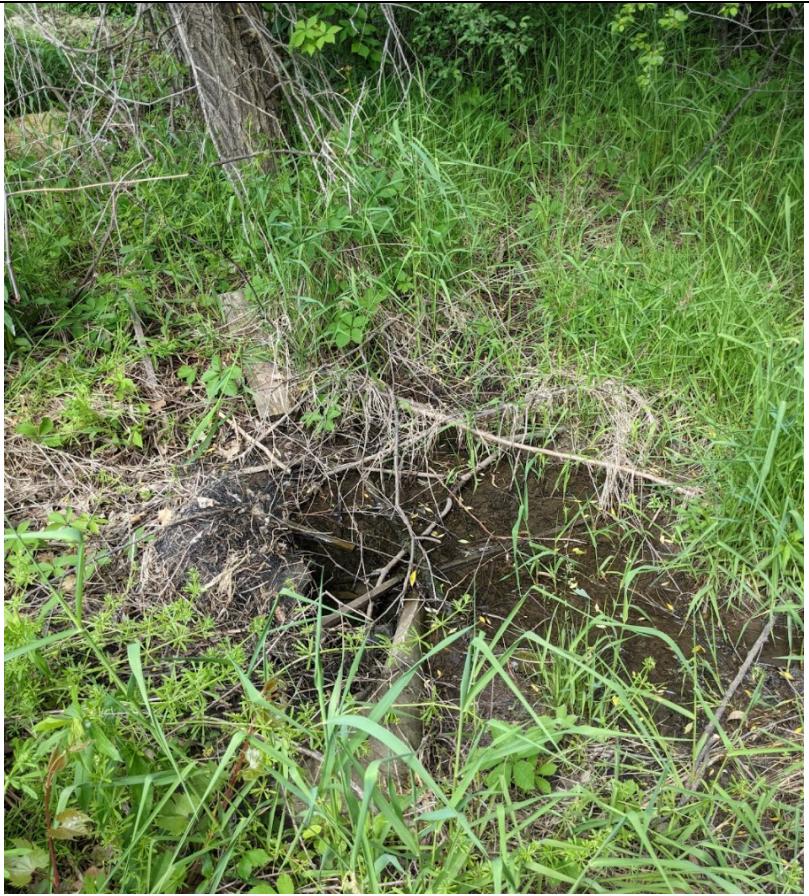
Compliance Verification	Design	Actual	Compliant Yes	No	Comments
Lower Discharge Control	(If Applicable)				
Opening Diameter (inches)	4"	4"	X		The normal water elevation at time of inspection was 784.70. This indicates that the outlet orifice most likely is significantly plugged and should be restored to original intent and working order.
Elevation	784.00	784.00	X		
Other (Description)					
Opening Type and Size (inches)					
Elevation					
Emergency Spillway					
Elevation	787.50	787.32	X		
Length of spillway (feet)	15'	16'	X		Some weedy vegetation growing, spray or hand remove
Embankment	Present Yes no		Comments/Maintenance Requirements		
Unauthorized Plantings, trees, or woody vegetation	X		There are numerous trees that have grown from small to large since the last inspection and should be removed.		
Animal burrows or slope erosion		X			
Storm Sewer Outfalls	Type & Size		Location		Comments
Outfall 1	RCP. 24"		South Edge		Significant sediment has accumulated at the end of pipe and within the end of the pipe. Sediment should be cleaned out and a riprap outfall pad installed at the end of the pipe.

View of outlet pipe in the wooded area, water flow is being hindered by sediment and vegetation
