STORMWATER MANAGEMENT FACILITIES OPERATION AND INSPECTION REPORT

NW1/4, Sec 25 Name of Business/Subdivision Harmony Hills II
N0098090 Address of Property _____

| Dry Pond | | Location of Pond | Outlet 4 – Pond #4 |

Inspector Name : Tyler Smith, PE
Inspection Date: 05.25.2021

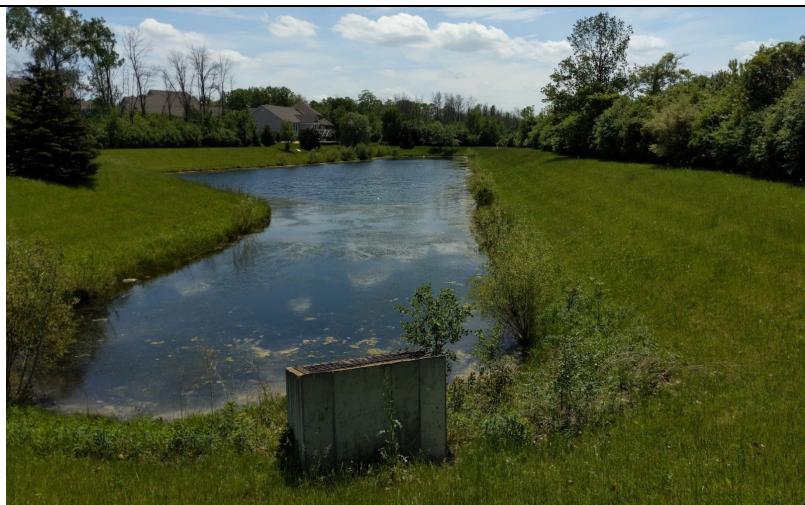
| Compliance Verification | Design | Actual | Compliant Yes | No | Comments (Condition of Structure) |
|---|---|---|---|---|--|
| Opening Diameter (inches) | 24"x36" | 24"x36" | X | | Riser Material Riser is a concrete structure with a metal rebar grate bolted to concrete structure. There is some slight erosion around the west side of the structure. |

Overall view of pond and outlet structure

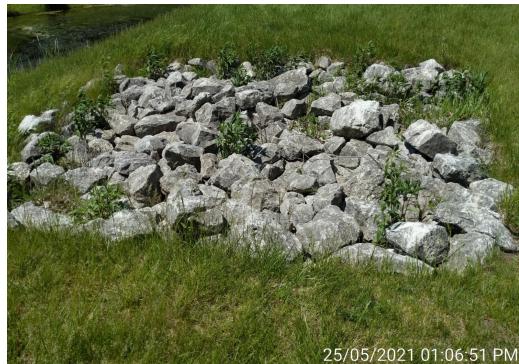
| Compliance Verification | Design | Actual | Compliant Yes | No | Comments | | |
|--|---|---|---|---|---|--|--|
| Elevation | 787.00 | 786.75 | X | | Some weedy vegetation growing, spray or hand remove | | |

Emergency riprap outflow weir

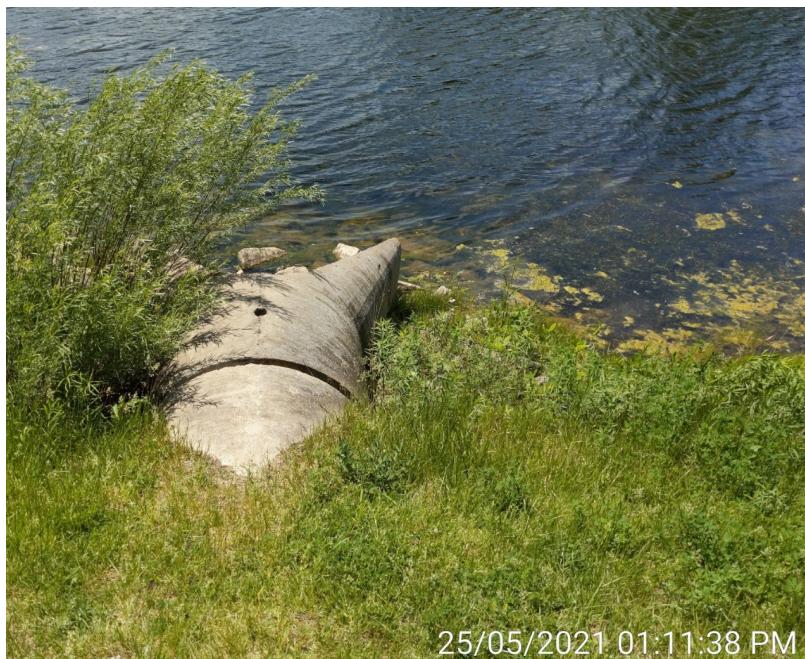
| Compliance Verification | Design | Actual | Compliant Yes | No | Comments | | |
|--|---|---|---|---|---|--|--|
| Outfall 1 | RCP. 42" | | Northeast Side | | From Dry Pond #3. End section has detached and volunteer trees starting to grow around end section. Needs to be repaired. | | |

Infall pipe from Dry Pond #3 with detached end section
