STORMWATER MANAGEMENT FACILITIES OPERATION AND INSPECTION REPORT

NE1/4, Sec 34
0133.216
Name of Business/Subdivision
Ravenswood Subdivision
Address of Property

Dry Pond		Pond ID: SWP34n003	Location of Pond	Outlet 3 – Pond #2
Wet Pond	X			Northern Pond
Other

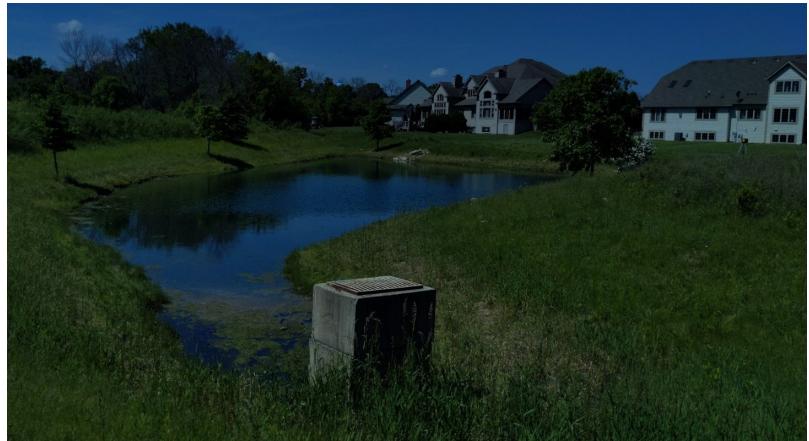
01/06/2021 11:00:13 AM

View of overall wet pond and outlet structure.

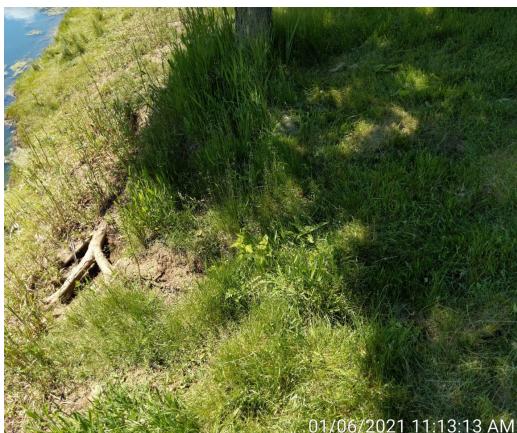
01/06/2021 11:13:13 AM

View of exposed roots and erosion.

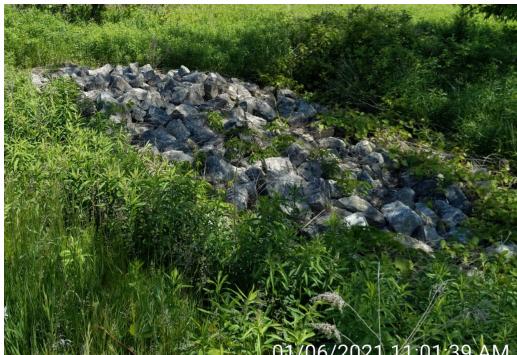
01/06/2021 11:01:39 AM

View of emergency overflow weir.

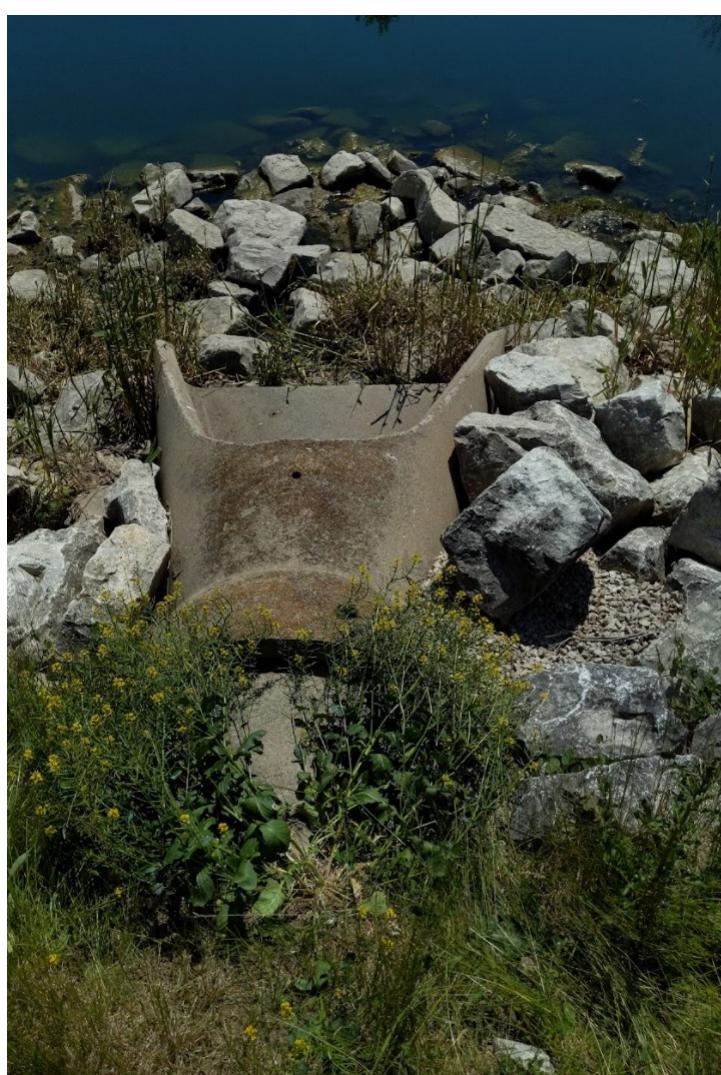
01/06/2021 11:08:00 AM

View of southwest infall pipe.

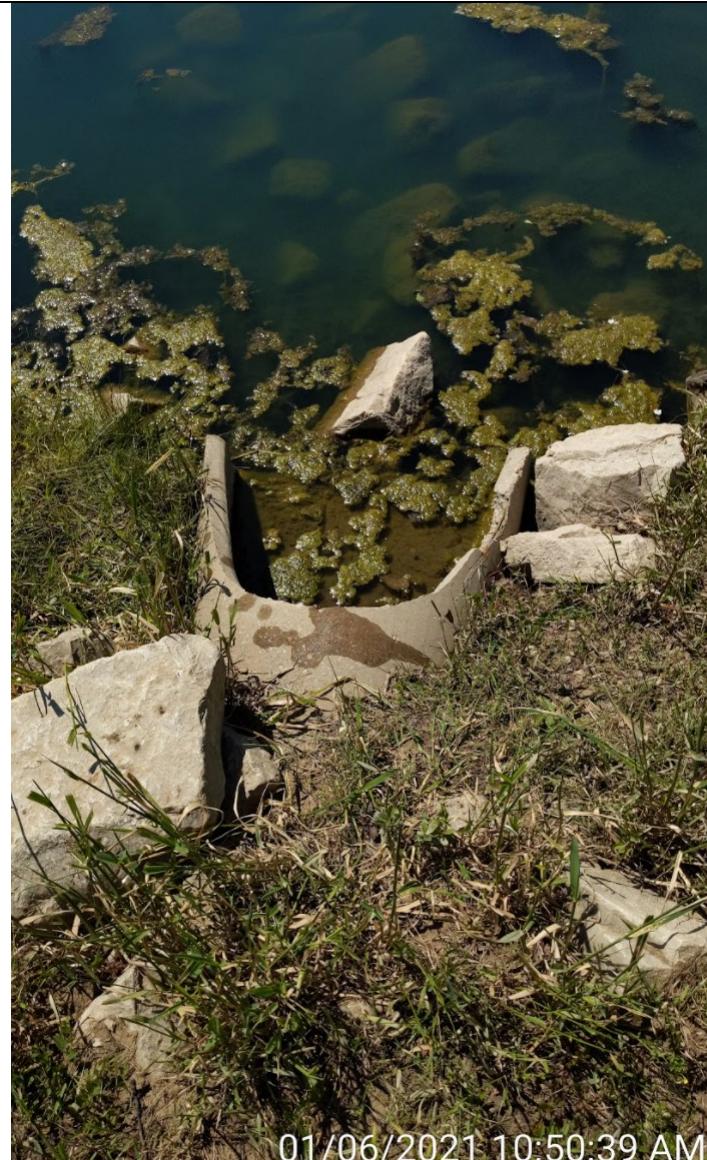
01/06/2021 10:50:39 AM

Northwest infall pipe.
