STORMWATER MANAGEMENT FACILITIES OPERATION AND INSPECTION REPORT

NE1/4, Sec 34
0133.216
Name of Business/Subdivision
Address of Property
Ravenswood Subdivision

Dry Pond		Pond ID: SWP34n004	Location of Pond	Outlet 2 – Pond #1
Wet Pond	X			Southern Pond
Other

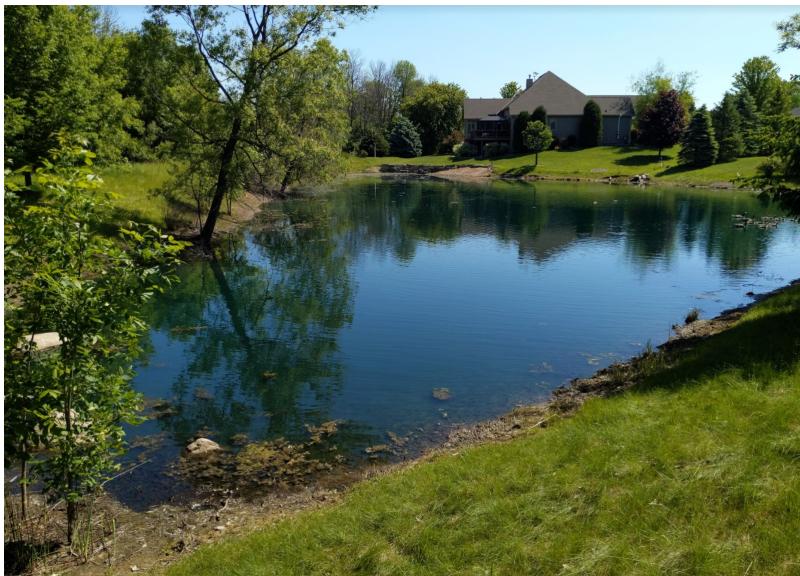
01/06/2021 10:23:34 AM
View of overall wet pond. Trees and woody vegetation shown here that should be removed.

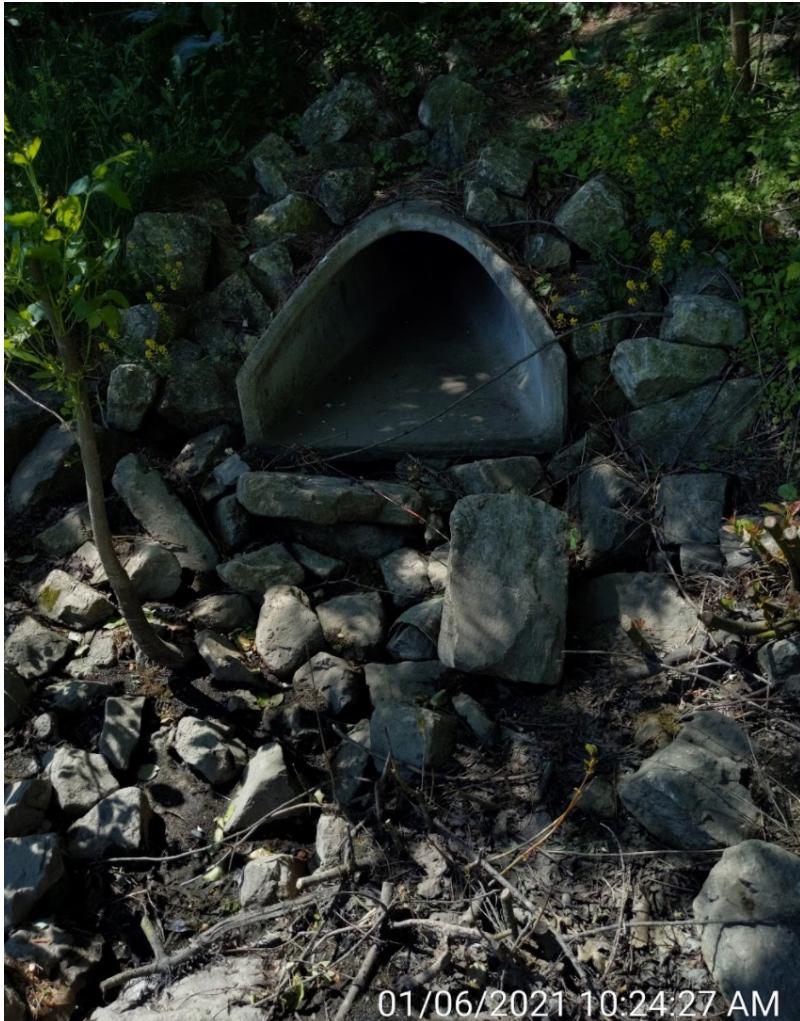
01/06/2021 10:24:27 AM
View of south infall pipe.

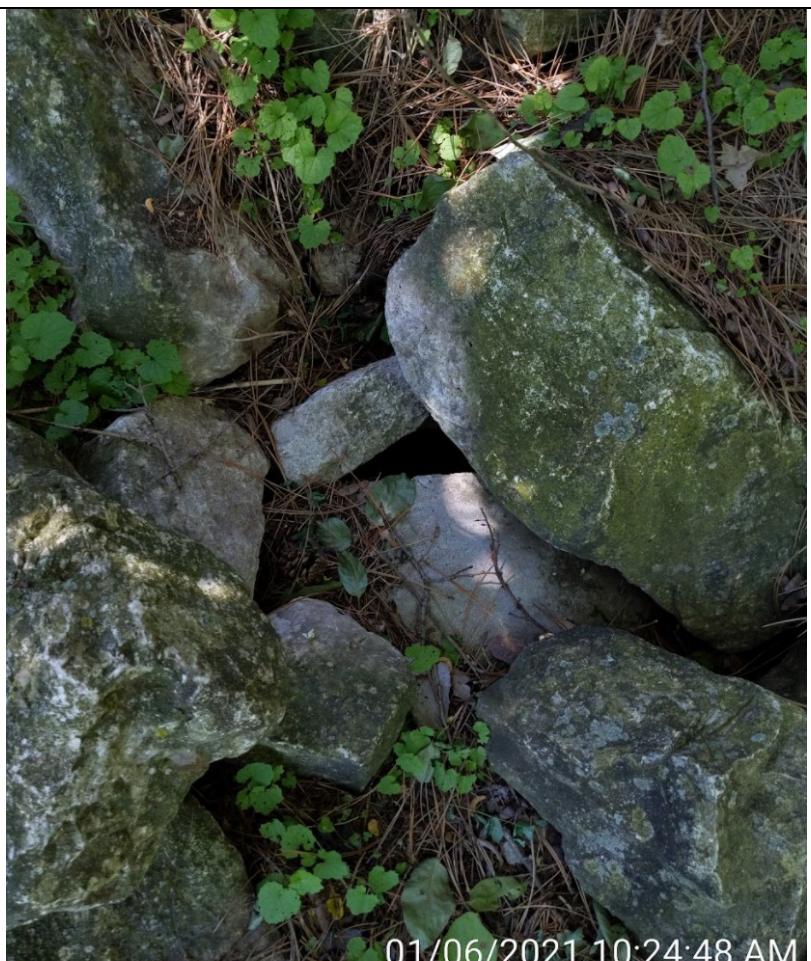
Animal burrows or slope erosion	X				
Storm Sewer Outfalls	Type & Size		Location		Comments
Outfall 1	RCP. 20"		West Edge		No signs of sediment accumulation at the end of the pipe. The little bit of riprap that is there appears to be stable, but there are areas in which soil is exposed and eroding into the Wet Pond. Recommend to remove riprap, add a geotextile fabric and replace the riprap along with additional riprap stones to secure the slope from the pipe to the water. The trees and woody vegetation between the pipe and the water should be removed. The endwall section of the pipe appears to have broken off of the main line pipe. This should be fixed.
Outfall 2	RCP, 24"		South Edge		There is some sediment accumulating within the endwall section, but most likely is due to the fact that the invert is slightly lower than the orifice of the outlet structure, causing water to pool and sediment to filter out in the pipe. The endwall starting to break away from main pipe. Excavate around endwall and re-attach endwall.

South infall pipe that is broken off at the endwall section.
