STORMWATER MANAGEMENT FACILITIES OPERATION AND INSPECTION REPORT

Quarter Section	SW 1/4 Section 36	Name of Business/Subdivision	Fairchild Equipment
Property Tax ID Number	MNFV0143999 041	Address of Property	N52W13821 Northpark Dr
Date			Menomonee Falls, WI 53051
Dry Pond	<input checked="" type="checkbox"/>	Location of Pond	SE side of property
Wet Pond	<input type="checkbox"/>		
Other	<input type="checkbox"/>		
Pond ID:		SWP365007

Inspection Firm: Ayres Associates
Phone Number: (262)-523-4488
Address: 20975 Swenson Drive
Suite 200
Waukesha WI, 53186

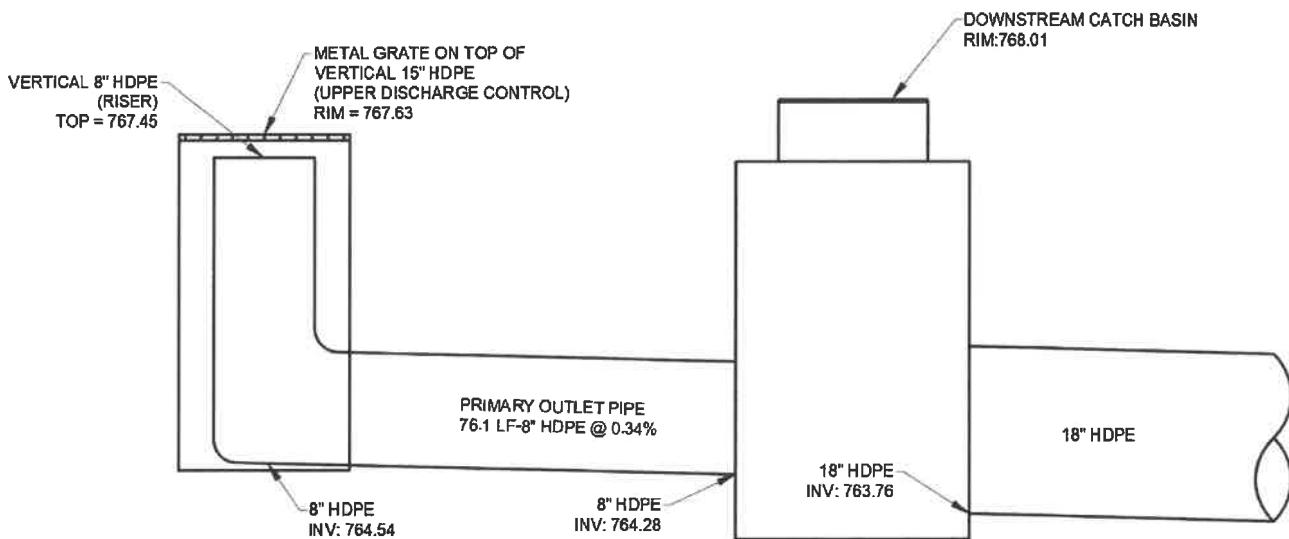
Sketch Outlet or Attach to Document

Compliance Verification		Design	Actual	Compliant Yes	No	Comments (Condition of Structure)
Primary Outlet Pipe						Outlet Pipe Material -All elevations are based on vertical datum NGVD29. -See attached detail
Opening Diameter (inches)	10"	8"	HDPE		X	
Upstream Invert	764.60	764.54	X			
Downstream Invert	764.31	764.28	X			
Length (feet)	76.1'	76.1'	X			
Slope (%)	0.38%	0.34%	X			
Secondary Outlet Pipe		(If Applicable)			Outlet Pipe Material	
Opening Diameter (inches)						
Upstream Invert						
Downstream Invert						
Length (feet)						
Slope (%)						
Riser		(If Applicable)			Riser Material	
Opening Diameter (inches)	10"	8"		X	8" HDPE vertical pipe inside of 15" HDPE pipe	
Elevation	767.00	767.45		X		
Upper Discharge Control		(If Applicable)			Steel open grate on top of 15" HDPE pipe	
Opening Diameter (inches)	15"	15"	X			
Elevation	767.82	767.63	X

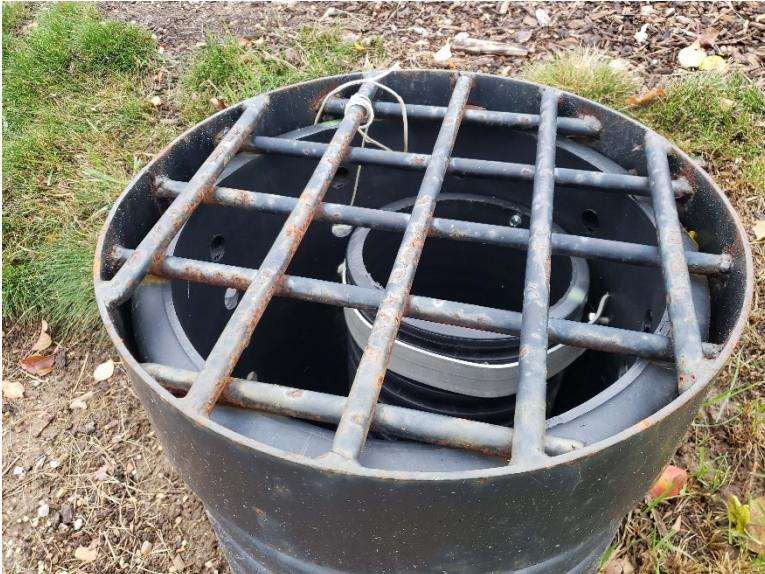
Dry detention basin outlet structure located at north side of the basin. Steel grate on top of vertical 15" CPP pipe with vertical 8" CPP inside.

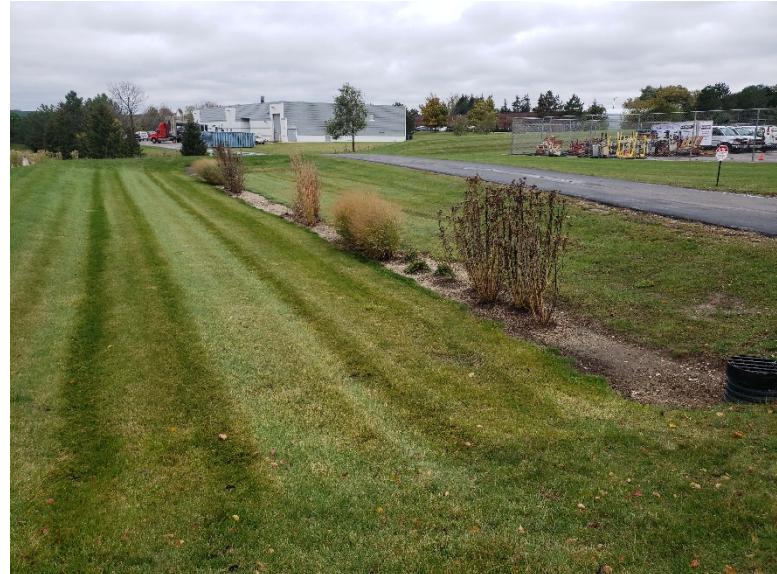
Dry detention basin looking south with landscaping down the middle.

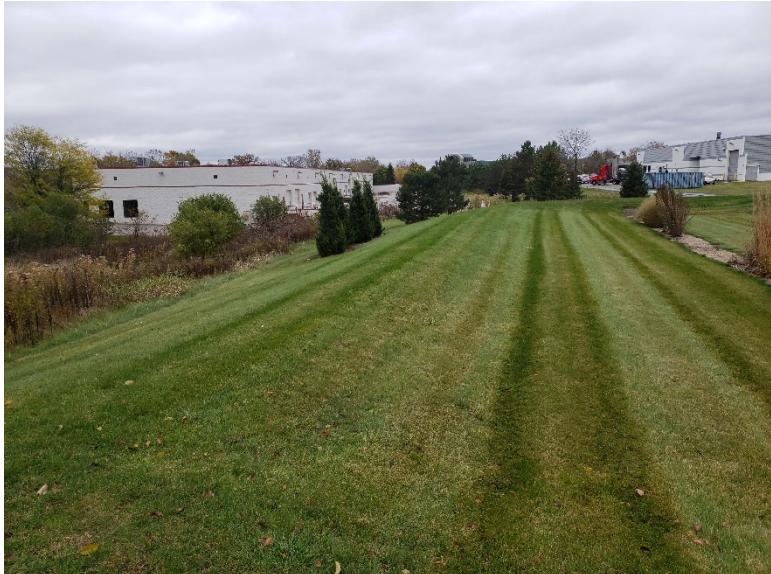
West side top of berm looking south.

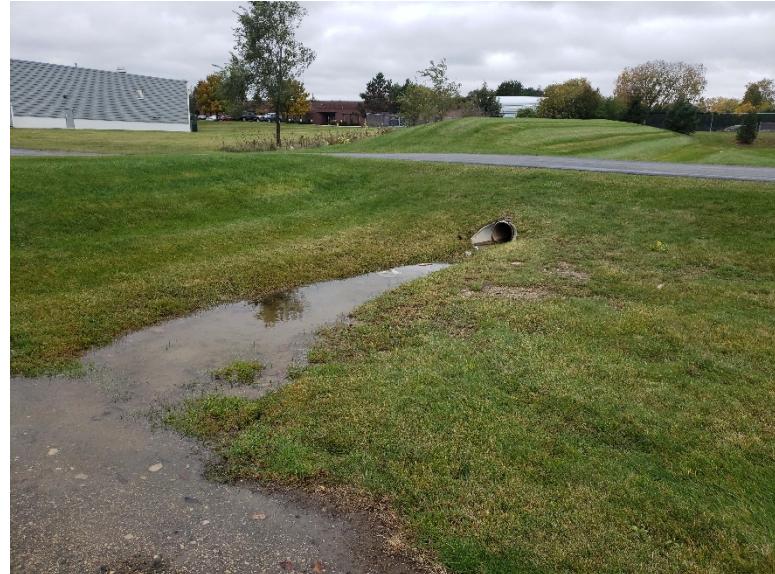
12" CMP storm sewer outfall pipe located in the southeast corner of the detention basin.
