STORMWATER MANAGEMENT FACILITIES OPERATION AND INSPECTION REPORT

Name of Business/Subdivision Breezy Hill
Address of Property N96W21627 County Line Road

Dry Pond		Location of Pond	Pond 2 – East Side of Property
Wet Pond	X		_____
Other			_____
Pond ID: <u>SWP 6N002</u>		_____

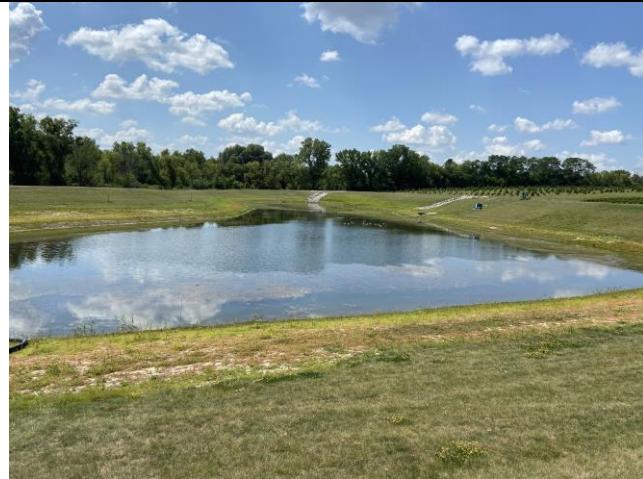
Pond 2 overview

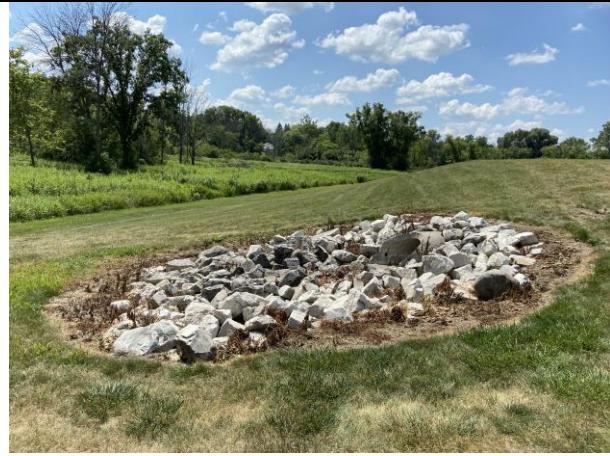
Compliance Verification	Design	Actual	Compliant Yes	No	Comments	
Lower Discharge Control	(If Applicable)					
Opening Diameter (inches)	N/A					
Elevation						
Other (Description)						
Opening Type and Size (inches)	N/A					
Elevation						
Emergency Spillway						
Elevation	876.00	878.30	Y		Good condition	
Length of spillway (feet)	18	20	Y			
Embankment	Present Yes no		Comments/Maintenance Requirements			
Unauthorized Plantings, trees, or woody vegetation		X	Grass is well maintained, there are no unauthorized plantings or natural weeds/invasive plants. There appeared to be no burrowing or other damage caused by wildlife in the area.			
Animal burrows or slope erosion		X				
Storm Sewer Outfalls	Type & Size		Location		Comments	
Outfall 1						
Outfall 2						
Outfall 3						
Storage Properties	Design	Actual	Compliant Yes	No	Not Applicable	Equipment Used
Normal Water Elevation (Wet Ponds)	871.50	874.00	Y			Pictures on 8/3/2021 display state of pond 2. Riprap is in good condition as well as emergency spillway. Primary outfall for pond 2 is in good condition and is above the waterline as shown in photos below.

Pond 2 primary outfall into wetland area

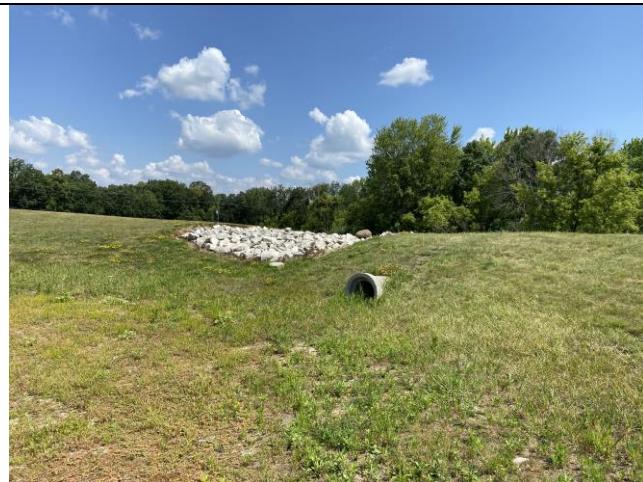
Pond 2 primary outfall from pond direction

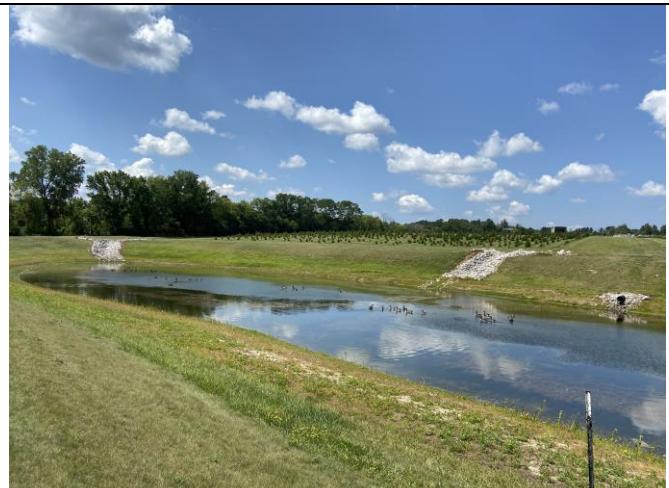
Pond 2 Riprap on
