STORMWATER MANAGEMENT FACILITIES OPERATION AND INSPECTION REPORT

NE 1/4 SEC 2 Name of Business/Subdivision Scion Dental
MNFV 0005007005 Address of Property N92 W14612 Anthony Ave.
Menomonee Falls, WI 53051

Pond ID: SWP 2 NO 14

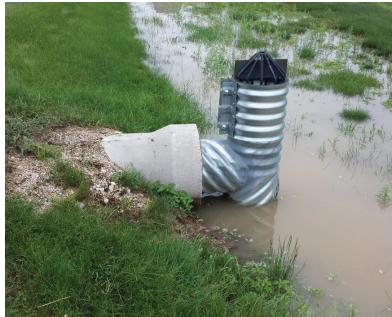
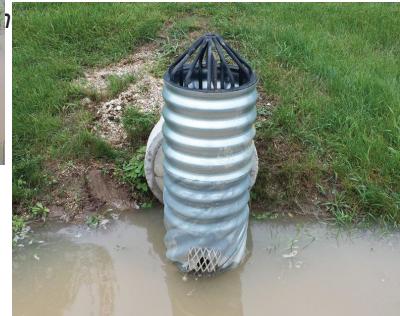
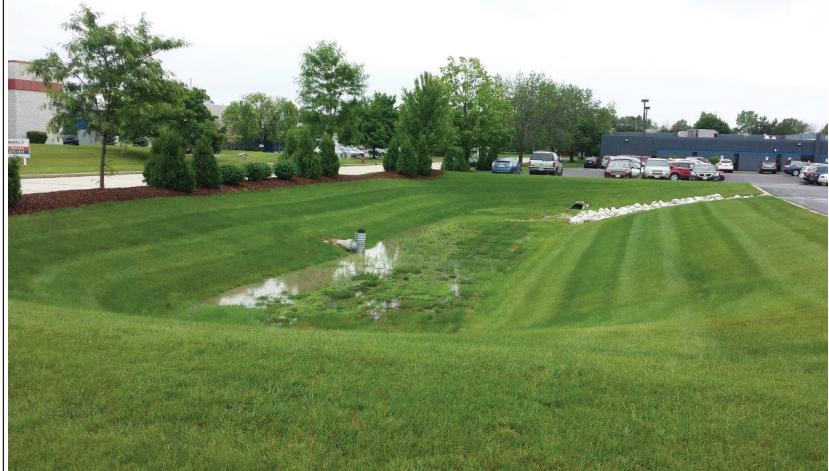
This Stormwater Pond was designed as an infiltration basin. However, prior to construction, preliminary sub-soil data showed that the sub-soils did not appear to be conducive to infiltration and this BMP was recalculated as wet pond.

During construction, the contractor appears to have installed "Engineered Soils" based on a previous 'Infiltration Basin' design.

In the past 5 years the property owner has noted that the pond rarely holds water, even after large rain events, and it appears that the infiltration aspects of the pond seem to be functioning, at least partially, as originally designed.
