## STORMWATER MANAGEMENT FACILITIES OPERATION AND INSPECTION REPORT

Bungalows of Menomonee Falls  
North of Bobolink & east of Pilgrim Rd

Pond ID: SWP26S006

North of Condo's with in the  
bungalows located on Bobolink

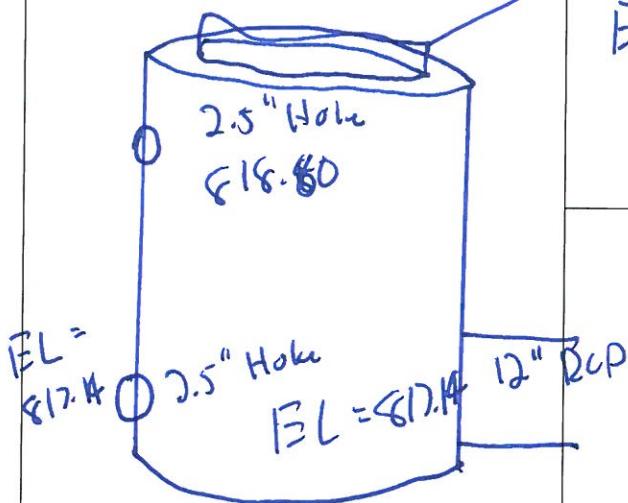
Sketch Outlet or Attach to Document

Grate  
Elv 819.68
