## STORMWATER MANAGEMENT FACILITIES OPERATION AND INSPECTION REPORT

Quarter Section SW 1/4 Sec 23 Name of Business/Subdivision Little League Complex  
Property Tax ID Number 0091.999 Address of Property Adjacent to Mill Road

Description: SWP 235 002 Location Of Pond Pond #002, See Attached map for location.

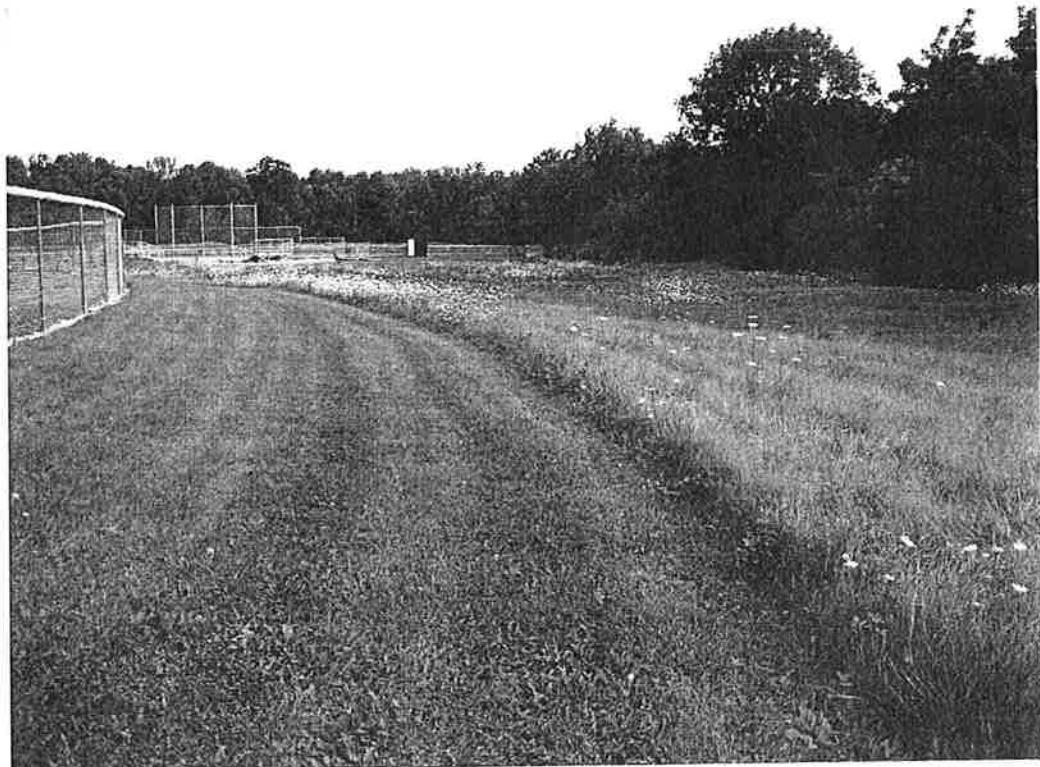
#1 - Looking North at Pond #002

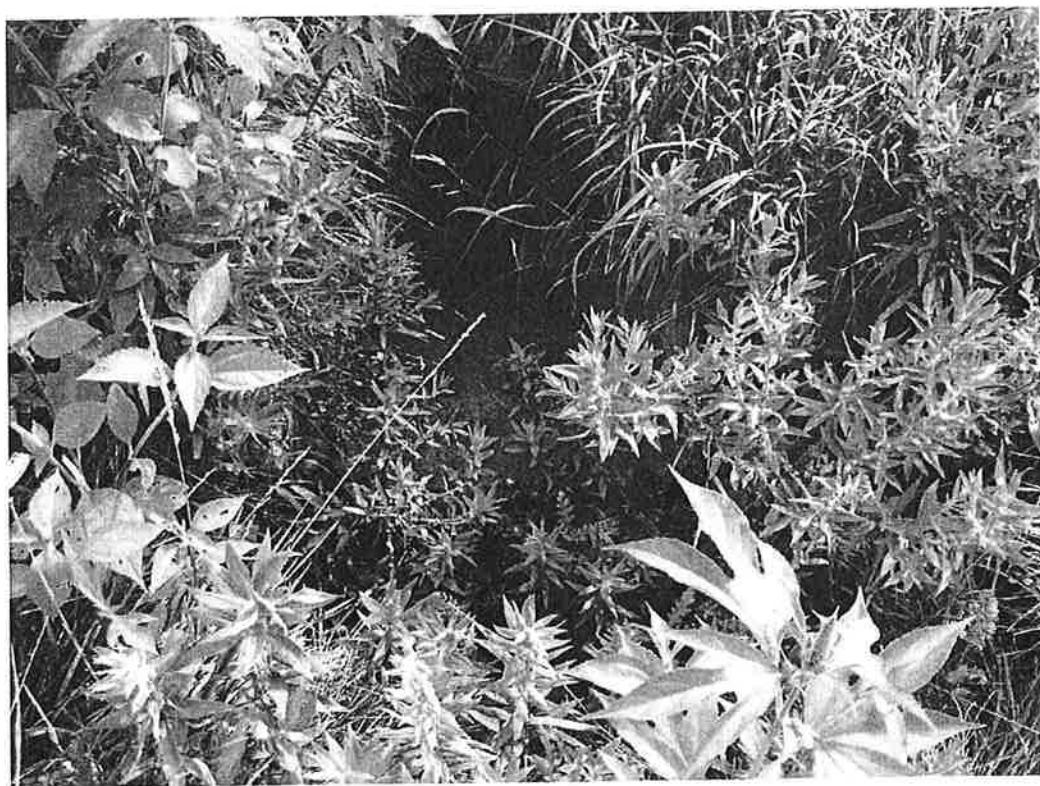
Compliance Verification	Design	Actual	Compliant Yes	No	Comments (Condition of Structure)
<b>Primary Outlet Pipe</b>					Outlet Pipe Material – Reinforced Concrete
Opening Diameter (inches)	12"		Yes		Upstream Outlet – Picture #2 – Minor Erosion around Apron Endwall.
Upstream Invert	815.40	816.70	No		Downstream Outlet – Picture #3 – Good
Downstream Invert	814.98		Yes		
Length (feet)	72'		Yes		
Slope (%)	0.50%		Yes		
<b>Secondary Outlet Pipe</b>	(If Applicable)		Outlet Pipe Material		
Opening Diameter (inches)					
Upstream Invert					
Downstream Invert					
Length (feet)					
Slope (%)					
<b>Riser</b>	(If Applicable)		Riser Material		
Opening Diameter (inches)					
Elevation					
<b>Upper Discharge Control</b>	(If Applicable)				
Opening Diameter (inches)					
Elevation

#2 - Upstream end of outfall, minor erosion around AEW

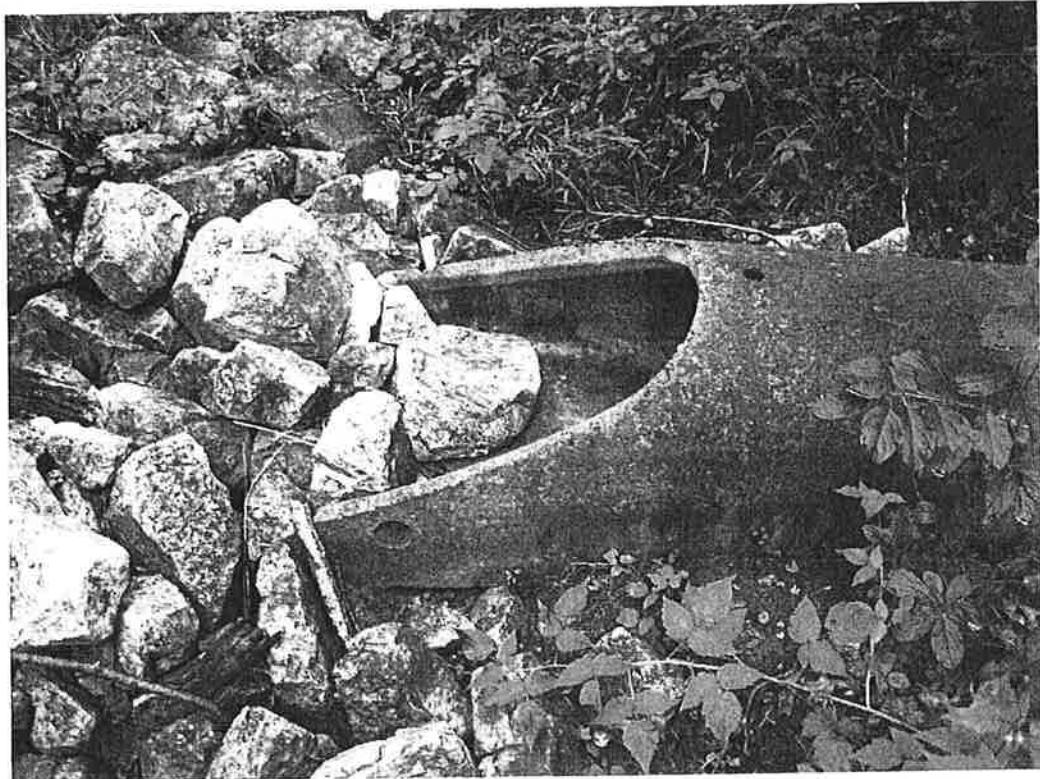
#3 - Downstream end of outfall

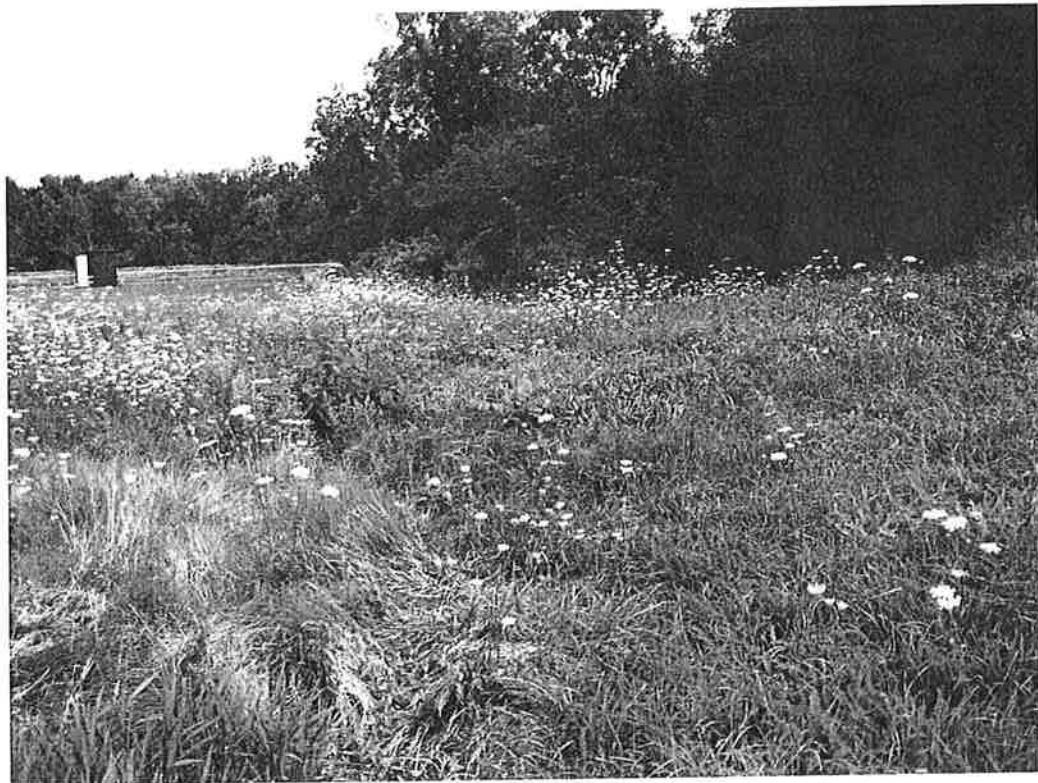
Compliance Verification		Design	Actual	Compliant Yes No		Comments			
<b>Lower Discharge Control</b>		(If Applicable)							
Opening Diameter (inches)									
Elevation									
<b>Other (Description)</b>									
Opening Type and Size (inches)									
Elevation									
<b>Emergency Spillway</b>									
Elevation	818.00		Yes		Picture #4				
Length of spillway (feet)			Yes						
<b>Embankment</b>		Present Yes no		Comments/Maintenance Requirements					
Unauthorized Plantings, trees, or woody vegetation		No							
Animal burrows or slope erosion		No							
<b>Storm Sewer Outfalls</b>		Type & Size		Location		Comments			
Outfall 1									
Outfall 2									
Outfall 3									
<b>Storage Properties</b>		Design	Actual	Compliant Yes No	Not Applicable	Equipment Used			
Normal Water Elevation (Wet Ponds)									
Design High Water Elevation									
Area at Normal Water Elevation (Ac) (Wet Ponds)									
Area at Design High Water Elevation (Ac)

#4 - Emergency Spillway.

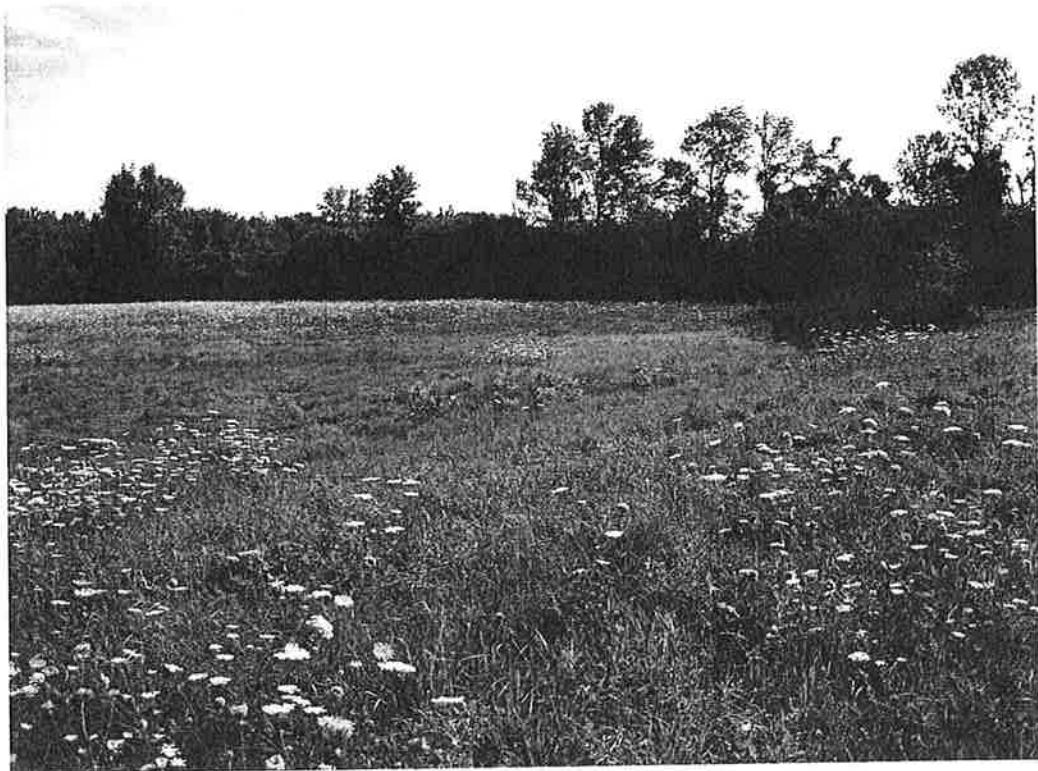
#1 - Looking Northeast over Pond #003

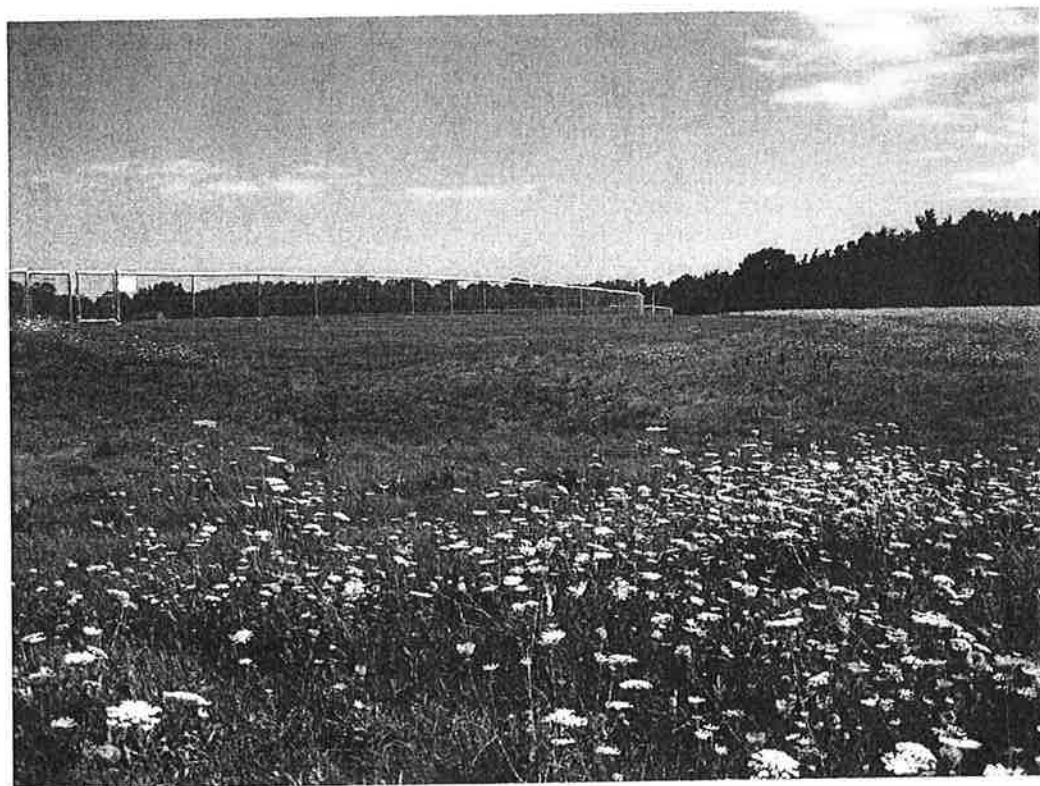
#2 - Looking North

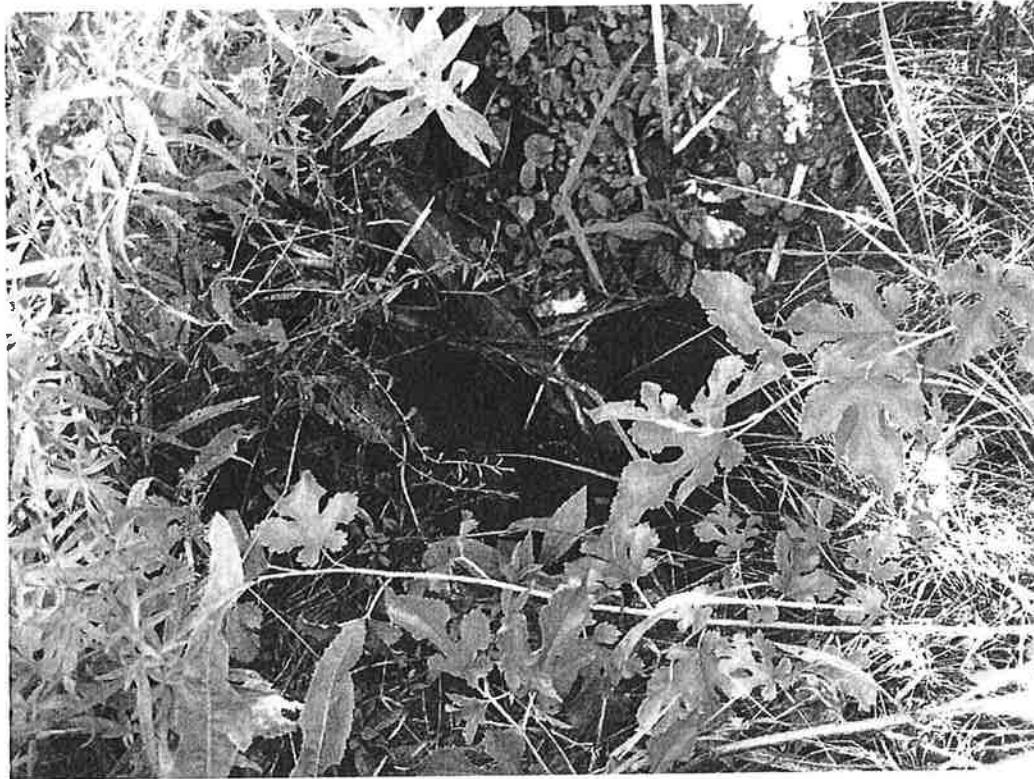
Compliance Verification	Design	Actual	Compliant Yes	Non-Compliant No	Comments (Condition of Structure)
<b>Primary Outlet Pipe</b>					Outlet Pipe Material – Reinforced Concrete
Opening Diameter (inches)	15"		Yes		Upstream Outlet – Picture #3 – Silt fence, Debris in front of pipe, no Apron Endwall.
Upstream Invert	812.40	814.01	No		Downstream Outlet – Picture #4 – Rocks & Silt Fence in Apron Endwall, minimal riprap.
Downstream Invert	811.98		Yes		
Length (feet)	72'		Yes		
Slope (%)	0.50%		Yes		
<b>Secondary Outlet Pipe</b>	(If Applicable)		Outlet Pipe Material		
Opening Diameter (inches)					
Upstream Invert					
Downstream Invert					
Length (feet)					
Slope (%)					
<b>Riser</b>	(If Applicable)		Riser Material		
Opening Diameter (inches)					
Elevation					
<b>Upper Discharge Control</b>	(If Applicable)				
Opening Diameter (inches)					
Elevation

#3 - Standing on top of Upstream outlet, silt fence, debris in front of pipe, does not look like AEW was put in or it was pulled out.

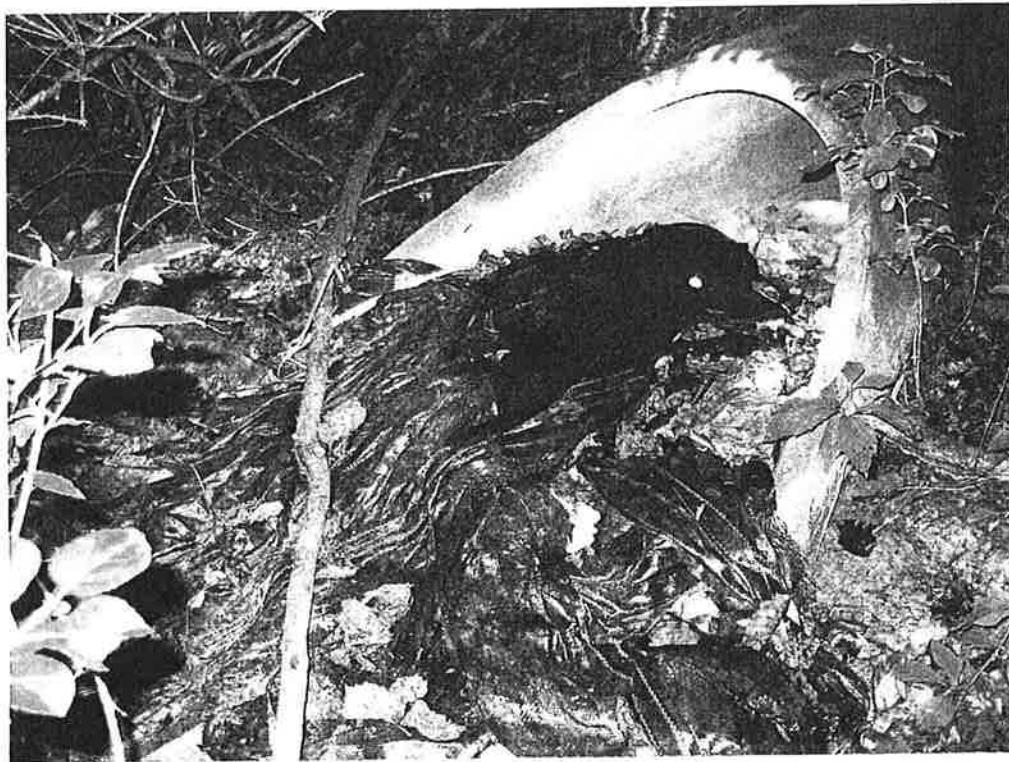
#4 - Downstream outfall, rocks and silt fence in AEW.

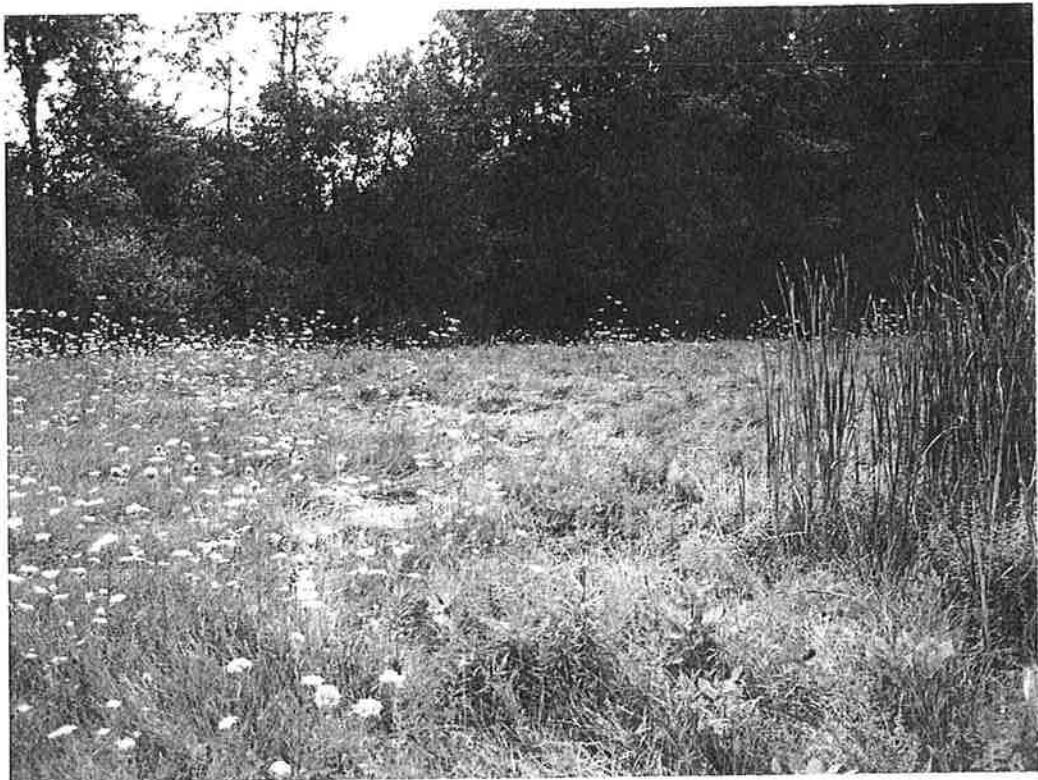
Compliance Verification		Design	Actual	Compliant Yes	No	Comments			
<i>Lower Discharge Control</i>		(If Applicable)							
Opening Diameter (inches)									
Elevation									
<i>Other (Description)</i>									
Opening Type and Size (inches)									
Elevation									
<i>Emergency Spillway</i>									
Elevation	816.00		Yes		Picture #5				
Length of spillway (feet)			Yes						
<i>Embankment</i>		Present Yes      no		Comments/Maintenance Requirements					
Unauthorized Plantings, trees, or woody vegetation		No							
Animal burrows or slope erosion		No							
<i>Storm Sewer Outfalls</i>		Type & Size		Location		Comments			
Outfall 1									
Outfall 2									
Outfall 3									
<i>Storage Properties</i>		Design	Actual	Compliant Yes	No	Not Applicable			
Normal Water Elevation (Wet Ponds)									
Design High Water Elevation									
Area at Normal Water Elevation (Ac) (Wet Ponds)									
Area at Design High Water Elevation (Ac)

#5 - Emergency Spillway.

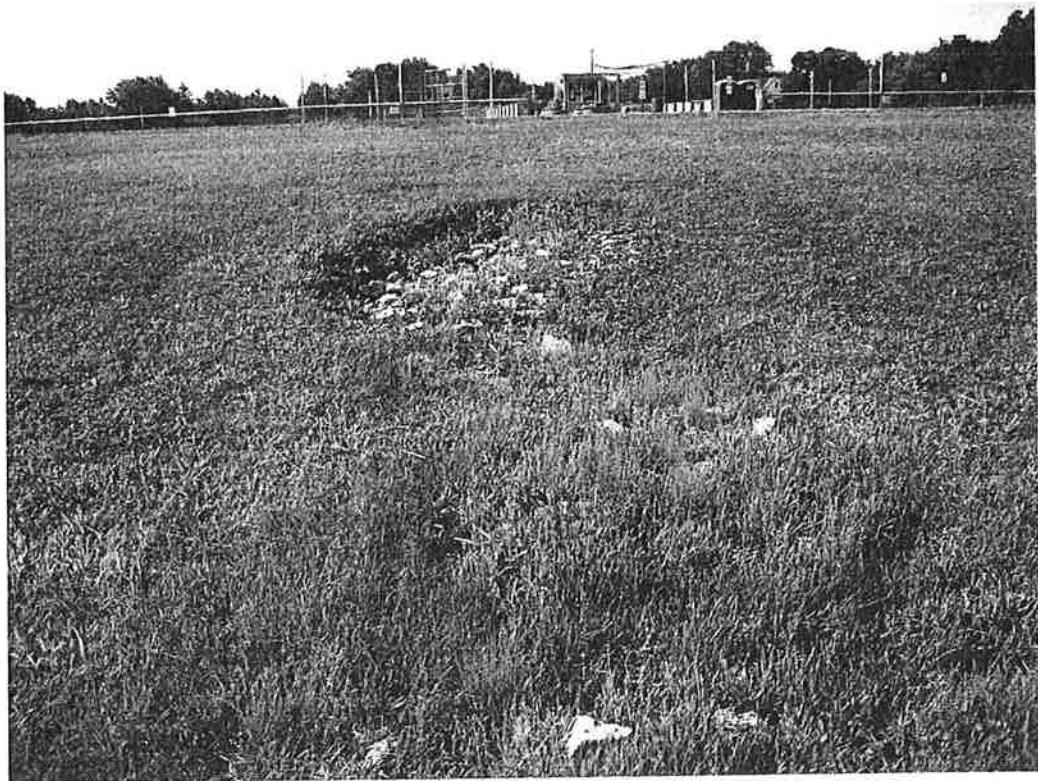
Compliance Verification		Design	Actual	Compliant Yes      No	Comments						
<b>Lower Discharge Control</b>		(If Applicable)									
Opening Diameter (inches)											
Elevation											
<b>Other (Description)</b>											
Opening Type and Size (inches)											
Elevation											
<b>Emergency Spillway</b>											
Elevation	815.00		Yes		Picture #8						
Length of spillway (feet)			Yes								
<b>Embankment</b>		Present Yes      no		Comments/Maintenance Requirements							
Unauthorized Plantings, trees, or woody vegetation		No	Low spot in SE corner of pond picture #3, regrade to flow out.								
Animal burrows or slope erosion		No	Fix erosion of slope by outfall #3 & 4								
<b>Storm Sewer Outfalls</b>		Type & Size		Location		Comments					
Outfall 1	8" corrugated plastic	SE Corner of Pond		Picture #2, minor area of no vegetation							
Outfall 2	8" corrugated plastic	South side of pond		Pic. #1, minor erosion, over growth

#1 - Storm outfall #2, South side of pond, Minor erosion around riprap, riprap push down slope.

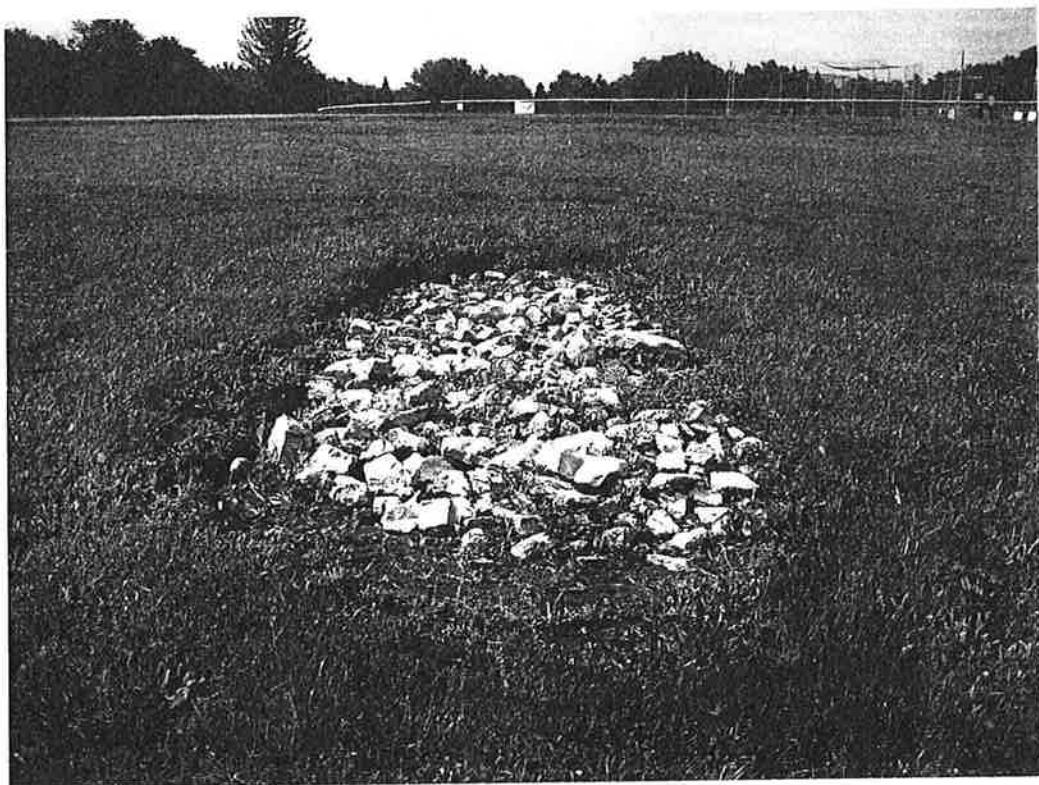
#2 - Storm outfall #1, SE corner of pond, minor areas of dead grass around riprap.

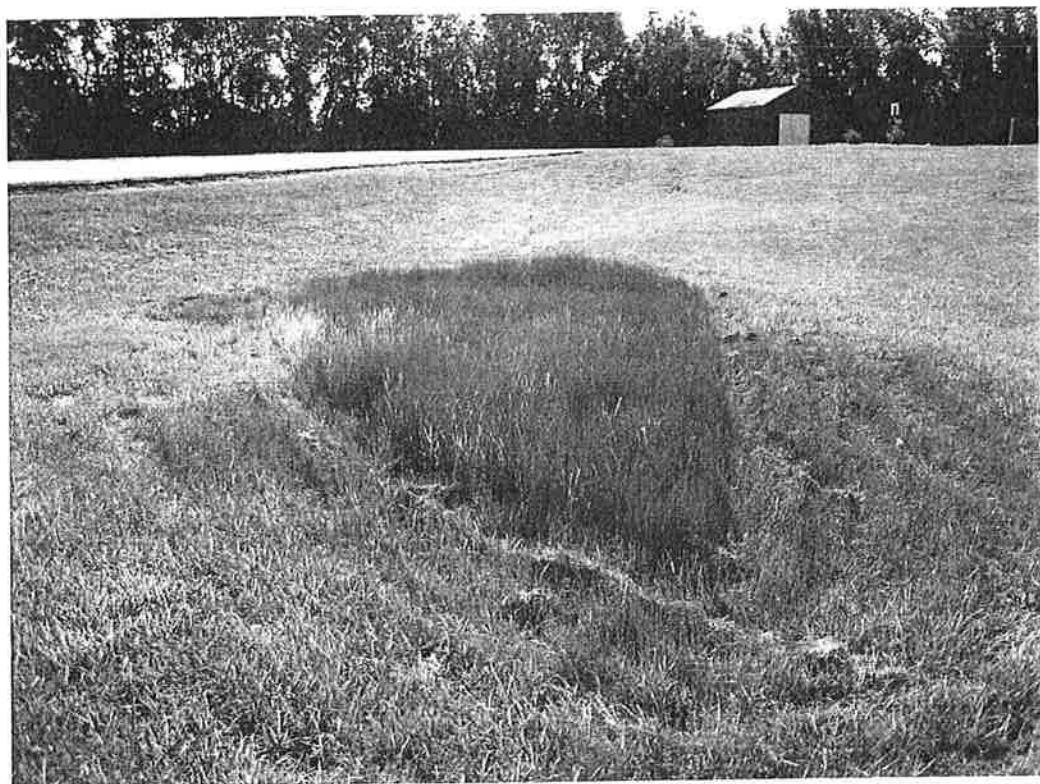
Outfall 3 & 4	8" corrugated plastic	SW Corner & West Side		Pic. #4 & 5 pipe exposed from erosion							
<b>Storage Properties</b>		Design	Actual	Compliant Yes      No	Not Applicable	Comments					
Normal Water Elevation (Wet Ponds)						Low spot on SE corner of pond, regrade to flow. Baseball field built in SW corner of pond, so it will affect pond storage from original design.					
Design High Water Elevation											
Area at Normal Water Elevation (Ac) (Wet Ponds)											
Area at Design High Water Elevation (Ac)											
Active Storage Available (Ac-Ft)*											
Lowest Elevation at Top of Embankment (If Applicable)	816.00										
Average Elevation at Top of Embankment (If Applicable)											
Maximum Bottom Elevation											
Average Pond Bottom Elevation											
Pond Bottom Area (Ac)											
Maximum Pond Depth	3.50'	3.02'									
Average Pond Depth											
Average Permanent Pool Depth (Wet Ponds)

#3 - Low spot in SE corner of pond.

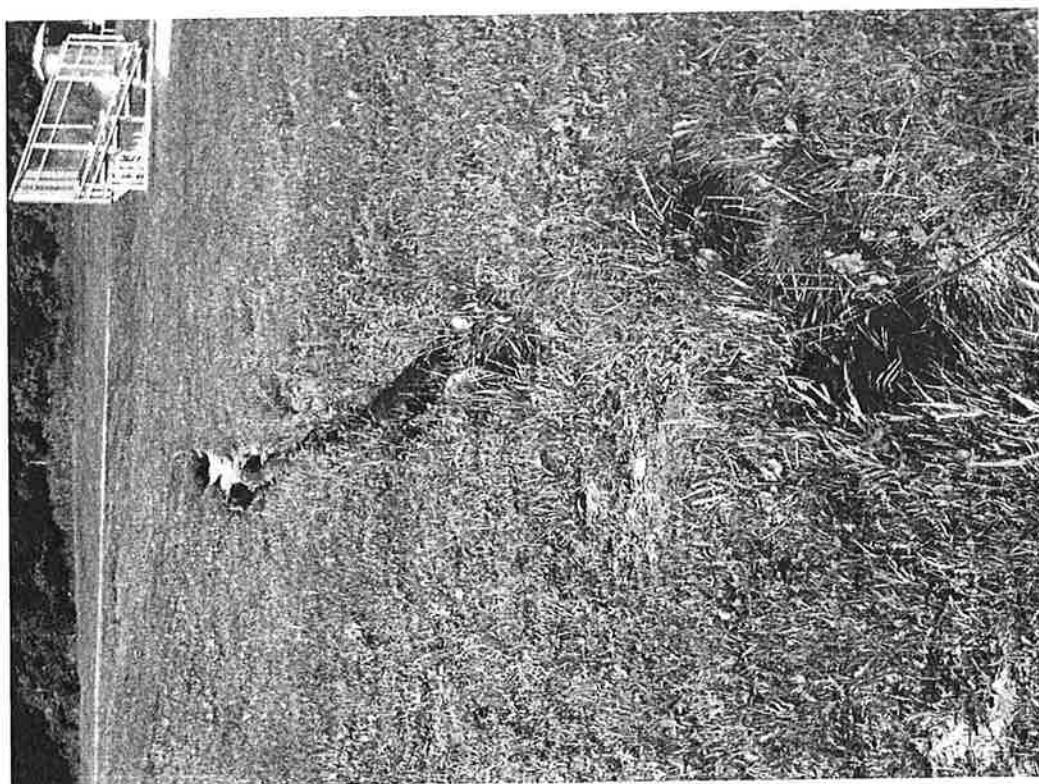
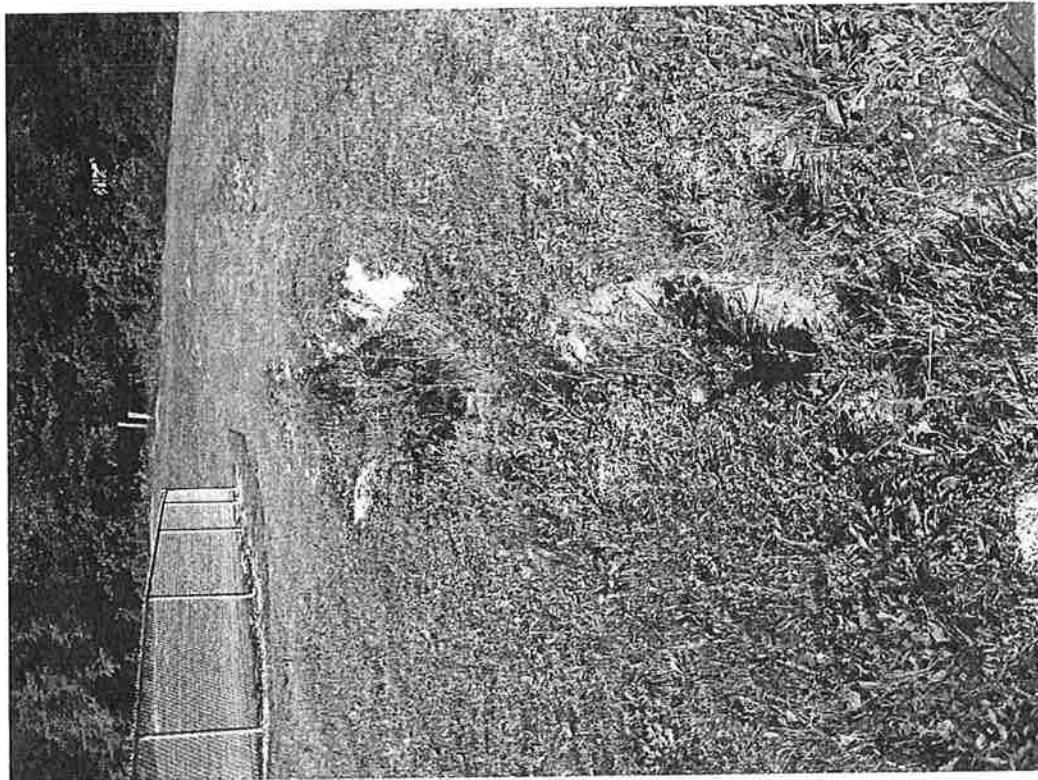
#4 - Storm outfall #3, SW corner of pond, ground eroded away on top of pipe and in front of pipe.

#5 - Storm outfall #4, west side of pond, ground eroded away on top of pipe and in front of pipe.

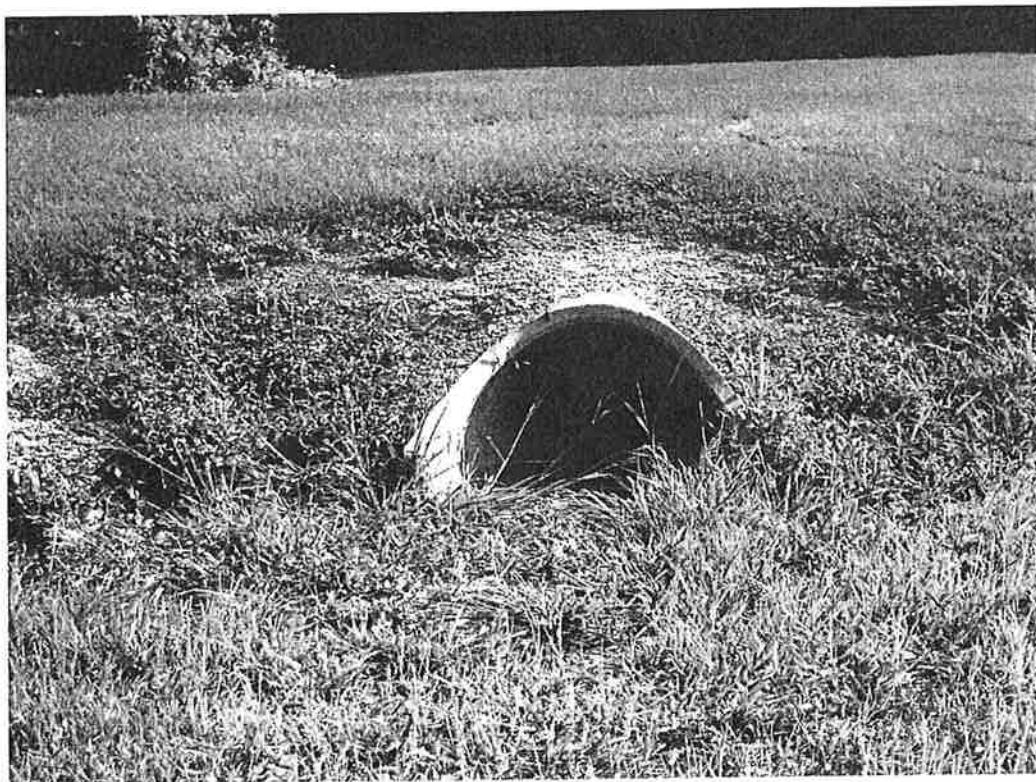
Compliance Verification	Design	Actual	Compliant		Comments (Condition of Structure)
			Yes	No	
<b>Primary Outlet Pipe</b>					Outlet Pipe Material – Reinforced Concrete
Opening Diameter (inches)	15"		Yes		Upstream Outlet – Picture #6 & 7 – minor vegetation around Apron Endwall, Debris in Endwall.
Upstream Invert	811.50	811.98	Yes		
Downstream Invert	810.98		Yes		Downstream Outlet – Picture #9 – Hole next to outfall, could be from animal, did not look like from erosion.
Length (feet)	98'		Yes		
Slope (%)	0.50%		Yes		
<b>Secondary Outlet Pipe</b>	(If Applicable)		Outlet Pipe Material		
Opening Diameter (inches)					
Upstream Invert					
Downstream Invert					
Length (feet)					
Slope (%)					
<b>Riser</b>	(If Applicable)		Riser Material		
Opening Diameter (inches)					
Elevation					
<b>Upper Discharge Control</b>	(If Applicable)				
Opening Diameter (inches)					
Elevation

#6 - Upstream end of outfall, minor vegetation around outfall.

#7 - Upstream end of outfall, debris caught in AEW.

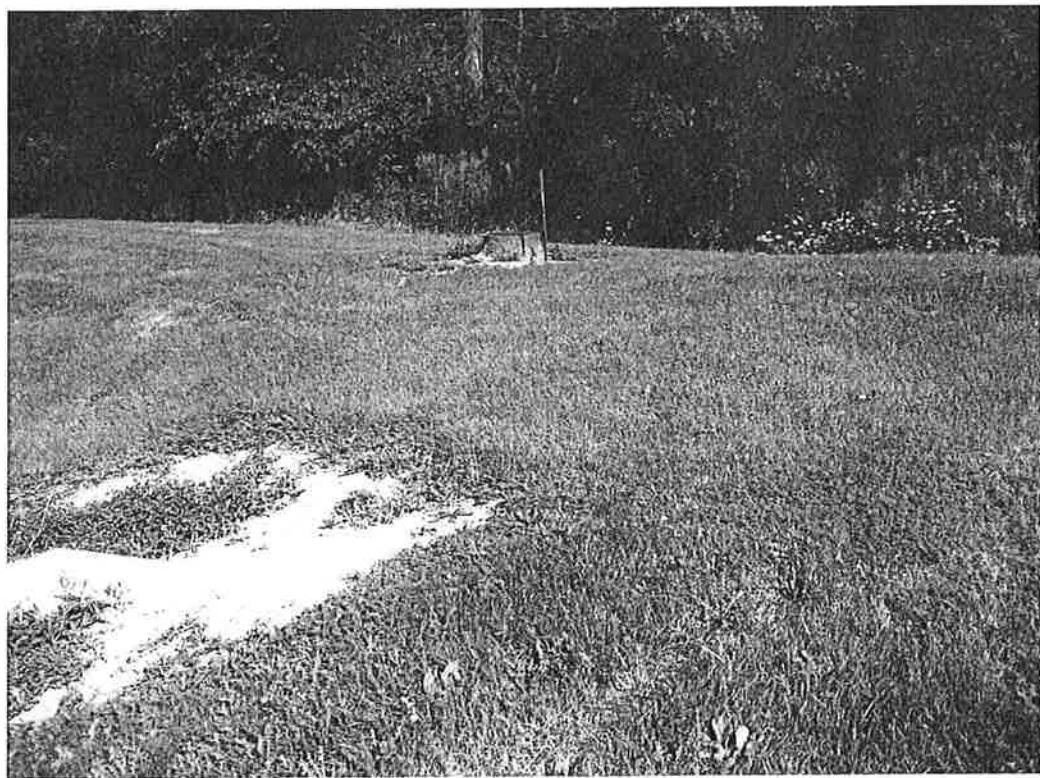
#8 - Emergency Spillway.

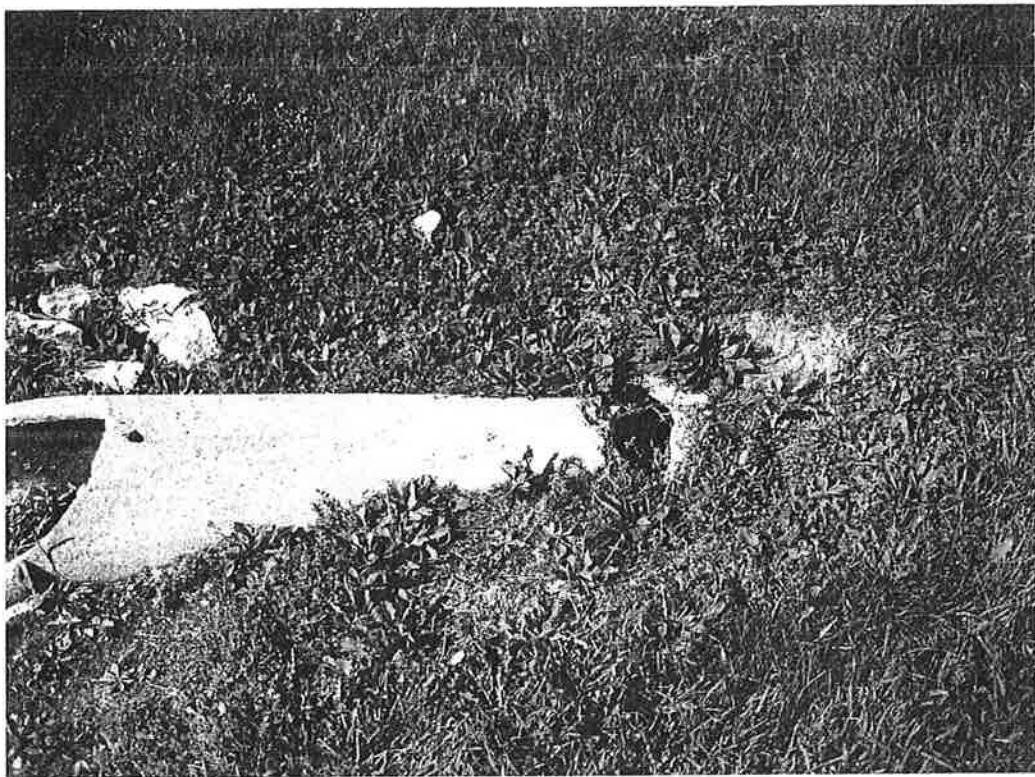
#1 - Downstream end of outfall, top of AEW and pipe broken out.

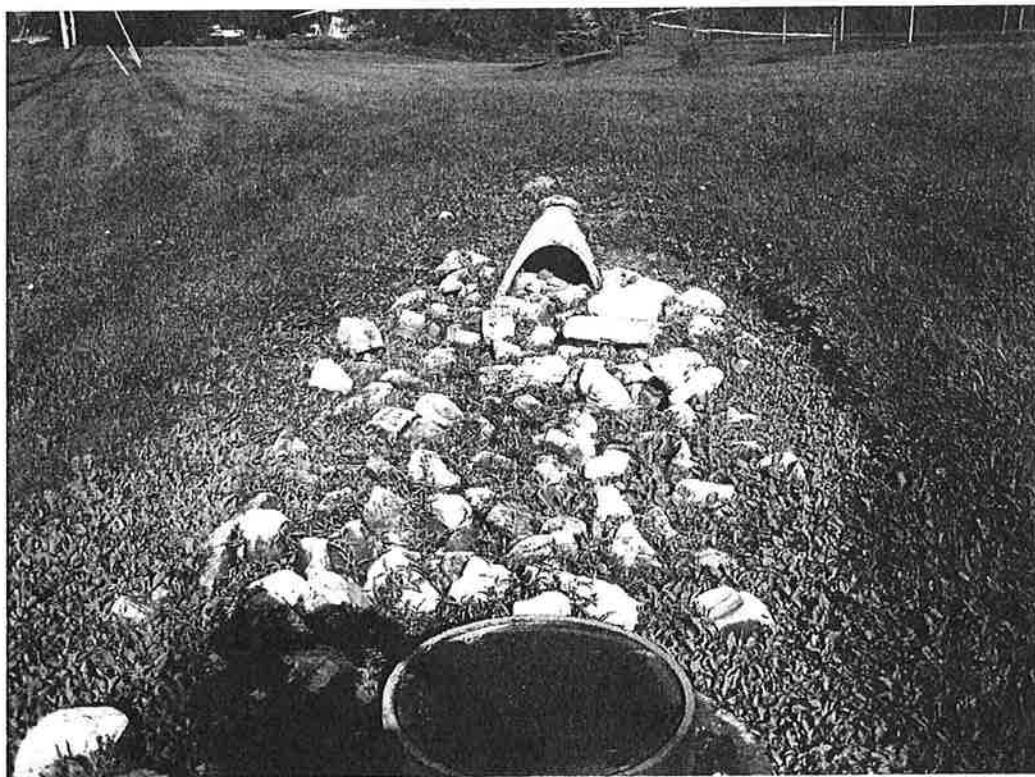
#2 - Downstream end of outfall, riprap getting grown in.

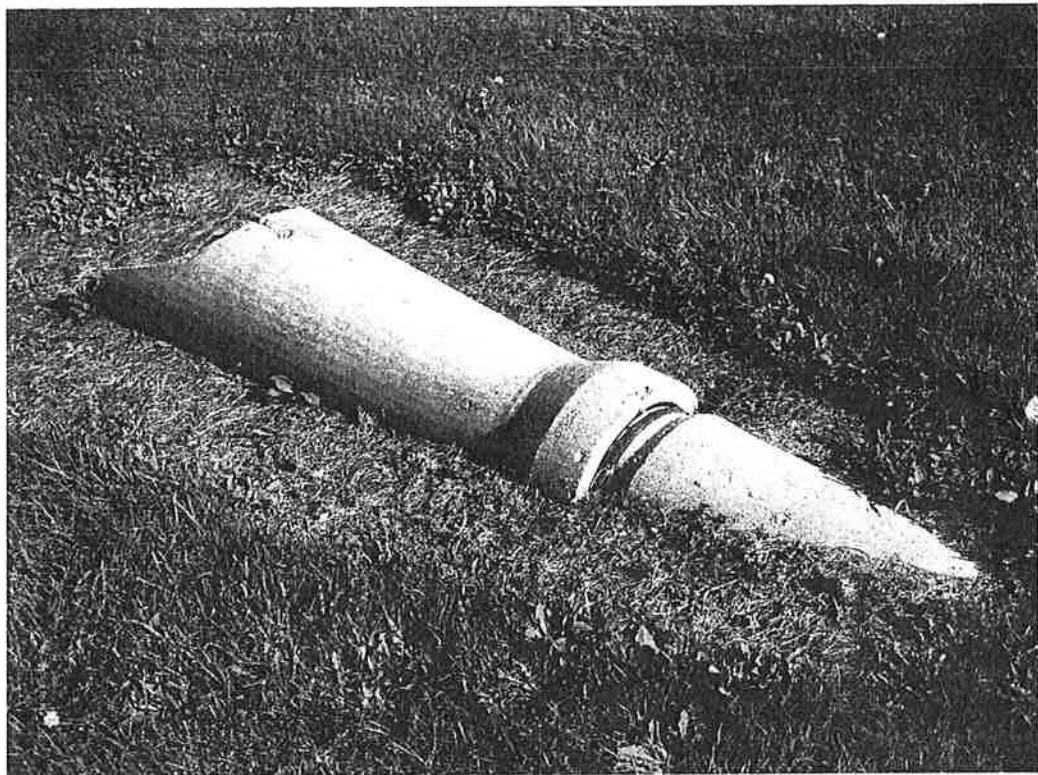
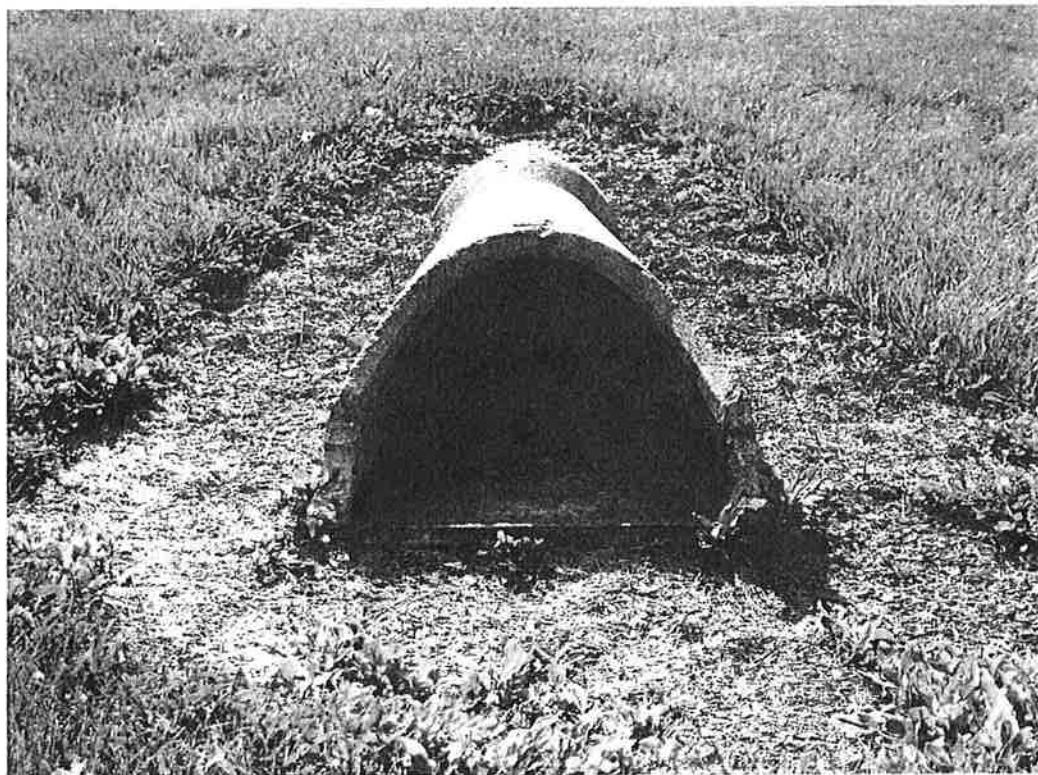
Compliance Verification	Design	Actual	Compliant Yes	Non-Compliant No	Comments ( Condition of Structure)
<b><i>Primary Outlet Pipe</i></b>					
Opening Diameter (inches)	12"		Yes		Outlet Pipe Material – Reinforced Concrete
Upstream Invert	819.10	819.27	Yes		Upstream Outlet – Picture #3 & 4 – Apron Endwall & Pipe separated, Riprap rocks in AEW, dead grass around endwall
Downstream Invert	818.84	818.83	Yes		Downstream Outlet – Picture #1 & 2 – Top of Apron Endwall & Pipe Broken out, minor overgrowth of riprap.
Length (feet)	50'		Yes		
Slope (%)	0.50%		Yes		
<b><i>Secondary Outlet Pipe</i></b>					
Opening Diameter (inches)					Outlet Pipe Material
Upstream Invert					
Downstream Invert					
Length (feet)					
Slope (%)					
<b><i>Riser</i></b>					
Opening Diameter (inches)					Riser Material
Elevation					
<b><i>Upper Discharge Control</i></b>					
Opening Diameter (inches)					
Elevation

#3 - Upstream end of outfall, AEW separated from pipe.

#4 - Upstream end of outfall, Riprap rocks in AEW, grass died around AEW

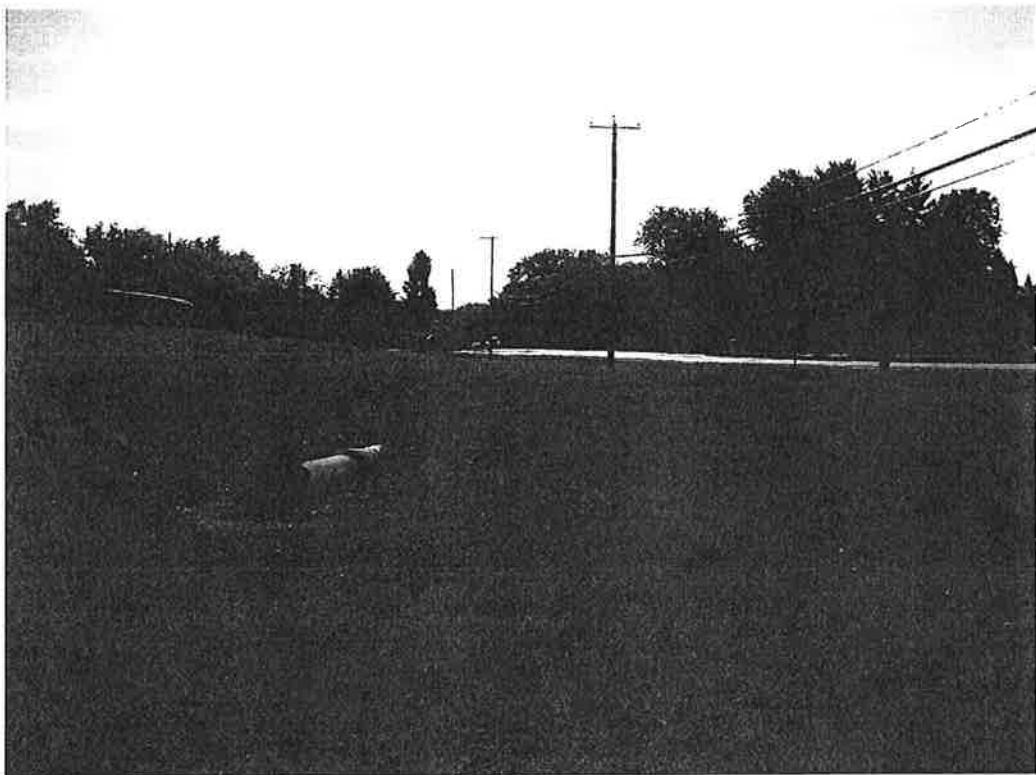
Compliance Verification	Design	Actual	Compliant Yes	No	Comments
<b>Lower Discharge Control</b>	(If Applicable)				
Opening Diameter (inches)					
Elevation					
<b>Other (Description)</b>					
Opening Type and Size (inches)					
Elevation					
<b>Emergency Spillway</b>					
Elevation	823.00	821.28	No		Picture #5, Spillway looks like built to the right of
Length of spillway (feet)			Yes		Outlet, design show it to be over outlet.
<b>Embankment</b>	Present Yes      no		Comments/Maintenance Requirements		
Unauthorized Plantings, trees, or woody vegetation		No	Landscape plan does not show pond in this area, so trees do not match plan, but no issue with trees planted. Embankment along		
Animal burrows or slope erosion		No	Mill road seems low compared to what was designed. Picture #6		
<b>Storm Sewer Outfalls</b>	Type & Size		Location		Comments
Outfall 1					
Outfall 2					
Outfall 3					
<b>Storage Properties</b>	Design	Actual	Compliant Yes	No	Not Applicable

#5 - Emergency Spillway built to the right of outfall, designed to be on top of outfall.

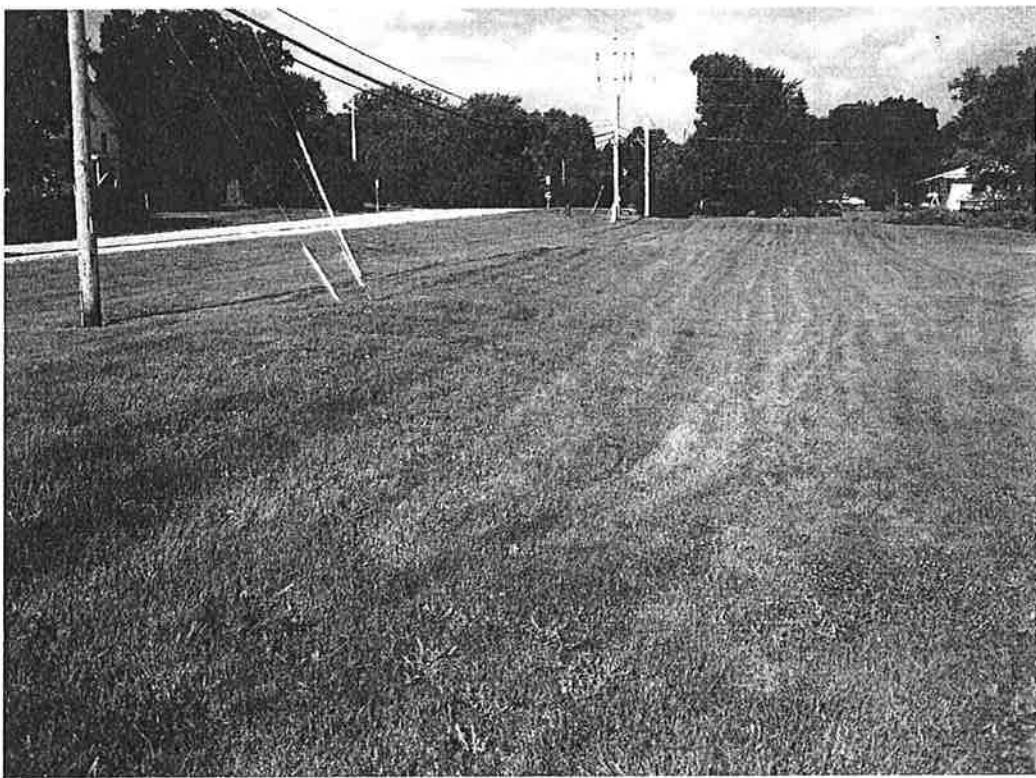
Normal Water Elevation (Wet Ponds)					
Design High Water Elevation					
Area at Normal Water Elevation (Ac) (Wet Ponds)					
Area at Design High Water Elevation (Ac)					
Active Storage Available (Ac-Ft)*					
Lowest Elevation at Top of Embankment (If Applicable)	824.00	821.98		No	
Average Elevation at Top of Embankment (If Applicable)					
Maximum Bottom Elevation					
Average Pond Bottom Elevation	820.00	820.00	Yes		
Pond Bottom Area (Ac)					
Maximum Pond Depth	3.70'	2.01'		No	
Average Pond Depth					
Average Permanent Pool Depth (Wet Ponds)

#6 South Embankment looking west, seems to be lower than what was designed.
