STORMWATER MANAGEMENT FACILITIES
 OPERATION AND INSPECTION REPORT

Quarter Section: ½ NW ¼ Section 34 T8N R20E Name of Business/Subdivision: ProHealth Care
 Property Tax ID Number: MNFV 0134.991 Address of Property Formerly Medical Associates
W165 N5595 Creekwood Crossing
Menomonee Falls, WI

Location of South side of parking lot, west
of Creekwood Crossing
 Description: SWP 34N002 Pond
Irregular shaped wet pond
with 6-inch outlet pipe

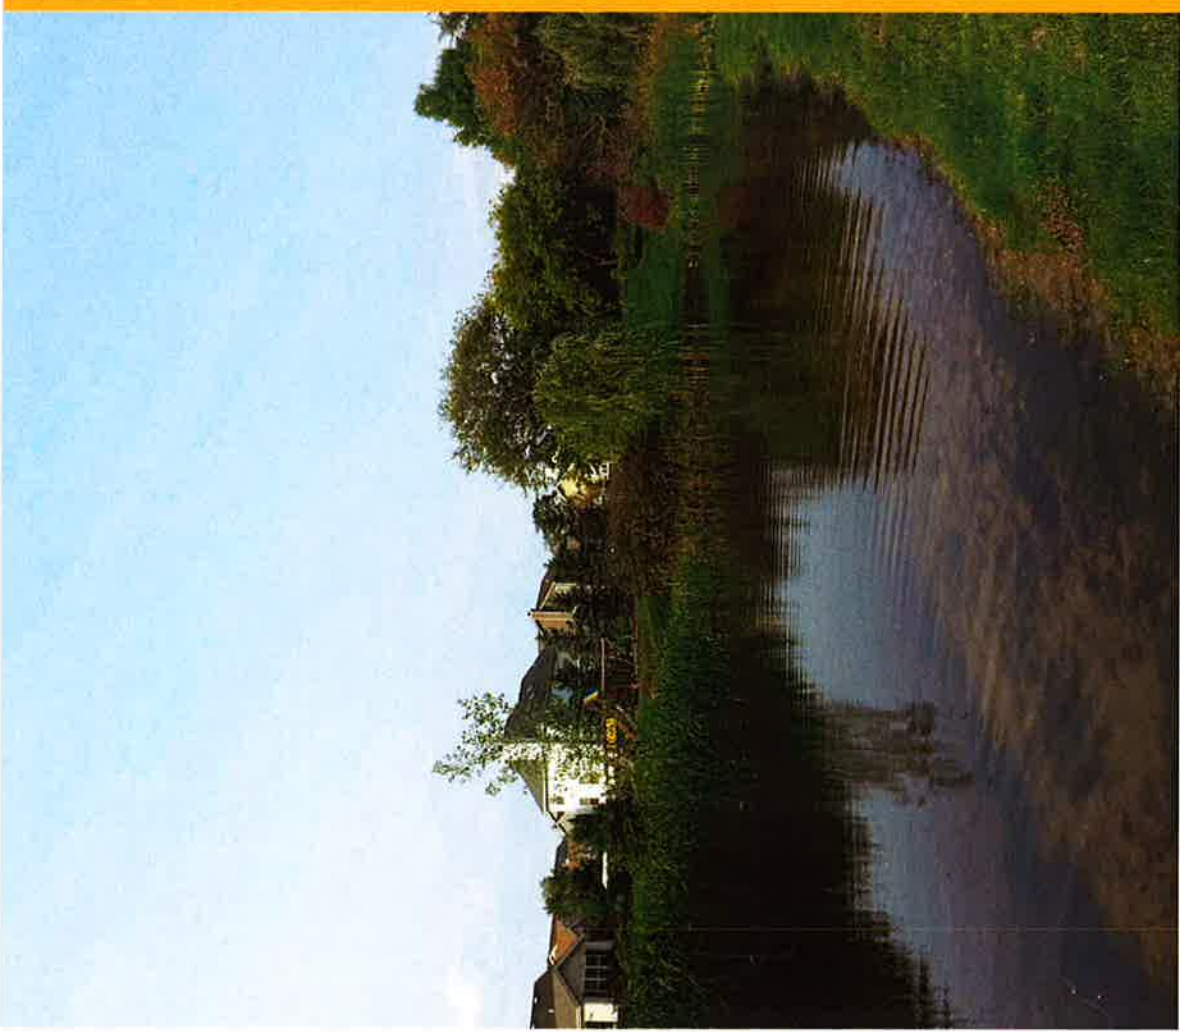
Photo Number: 1
Date of Photo: 9/14/2012

**Description: Storm Water
Pond (looking
west/southwest)**

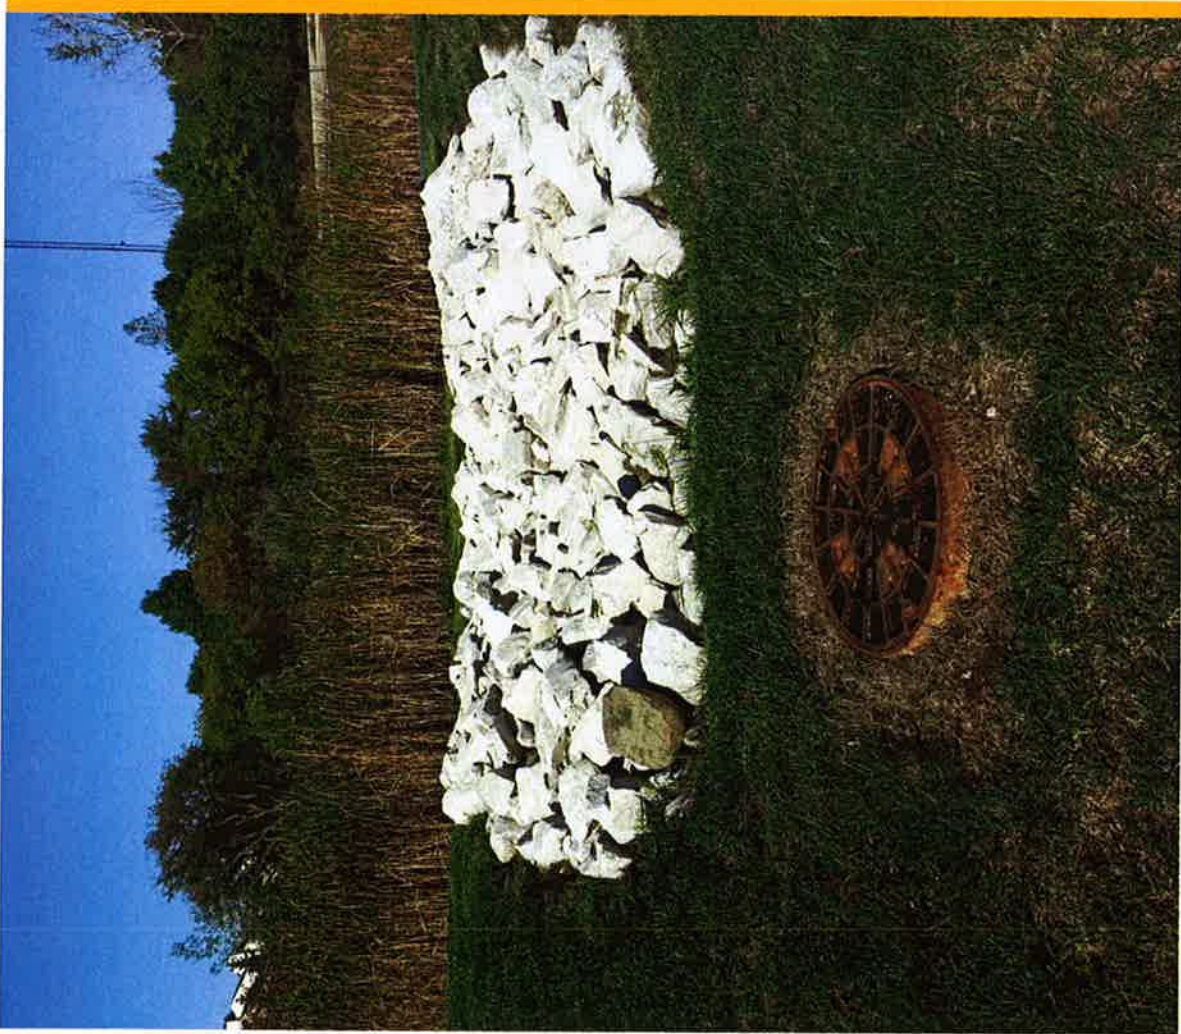
Photo Number: 2
Date of Photo: 9/14/2012

| Compliance Verification | Design | Actual | Compliant | | Comments | |
|---|---|---|---|---|--|--|
| Elevation | 837.5-ft | 836.7-ft | | X | Elevation is lower than design; spillway functioning like a 2 nd outlet at 2-yr storm | |

**Description: Emergency
Spillway (looking west).**
