STORMWATER MANAGEMENT FACILITIES OPERATION AND INSPECTION REPORT

Quarter Section	NW 1/4 of Section 9	Name of Business/Subdivision	
Property Tax ID Number	MNFV00342 74	Address of Property	Verona Subdivision
Date	5-16-13		Verona Subdivision South Pond (Intersection of Main Street and Lawrence Ave.)
Dry Pond		Location of Pond	Pond is located southwest of lots 6
Wet Pond	X		and 7 of the Verona Subdivision adjacent to Main Street (S.T.H. 74) and south of Lawrence Ave.
Other		Pond ID:	SWP09N002

Quarter Section	NW 1/4 of Section 9	Name of Business/Subdivision	Verona Subdivision
Property Tax ID Number	MNFV00342 73	Address of Property	Verona Subdivision North Pond (Intersection of Main Street and Lawrence Ave.)
Date	5-16-13		
Dry Pond		Location of Pond	Pond is located north of lots 1 and
Wet Pond	X		2 of the Verona Subdivision adjacent to Main Street (S.T.H. 74) and north of Lawrence Ave.
Other		Pond ID:	SWP09N001

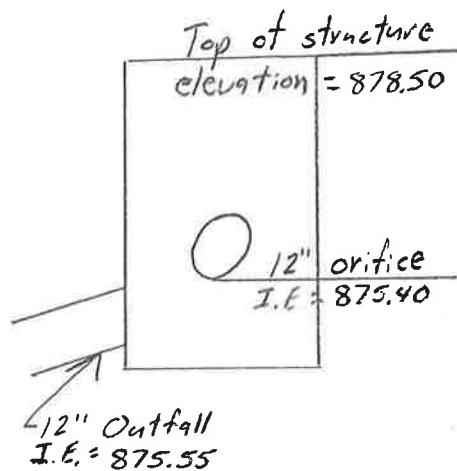
Compliance Verification	Design	Actual	Compliant Yes	No	Comments (Condition of Structure)
Primary Outlet Pipe					Outlet Pipe Material
Opening Diameter (inches)	12	12	X		Outlet pipe material is reinforced concrete in good condition.
Upstream Invert	876.00	875.55	X		
Downstream Invert	874.84	874.84	X		
Length (feet)	37	37	X		
Slope (%)	3.13%	1.92%	X		
Secondary Outlet Pipe	(If Applicable)				Outlet Pipe Material
Opening Diameter (inches)					
Upstream Invert					
Downstream Invert					
Length (feet)					
Slope (%)					
Riser	(If Applicable)				Riser Material
Opening Diameter (inches)	54" square	54" square	X		Concrete in good condition Debris in box outlet structure (see attached picture)
Elevation	879.10	878.50	X		
Upper Discharge Control	(If Applicable)				
Opening Diameter (inches)	4	12			
Elevation	876.00	875.40

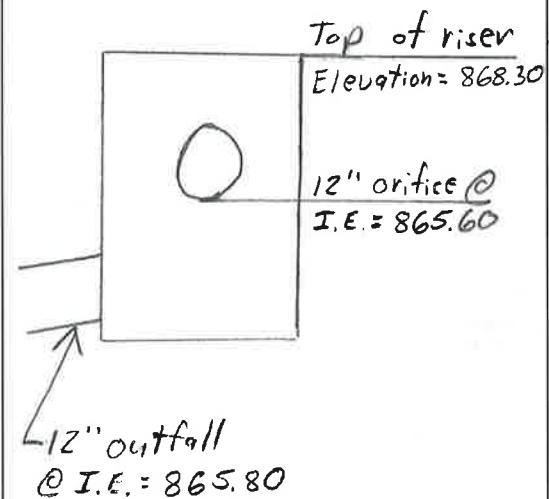
Compliance Verification	Design	Actual	Compliant Yes No	Comments (Condition of Structure)
Primary Outlet Pipe				Outlet Pipe Material
Opening Diameter (inches)	12	12	X	Outlet pipe material is reinforced concrete in good condition.
Upstream Invert	866.50	865.80	X	
Downstream Inver	865.67	865.67	X	Note: A 24" inlet pipe into the pond located at the southwest corner of the pond has sediment on the end wall as shown in the attached pictures.
Length (feet)	40	40	X	
Slope (%)	2.08%	0.33%	X	
Secondary Outlet Pipe	(If Applicable)			Outlet Pipe Material
Opening Diameter (inches)				
Upstream Invert				
Downstream Invert				
Length (feet)				
Slope (%)				
Riser	(If Applicable)			Riser Material
Opening Diameter (inches)	54" square	54" square		Concrete in good condition
Elevation	869.10	868.30		
Upper Discharge Control	(If Applicable)			
Opening Diameter (inches)	3	none		
Elevation	867.00	none

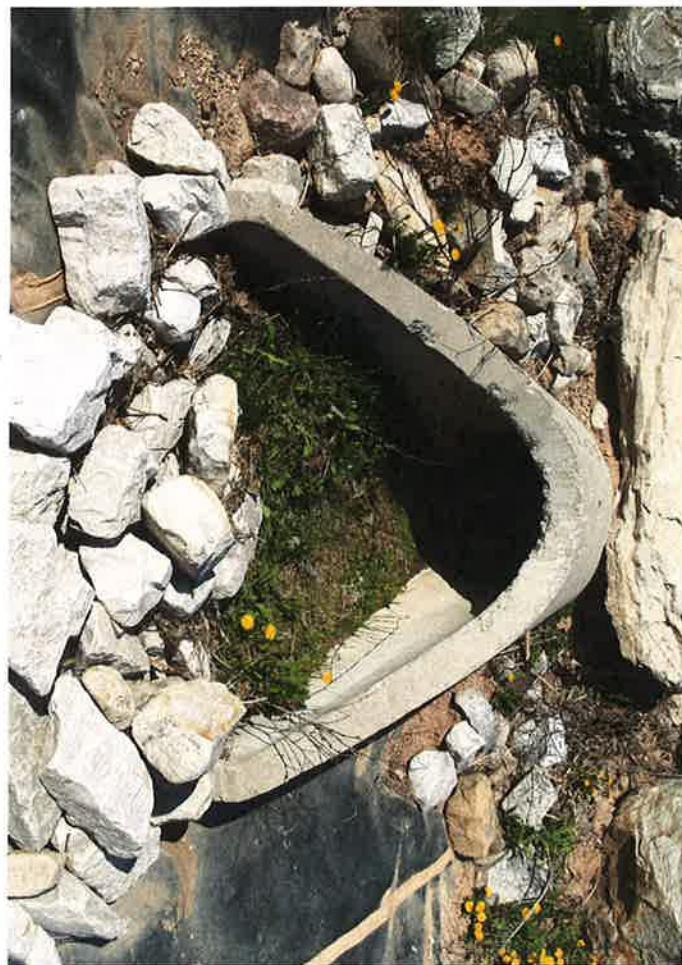
24" inlet pipe to North Pond
