STORMWATER MANAGEMENT FACILITIES OPERATION AND INSPECTION REPORT

Quarter Section _____ Name of Business/Subdivision Securant Bank (Formerly Milw. Western Bank)
Property Tax ID Number MNFV00139 Address of Property W178 N9358 Water Tower Place
Date 5/2/14

Pond ID: SWP 04 N004

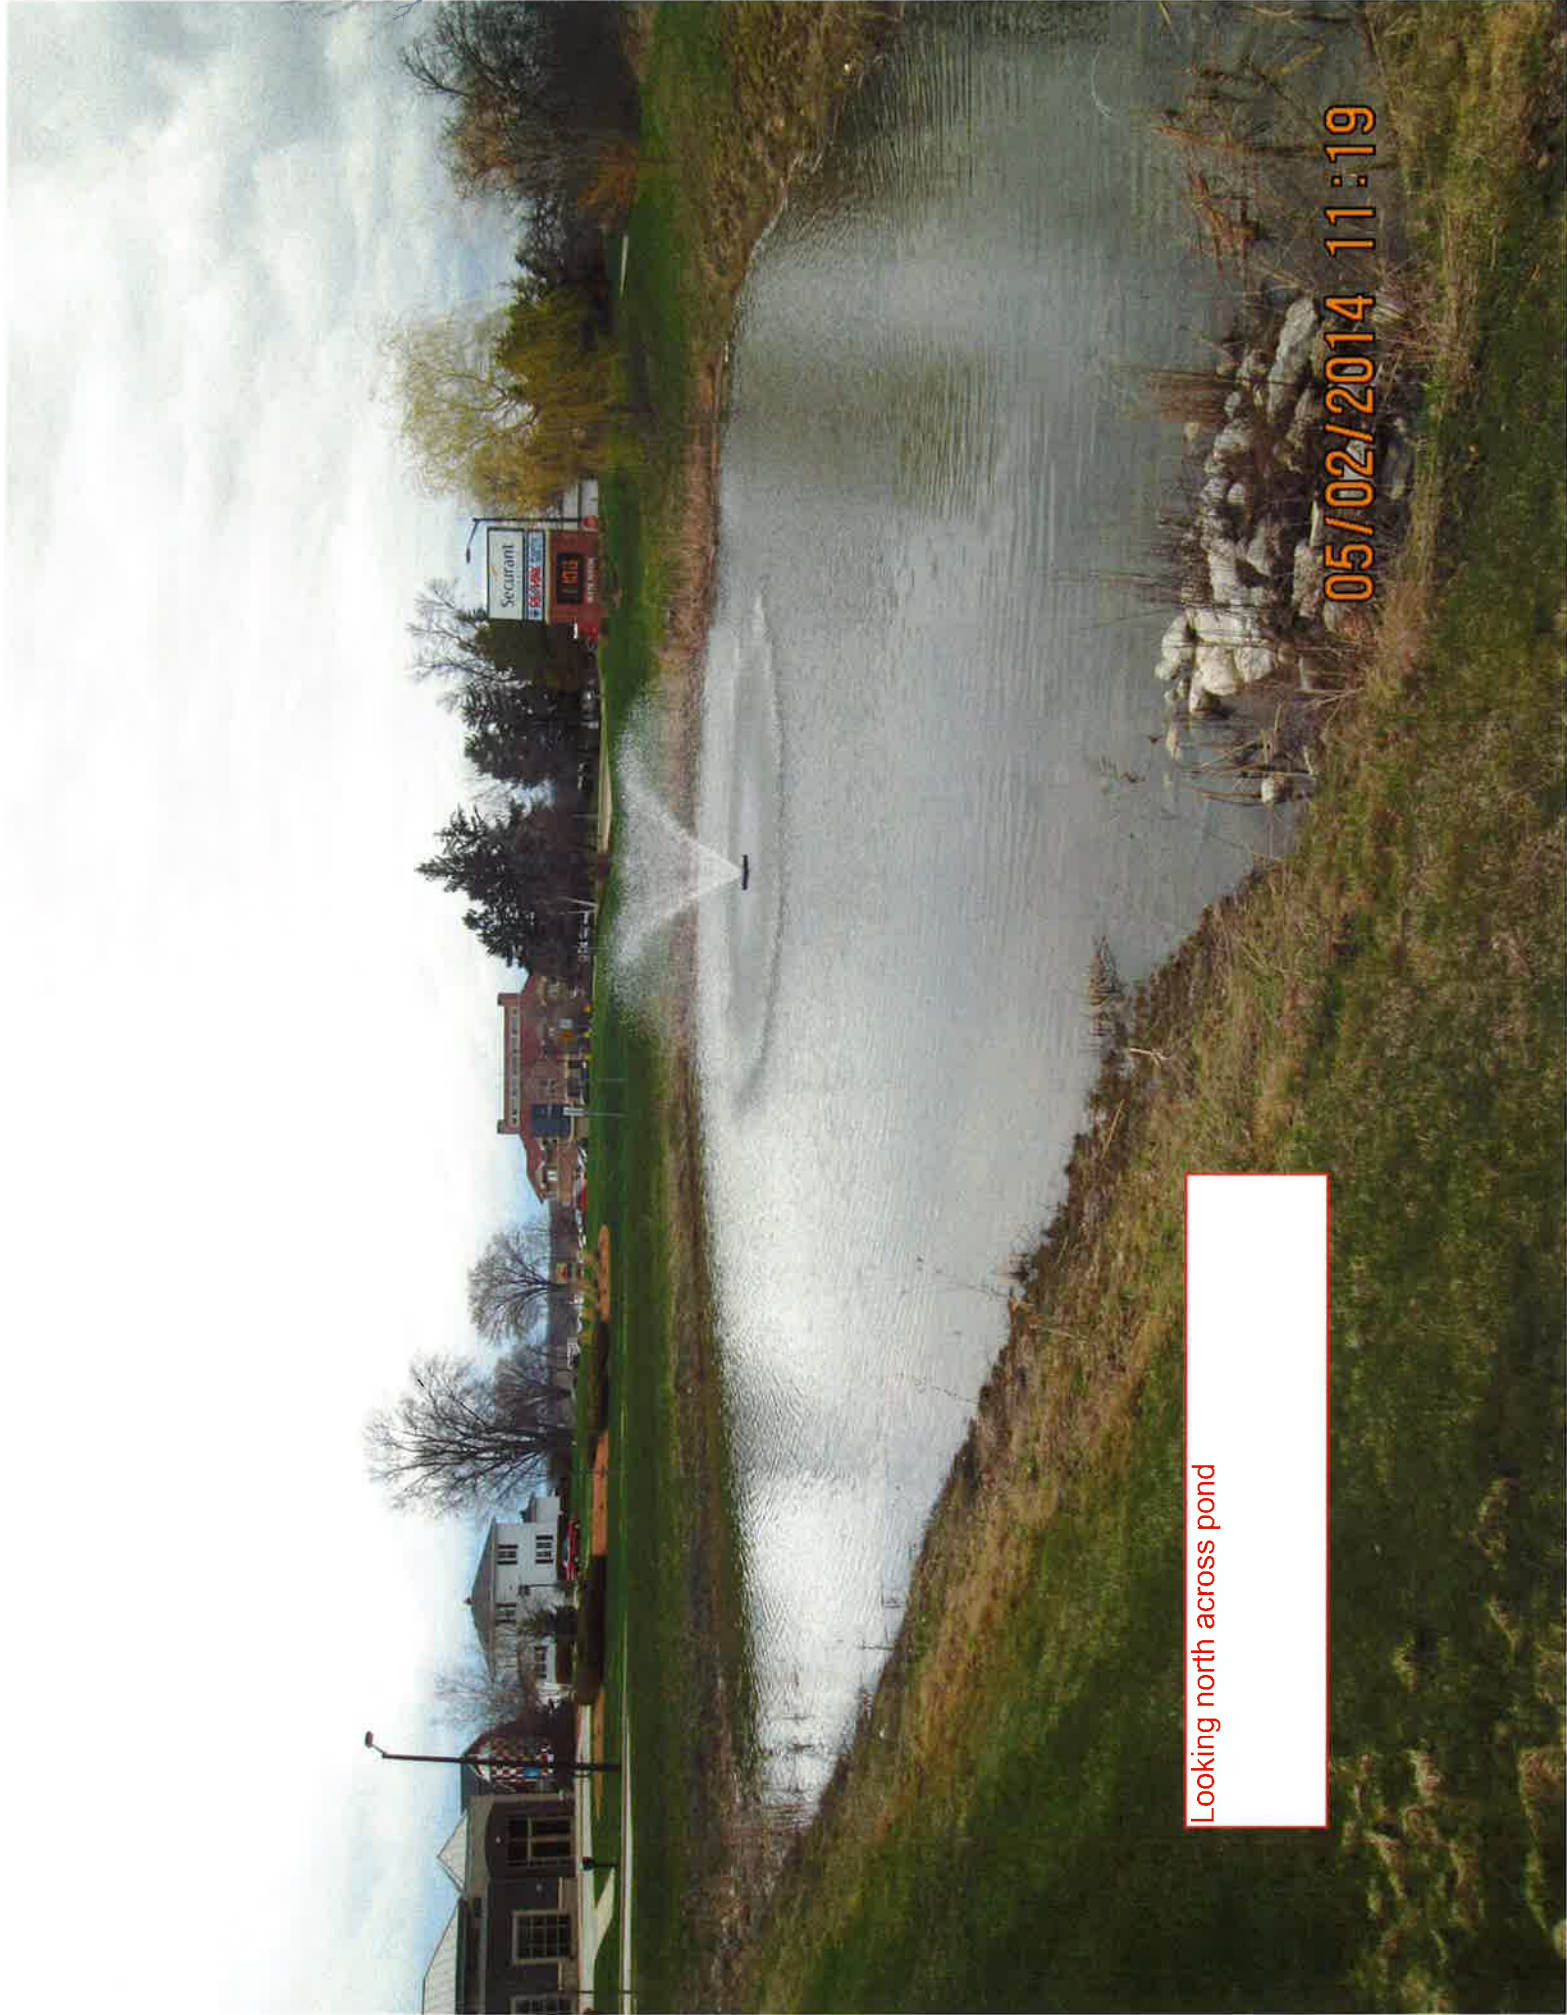
Looking north across pond

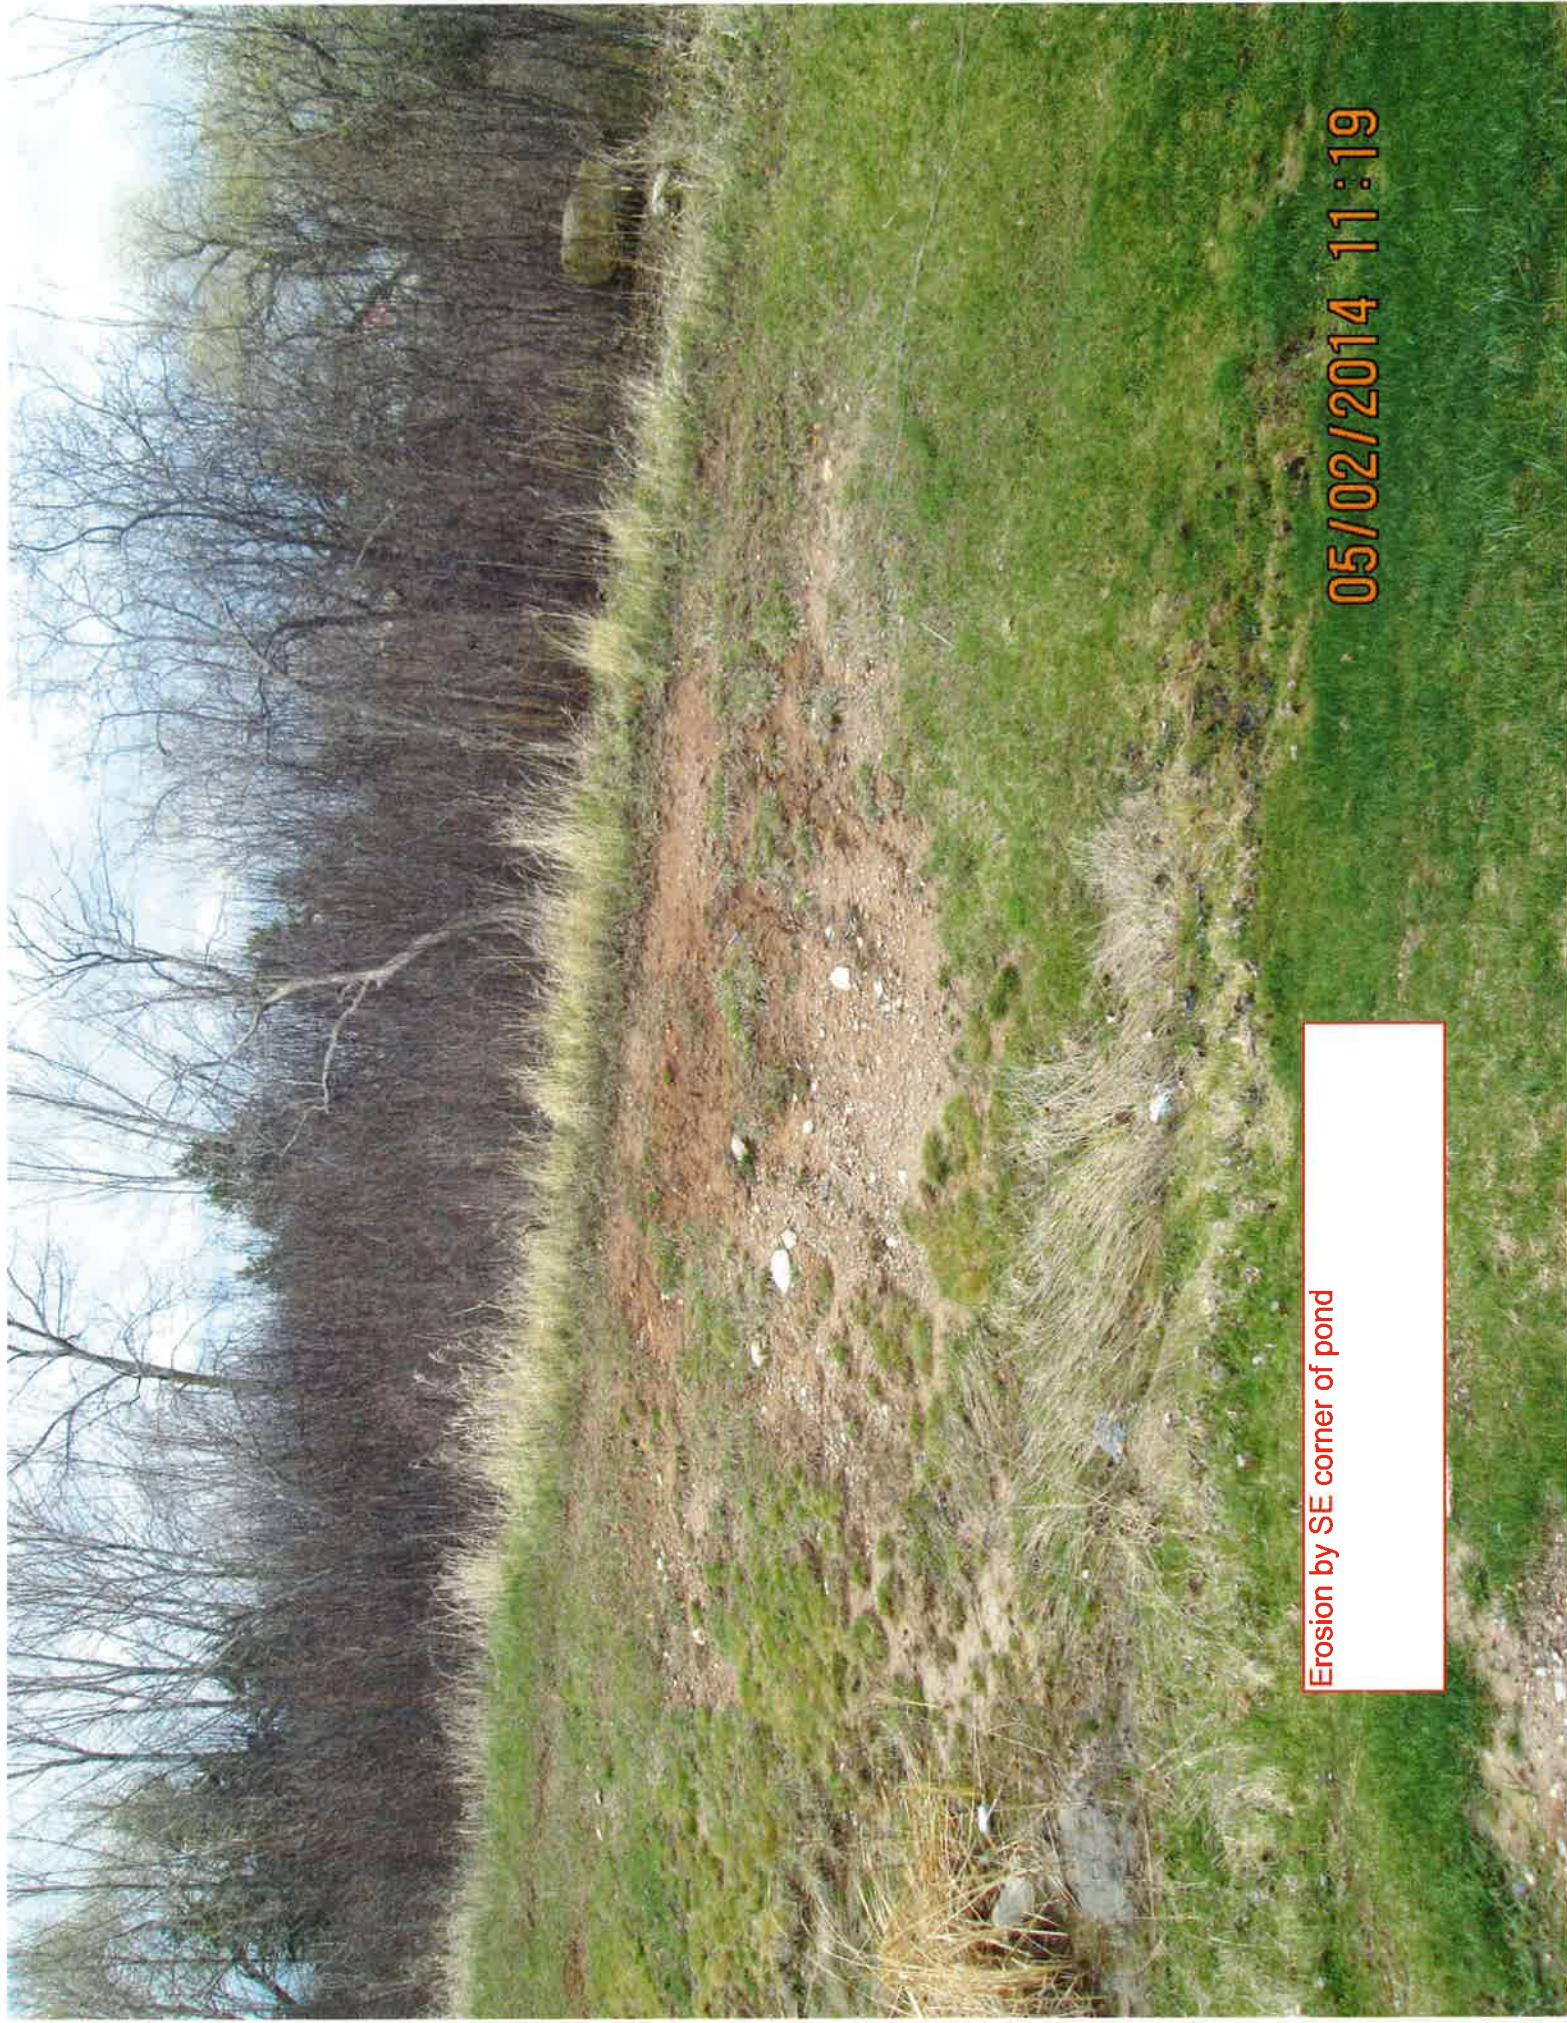
| Compliance Verification | Design | Actual | Compliant Yes No | Comments | |
|--|---|---|--|---|---|
| Unauthorized Plantings, trees, or woody vegetation | x | | Small tree growing from east berm sideslope; tree should be cut down; erosion and bare soil present along east berm sideslope especially by southeast corner of basin; slope should be stabilized w/ topsoil, matting and seed | | |

Erosion by SE corner of pond

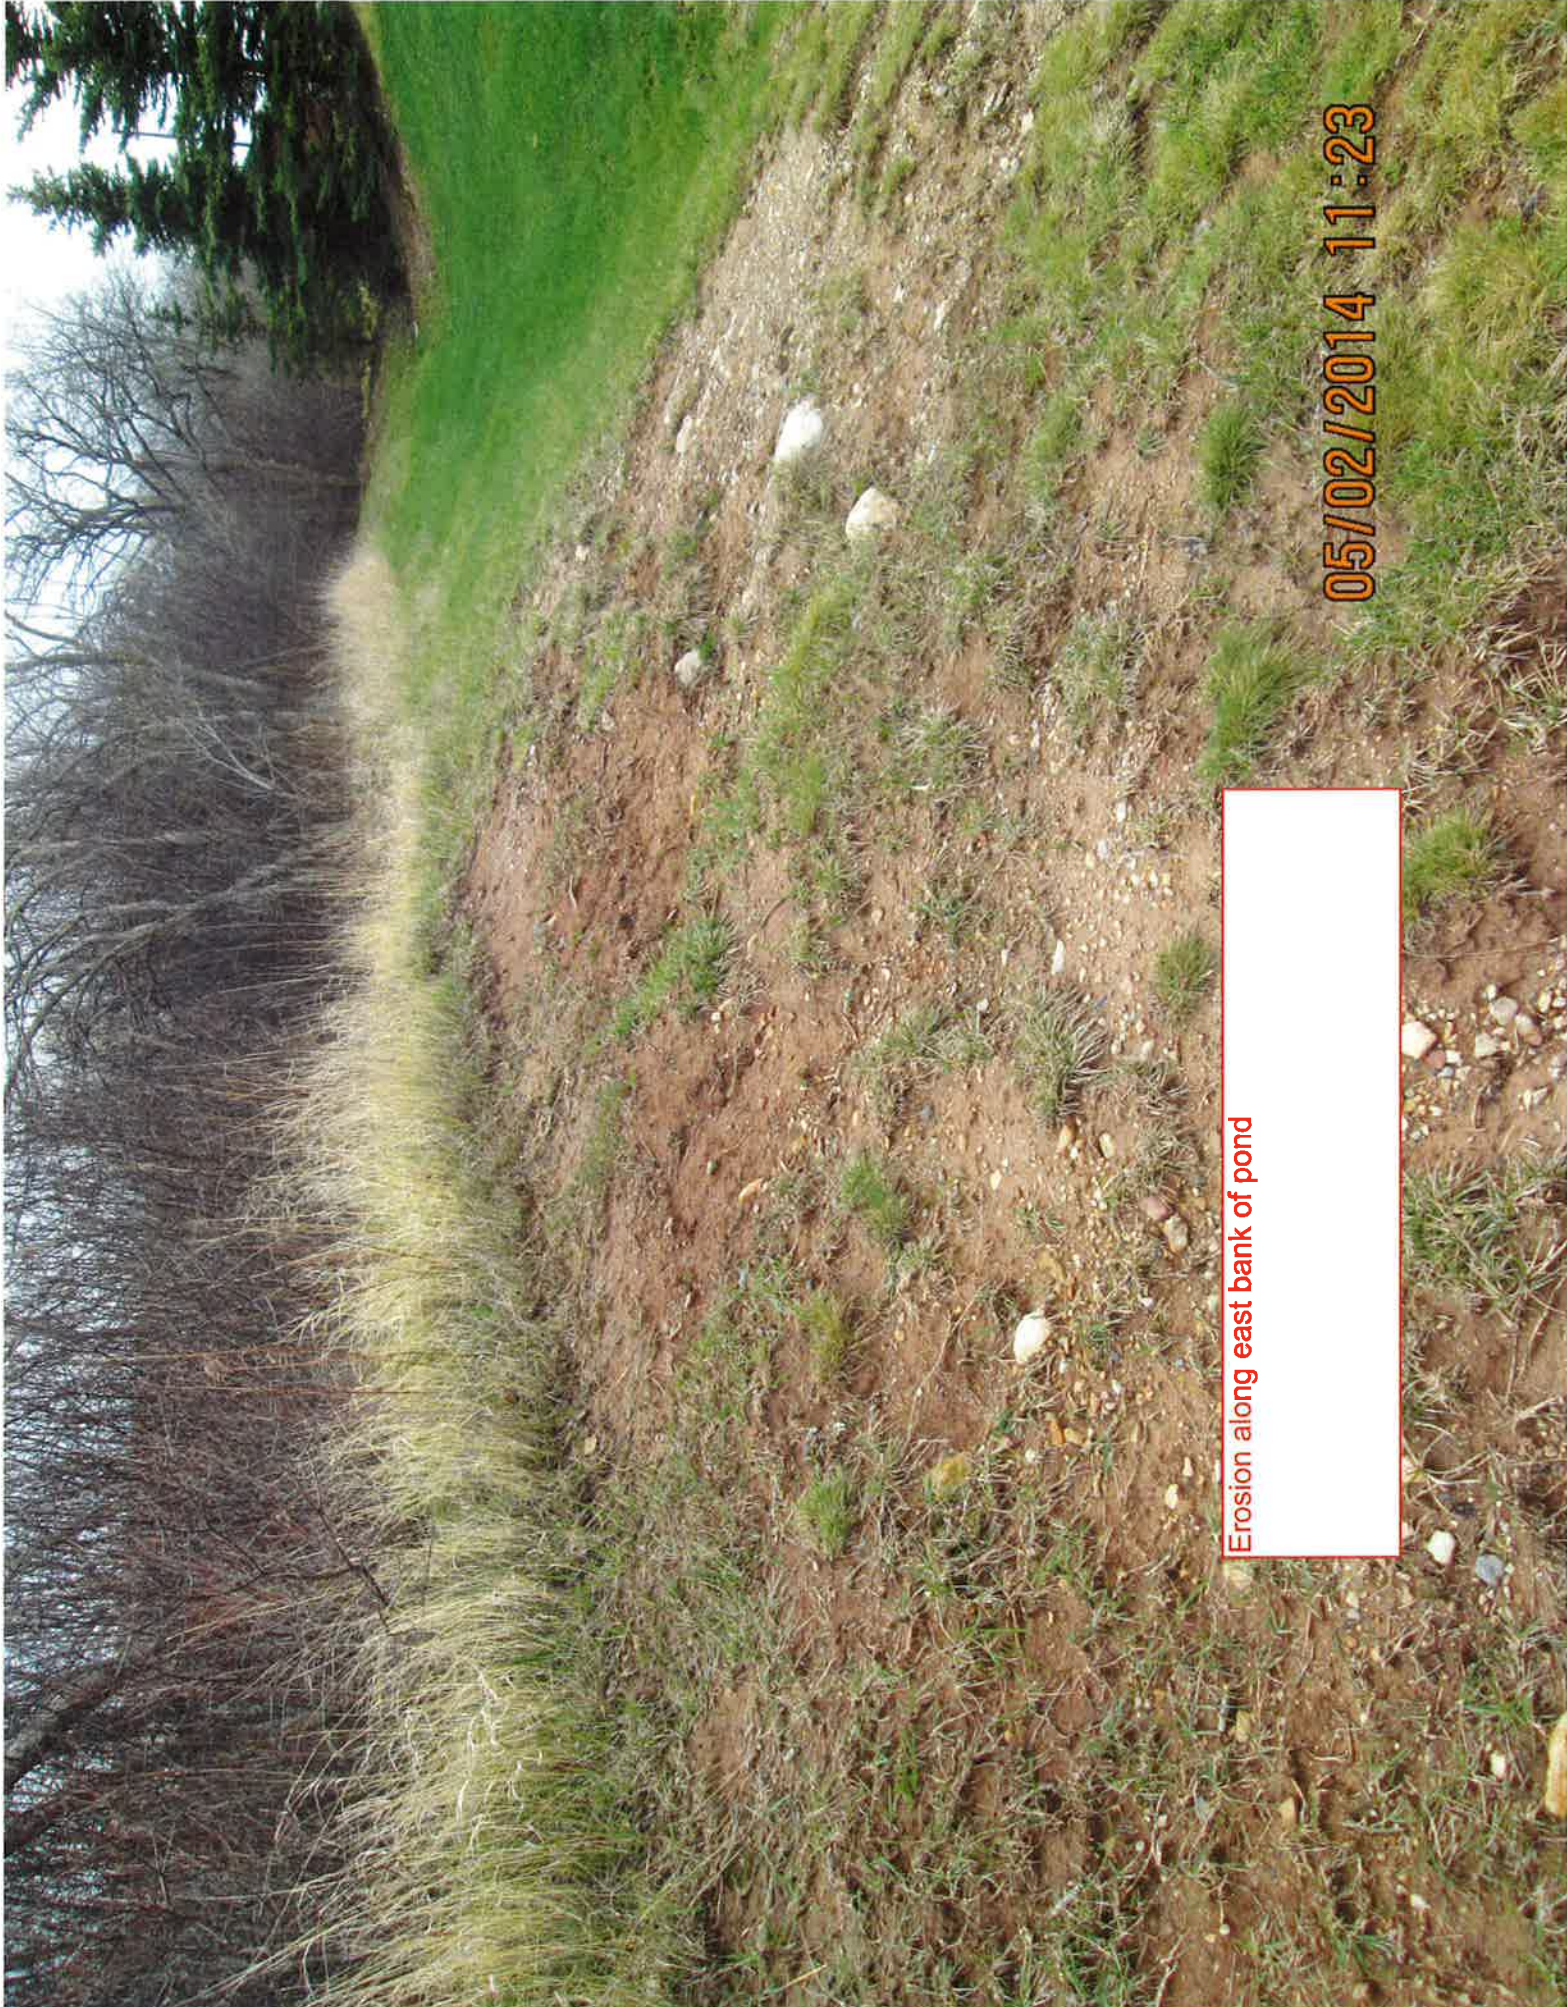
Erosion along east bank of pond

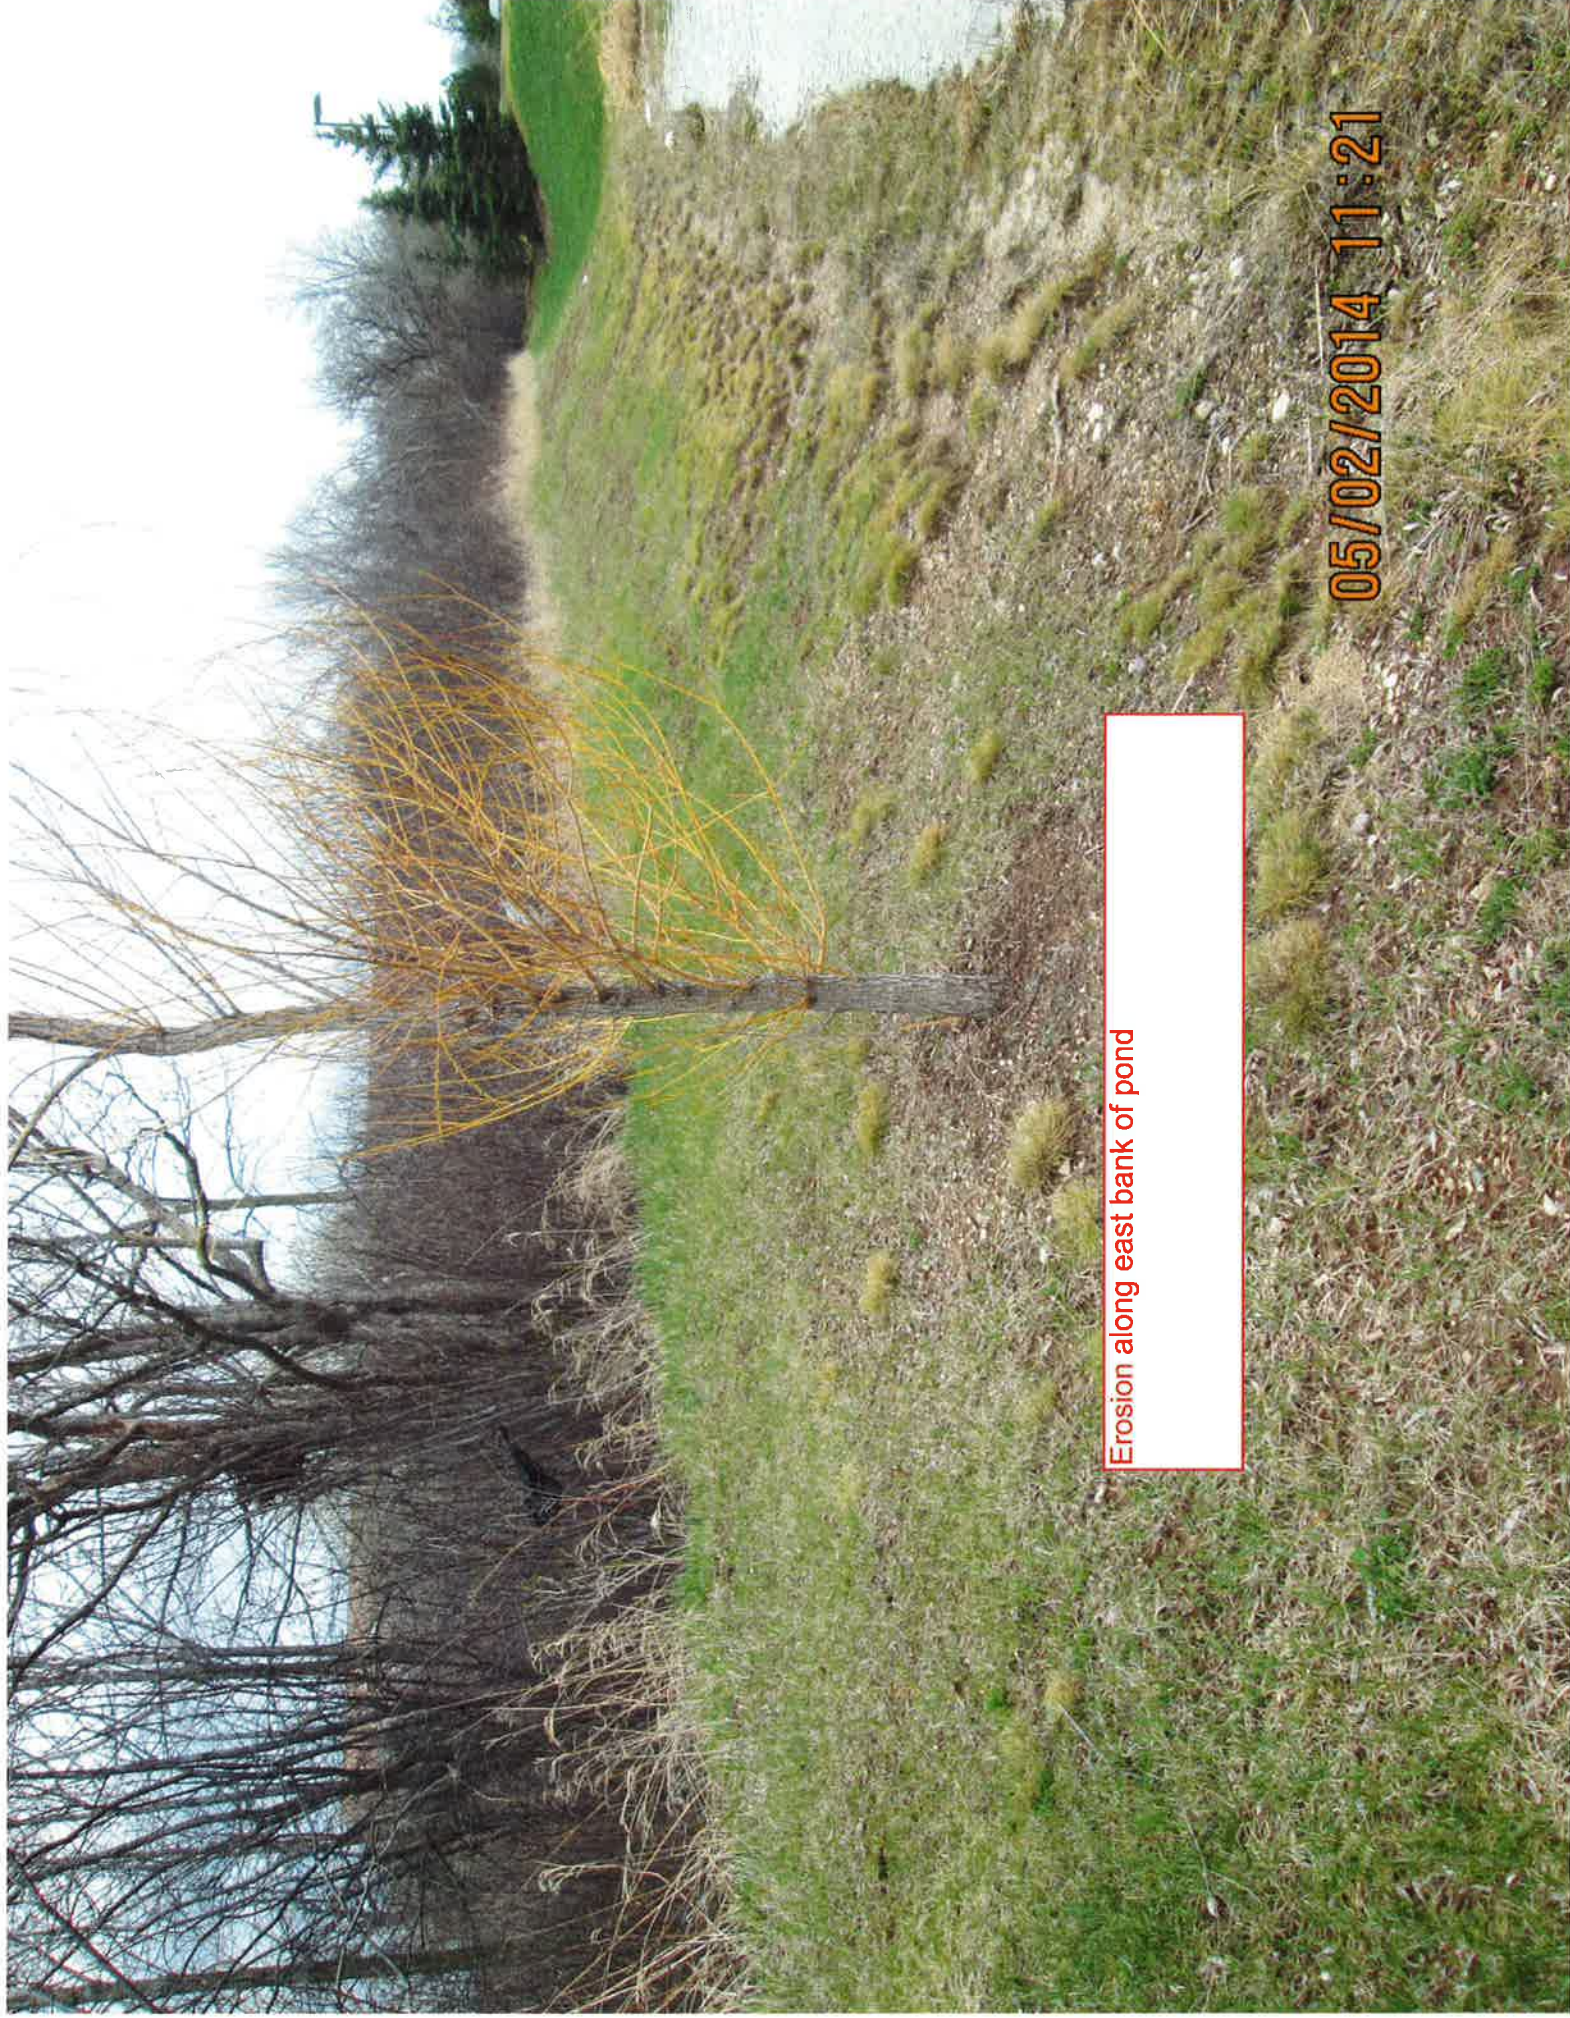
Erosion along east bank of pond

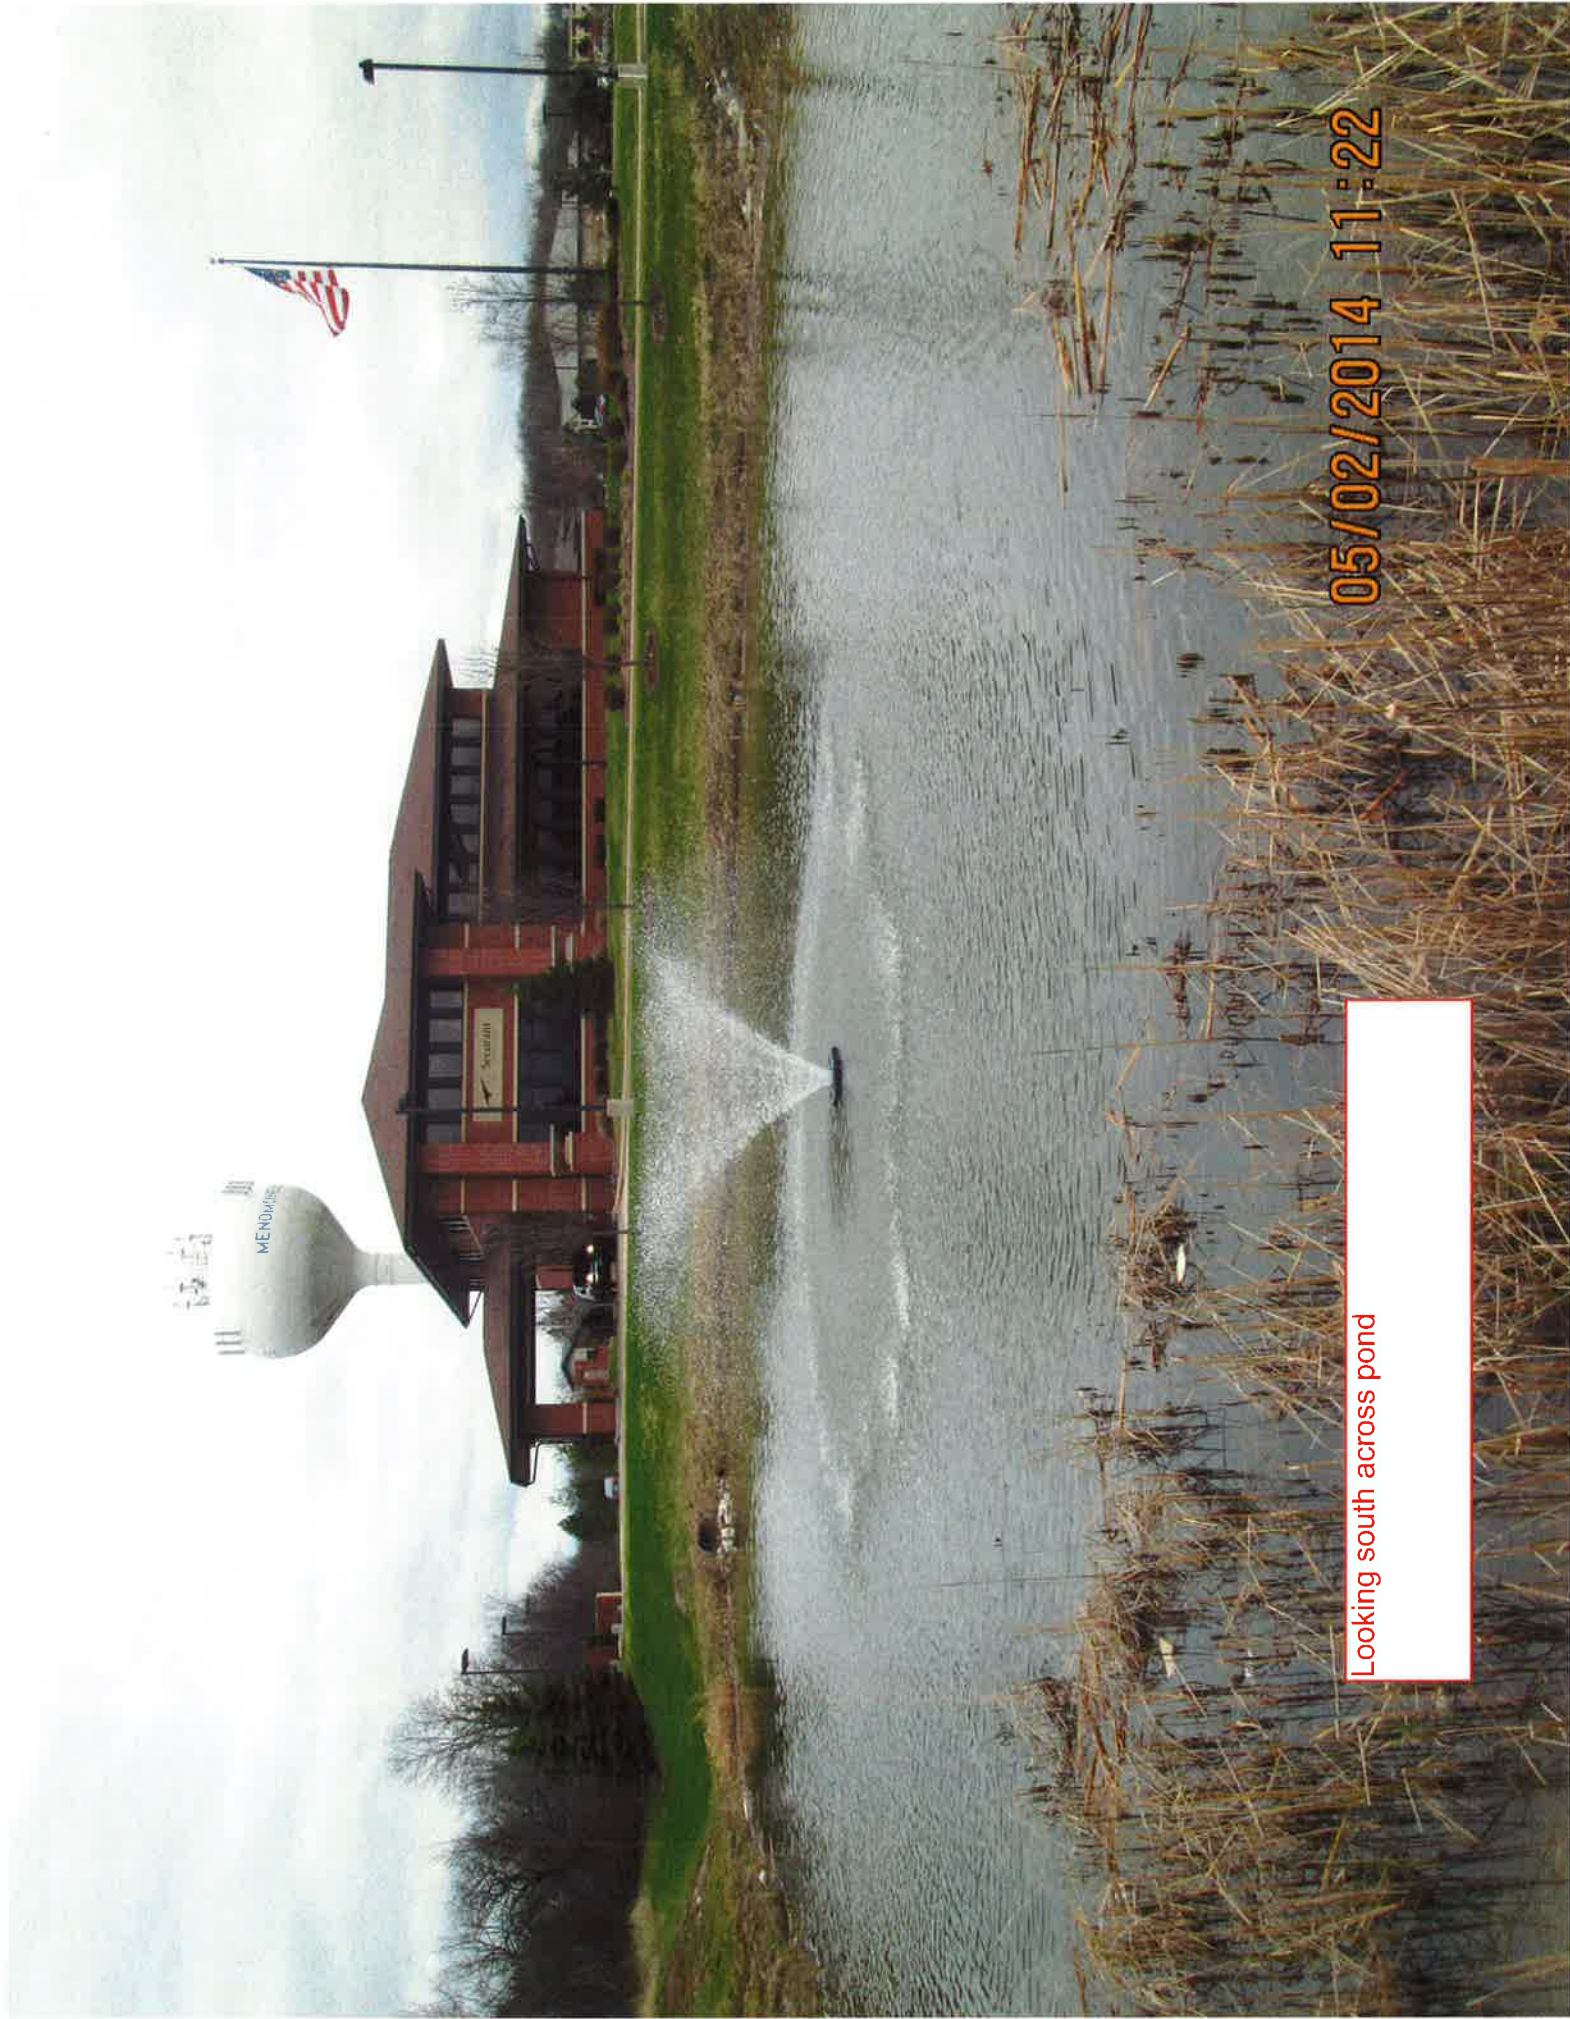
Looking south across pond

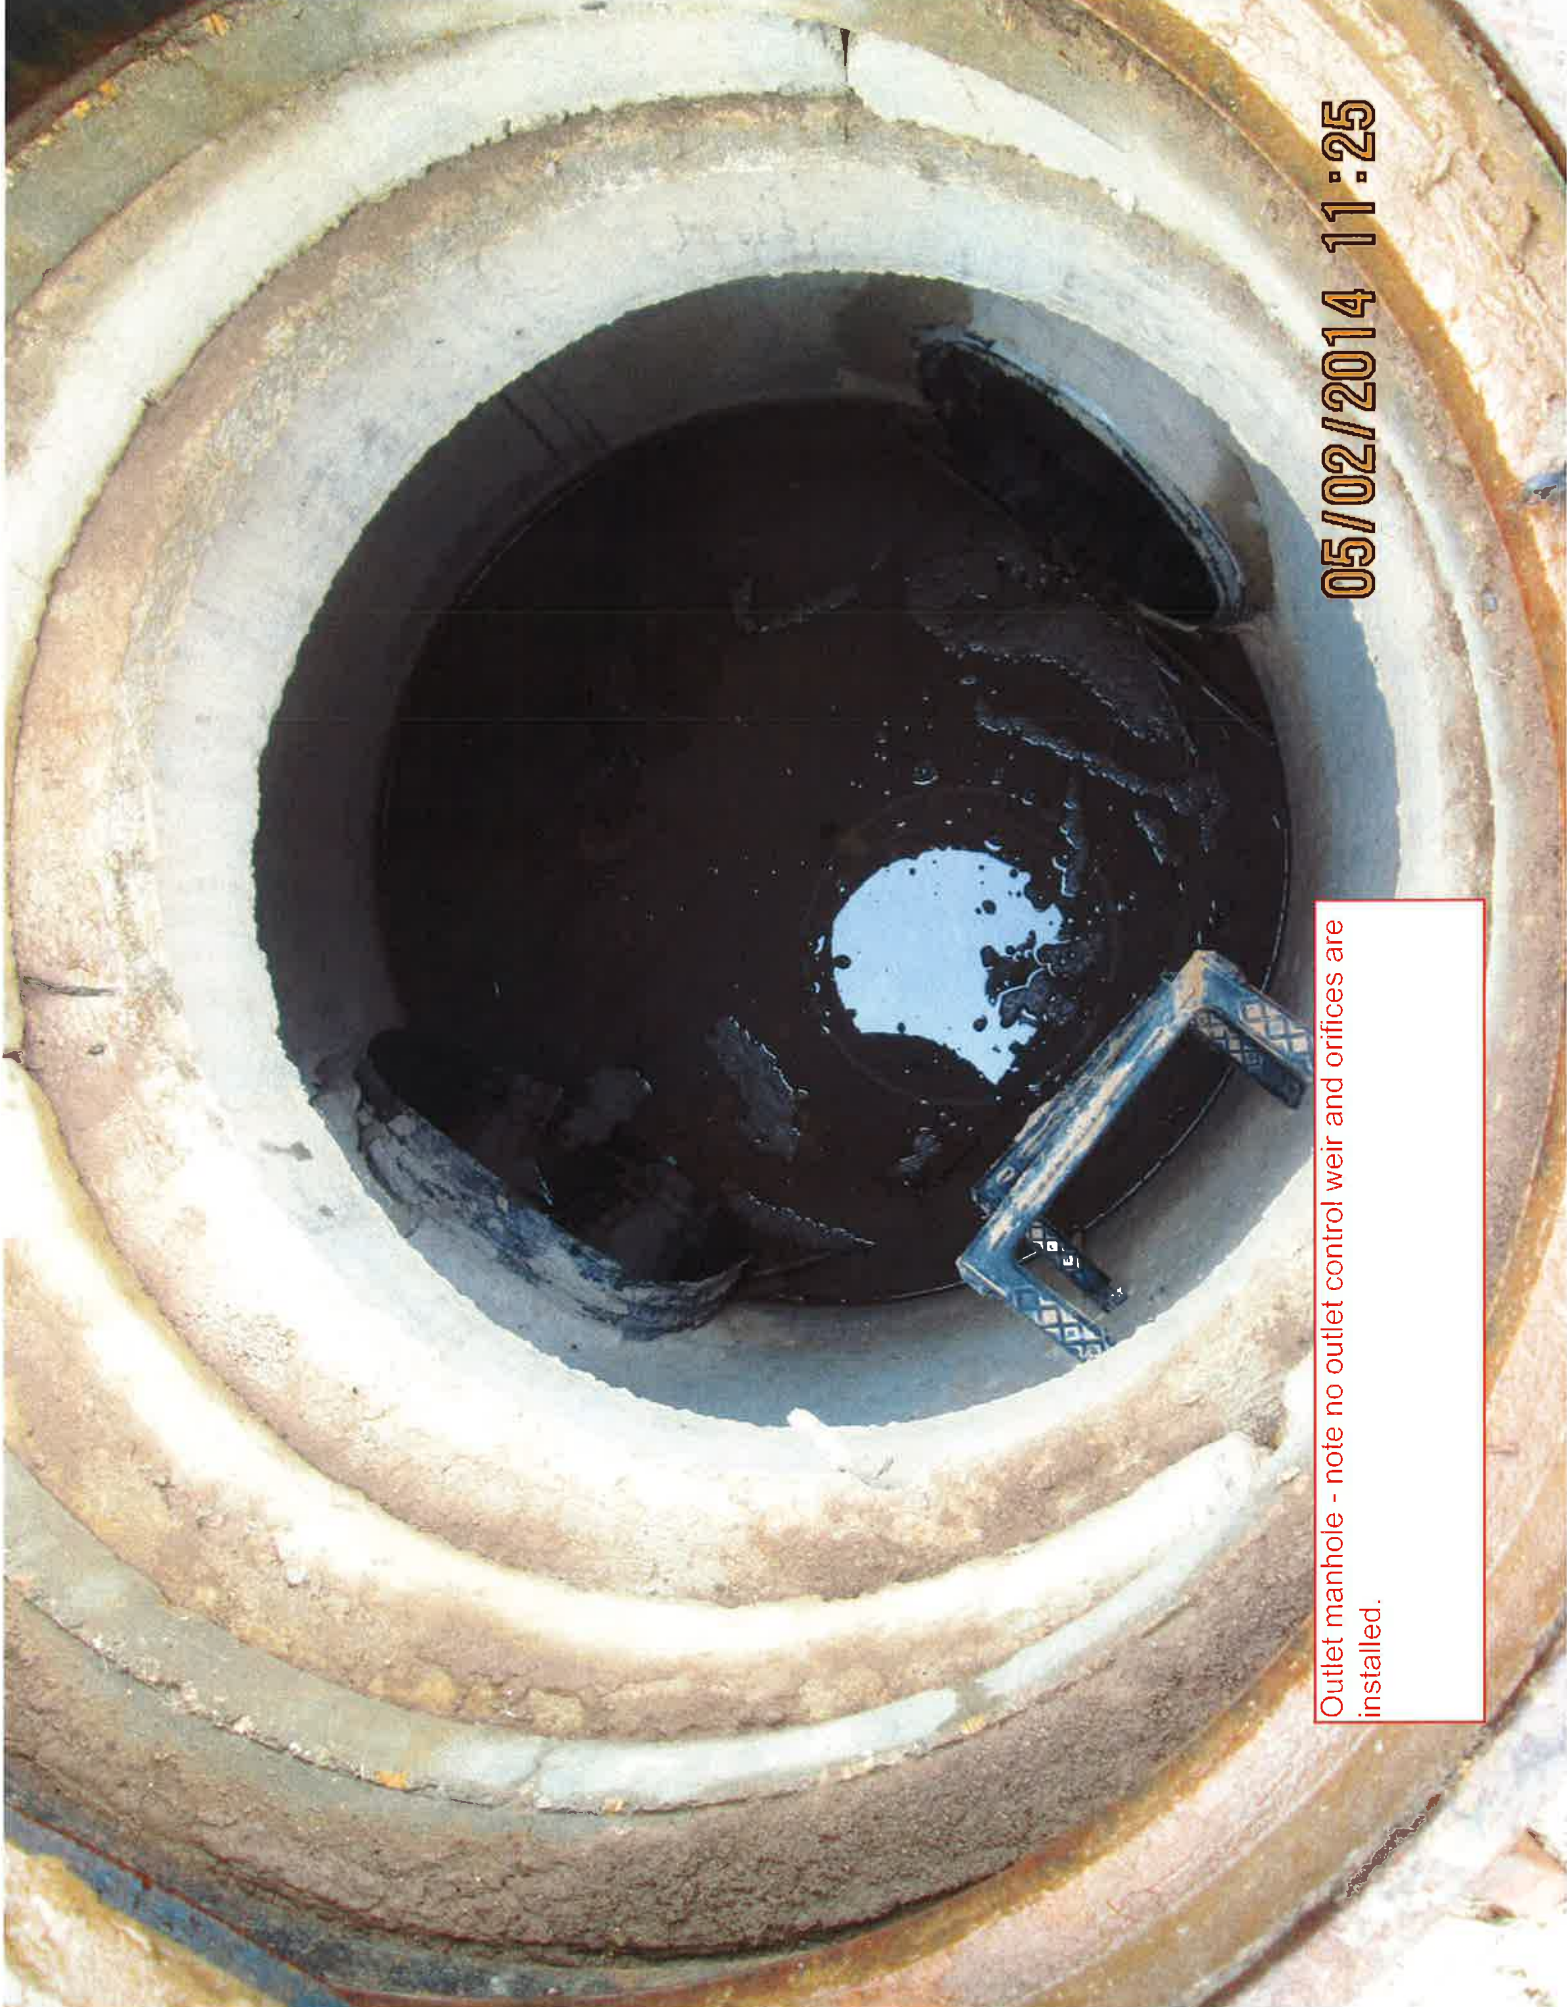
| Compliance Verification | Design | Actual | Compliant Yes No | Comments (Condition of Structure) |
|---|---|---|---|---|
| Opening Diameter (inches) | NA | NA | X | Overflow weir and outlet controls not installed per design |

| Compliance Verification | Design | Actual | Compliant Yes No | Comments | |
|--|---|---|--|---|---|
| Opening Diameter (inches) | 4 | NA | | X | Outlet controls not installed per design |

Outlet manhole - note no outlet control weir and orifices are installed.

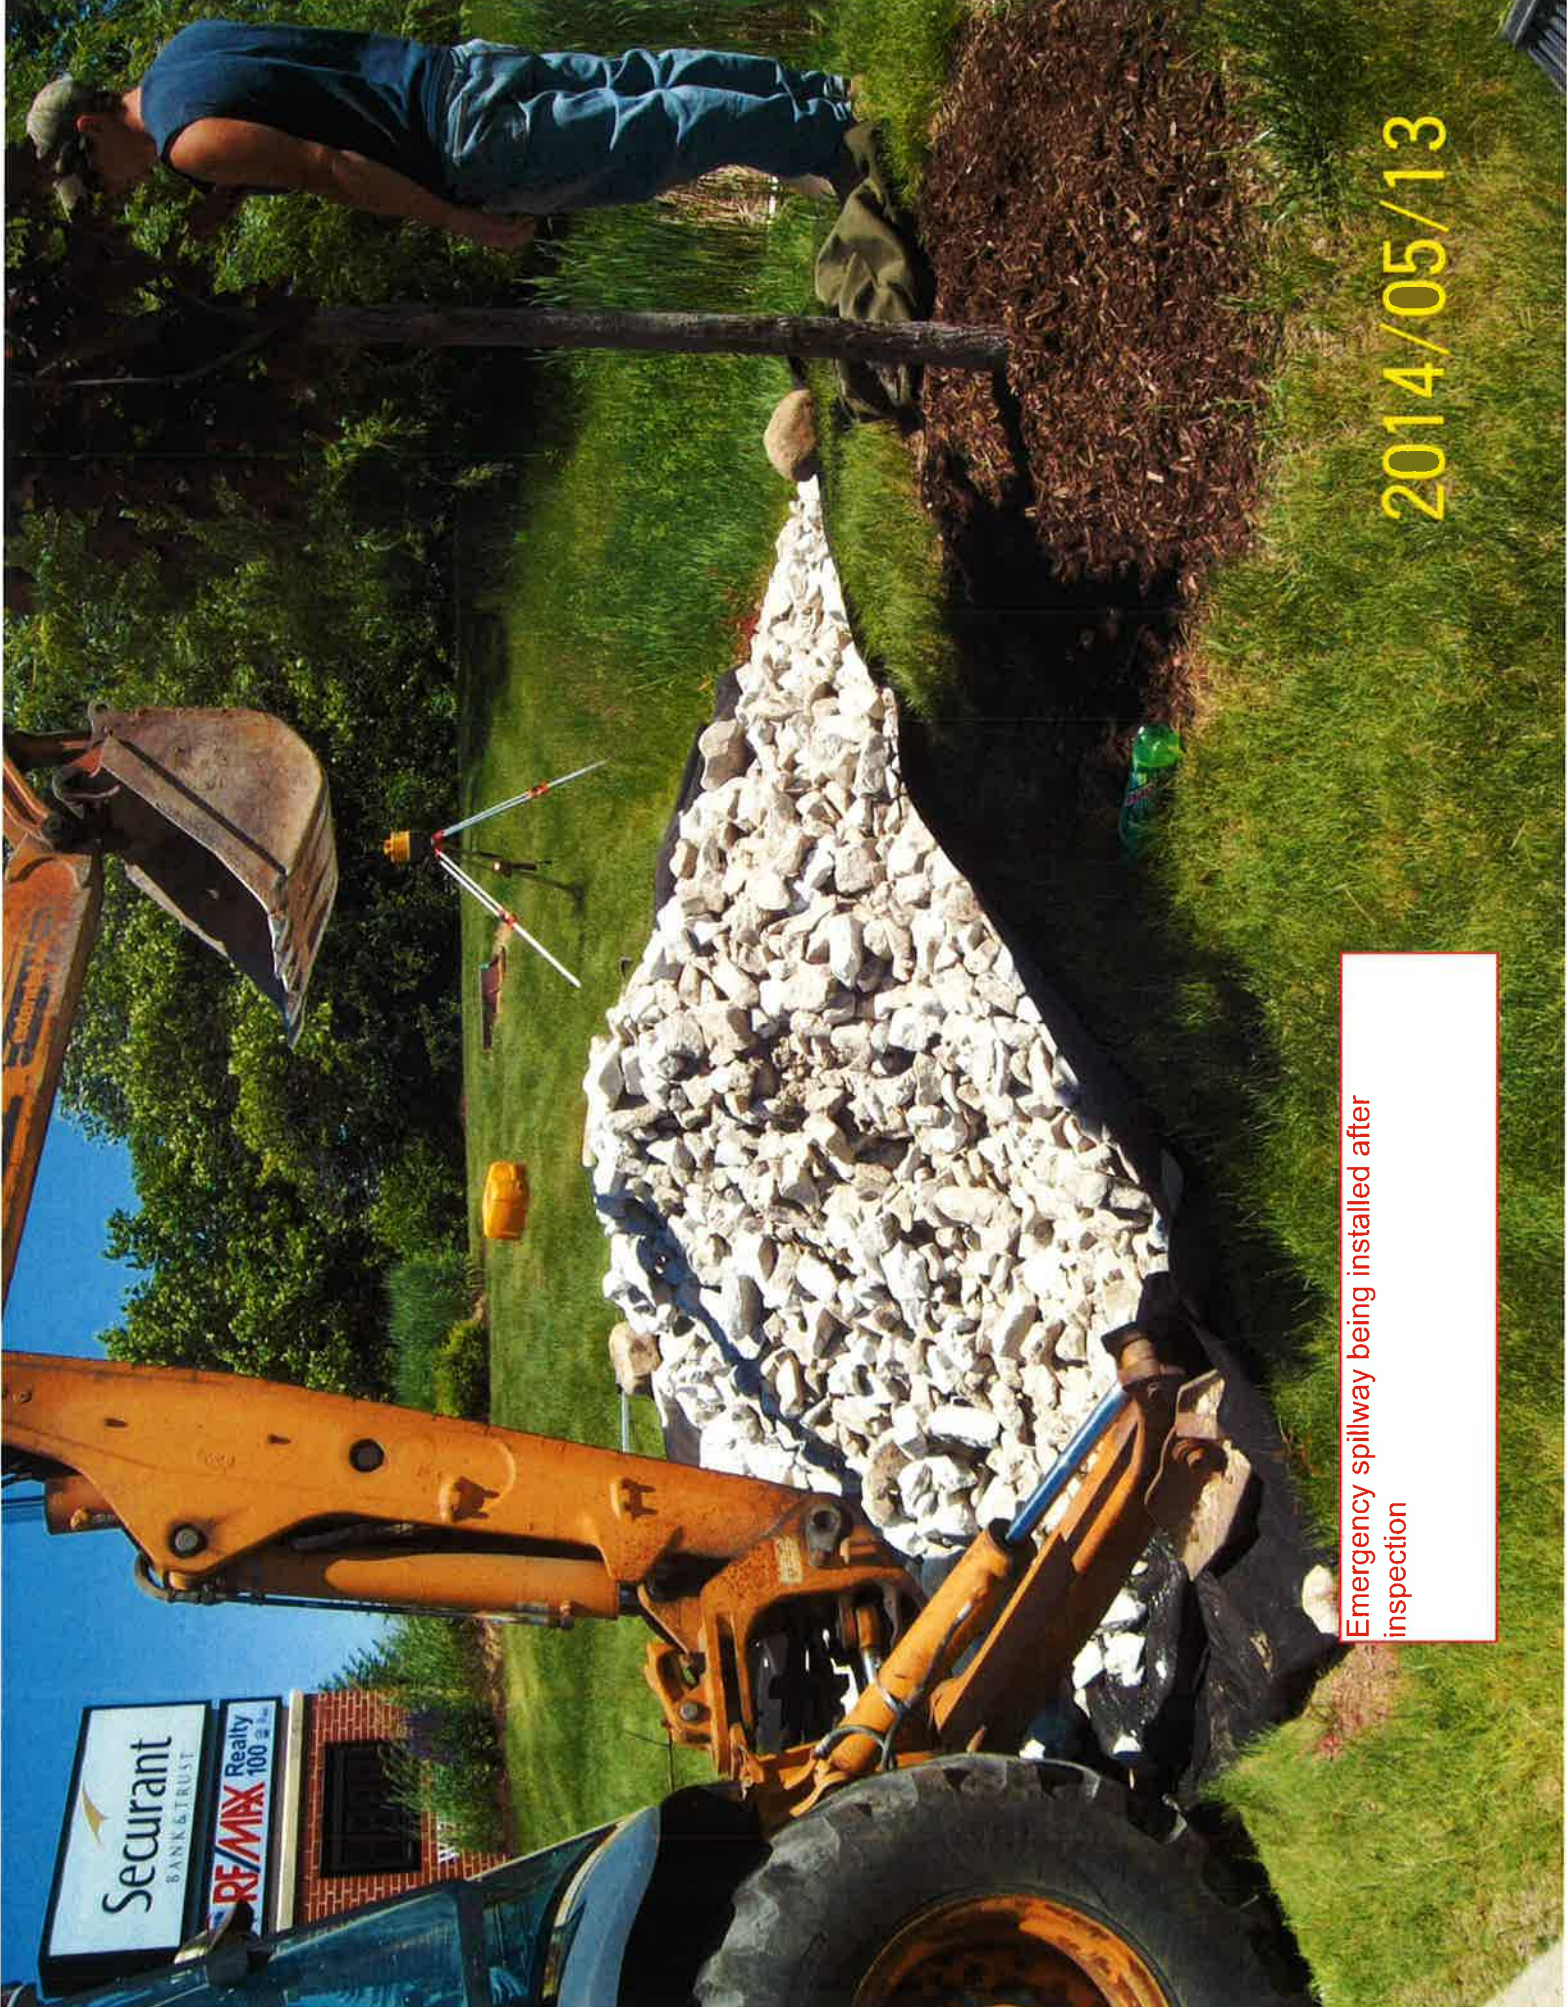
| Compliance Verification | Design | Actual | Compliant Yes No | Comments | |
|--|---|---|--|---|---|
| Elevation | 903.2 | NA | | X | Overflow spillway not constructed at time of inspection; overflow spillway installed after inspection – see attached photos |

Emergency spillway being installed after inspection
