STORMWATER MANAGEMENT FACILITIES OPERATION AND INSPECTION REPORT

Quarter Section _____ Name of Business/Subdivision Securant Bank (Formerly Milw. Western Bank)
Property Tax ID Number MNFV00139 Address of Property W178 N9358 Water Tower Place
Date 5/2/14

Pond ID: SWP 04 N004

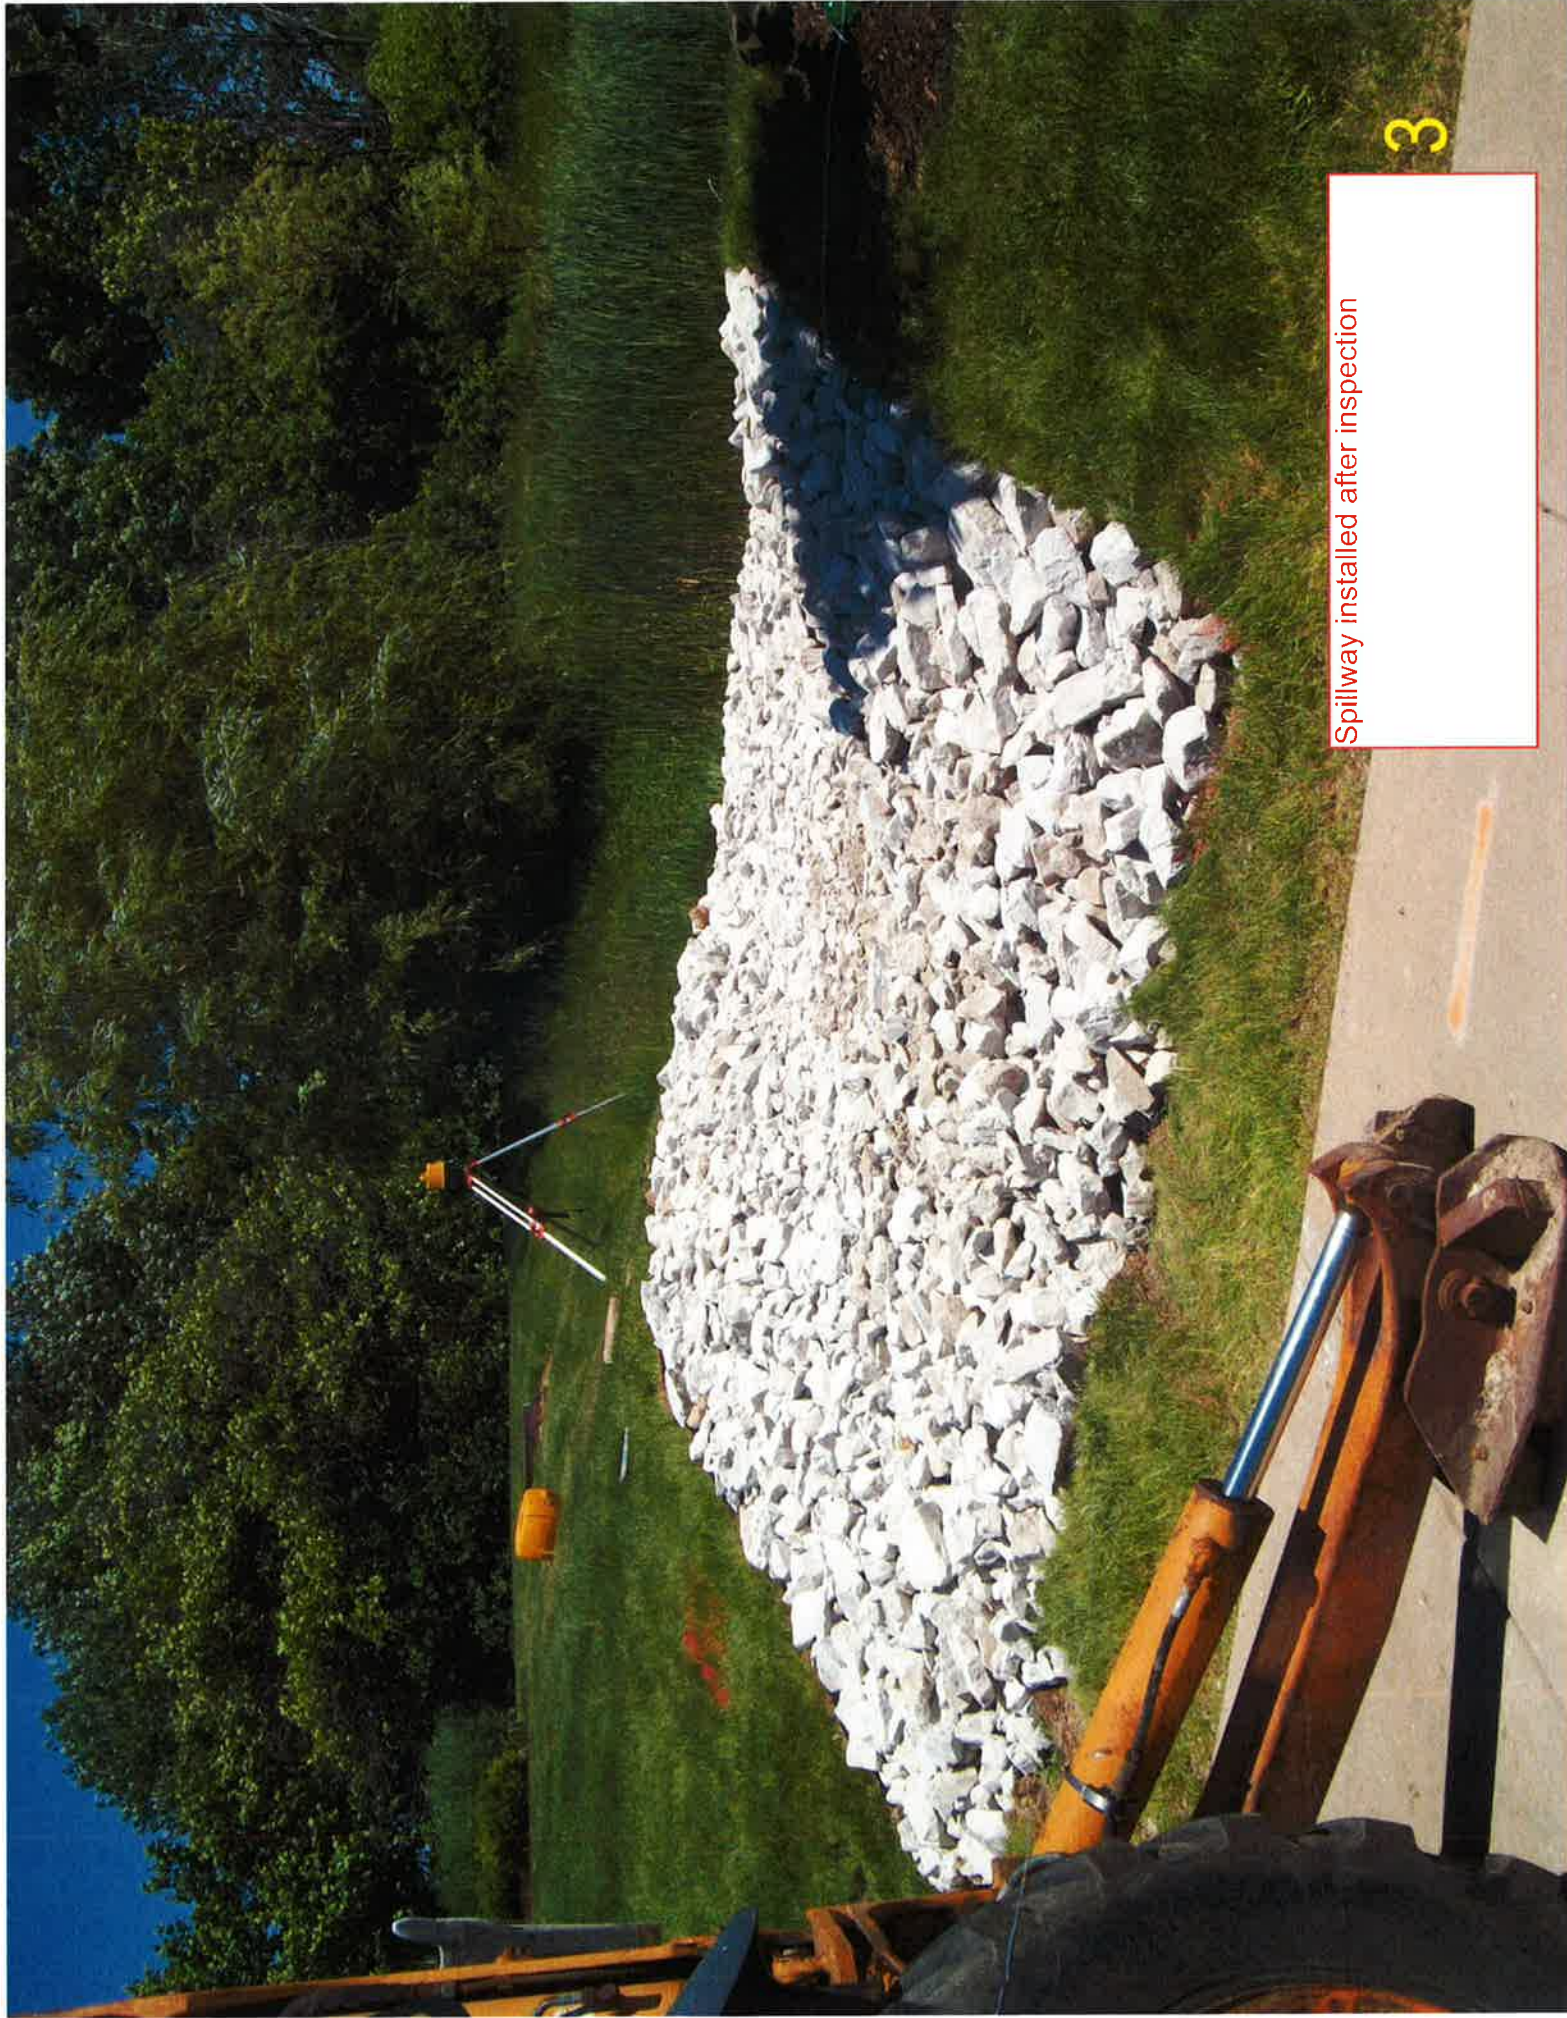
Spillway installed after inspection
