**STORMWATER MANAGEMENT FACILITIES  
OPERATION AND INSPECTION REPORT  
POUROUS PAVEMENT**

Quarter Section	<u>SW 1/4 Sec 26</u>	Name of Business/Subdivision	<u>Shecterle Commercial Properties 6</u>
Property Tax ID Number	<u>0103-983</u>	Address of Property	<u>PO Box 1205</u> <u>Brookfield, WI 53005</u>

**Pilgrim Spring Market Place  
POUROUS PAVEMENT – Photo Log**

Photos taken: 10/30/2014 (Fall inspection)

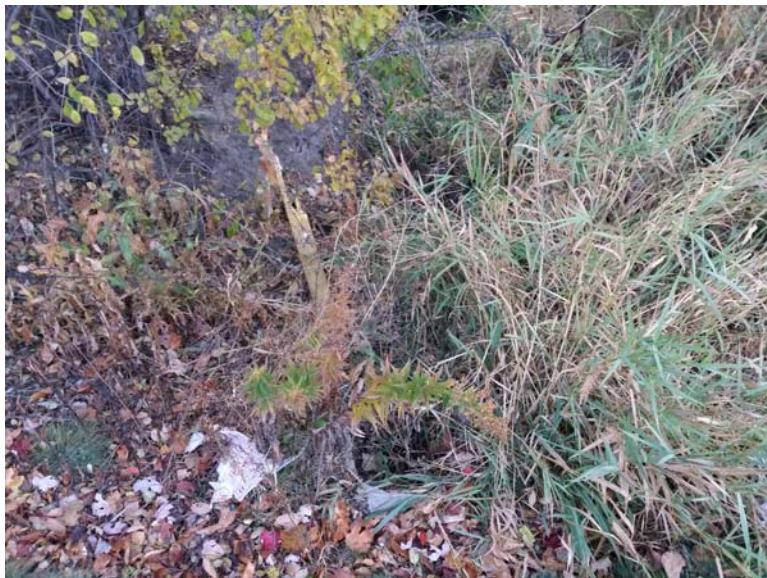
Photo #1: Outfall channel flow clear. Vegetation has accumulated at endwall.

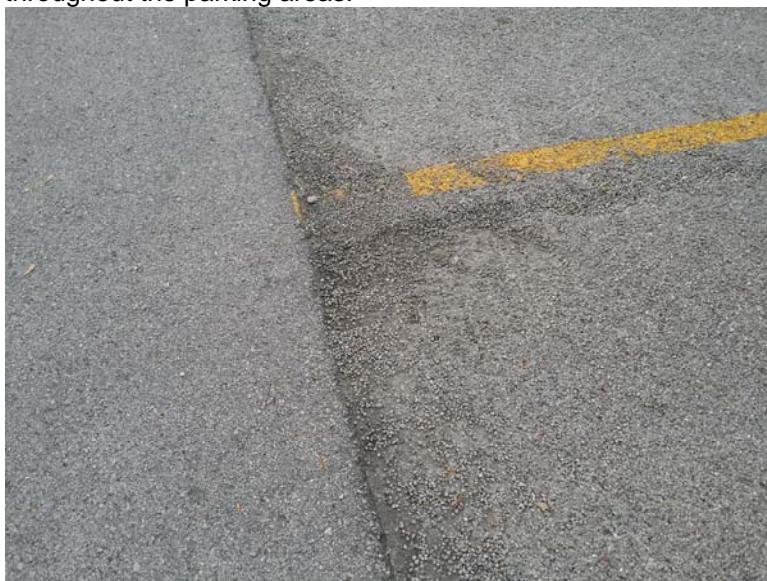
Photo #2: Minor surface spalling is present along the asphalt/concrete joint at numerous locations throughout the parking areas.

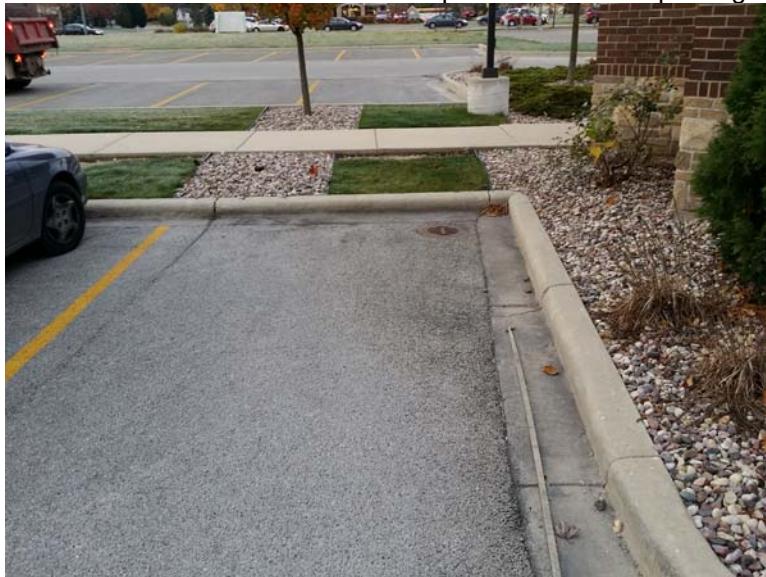
Photo #3: No debris observed at low points in concrete parking areas.

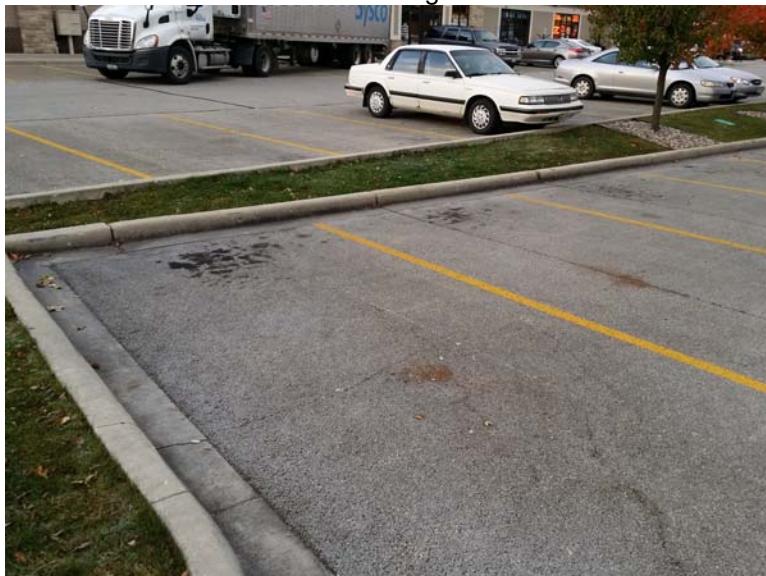
Photo #4: Minor vehicle fluid staining was observed within concrete parking areas.

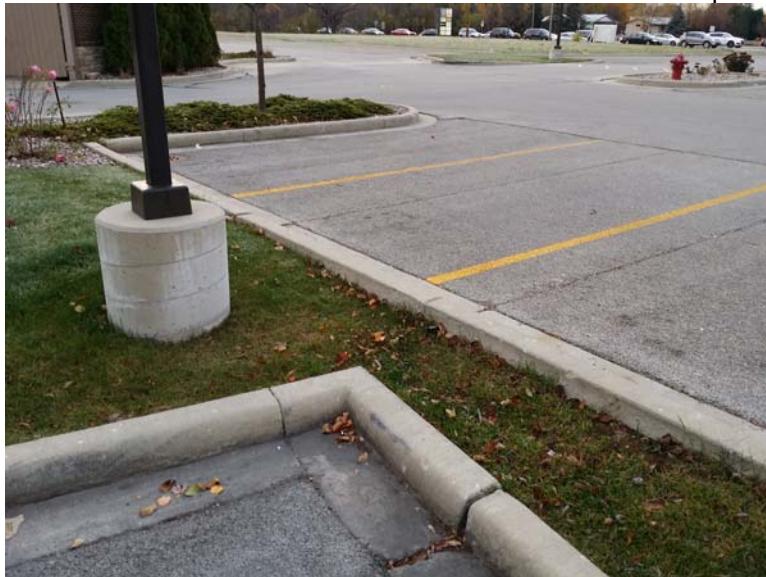
Photo #5: Minor settlement was observed within the interior parking lot landscape areas.

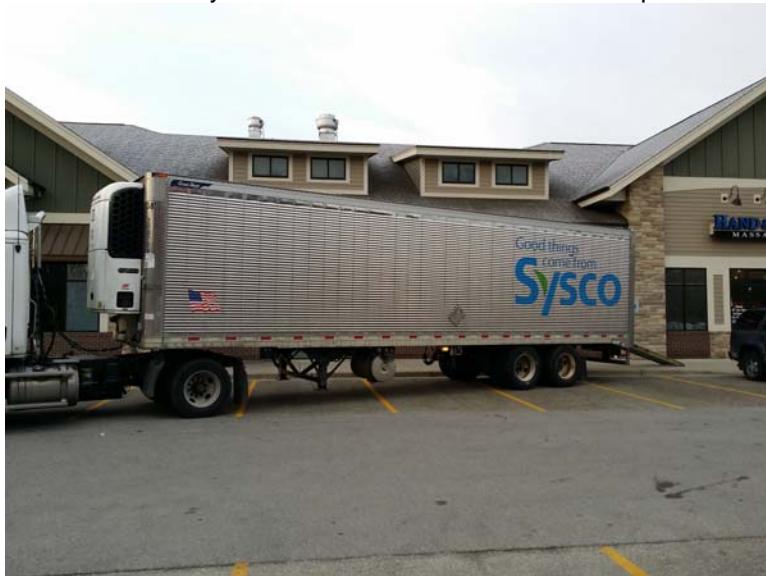
Photo #6: Delivery trucks should be minimized on the porous concrete areas to prolong service life.

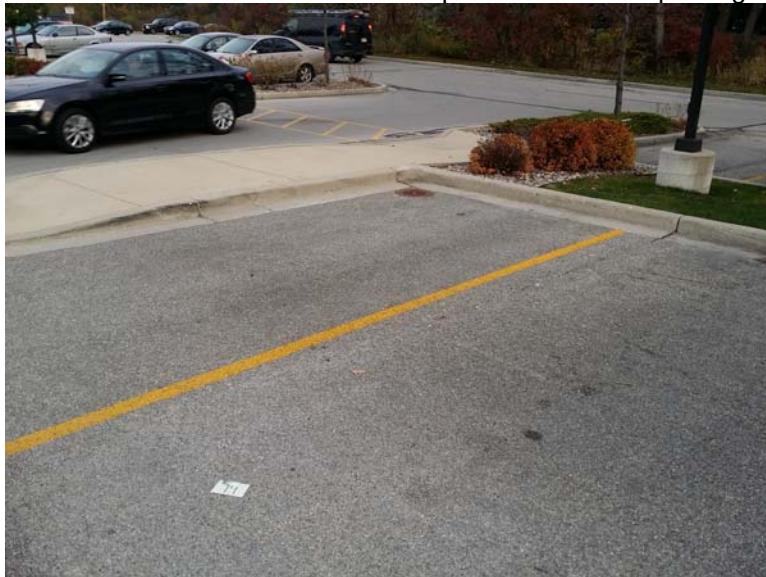
Photo #7: No debris observed at low points in concrete parking areas.

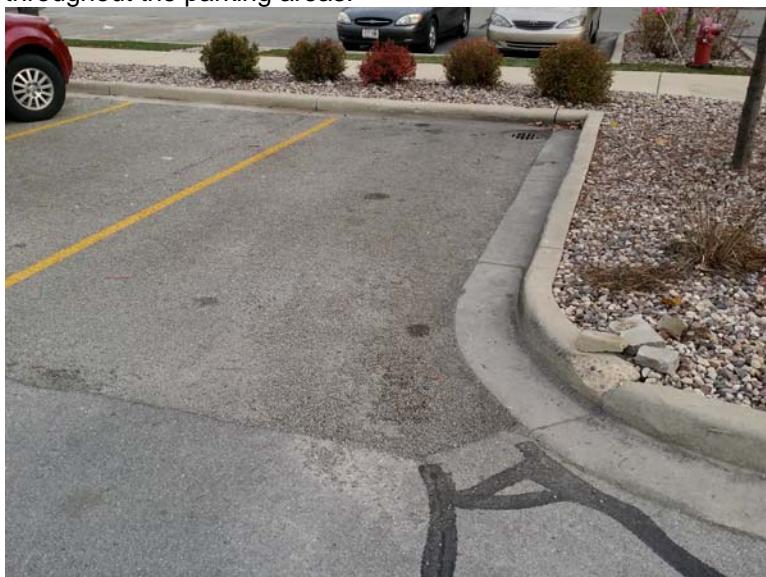
Photo #8: Minor surface spalling is present along the asphalt/concrete joint at numerous locations throughout the parking areas.

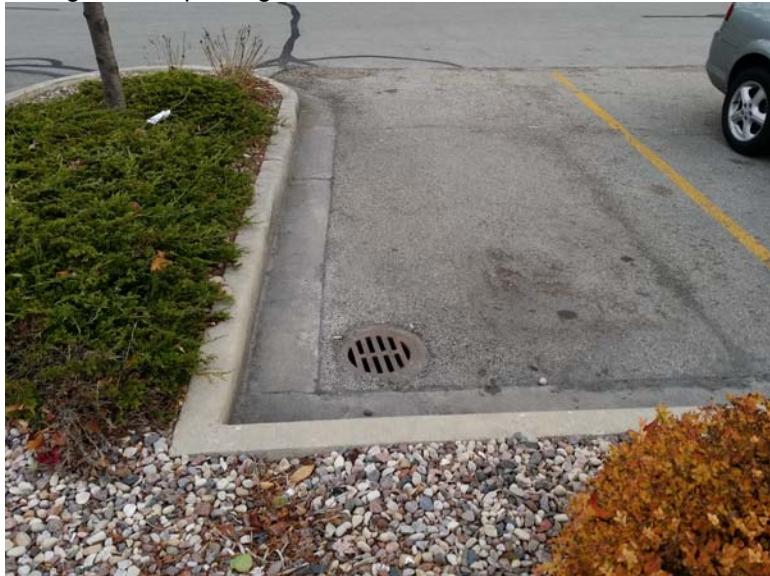
Photo 9: Minor surface spalling is present along the asphalt/concrete joint at numerous locations throughout the parking areas.

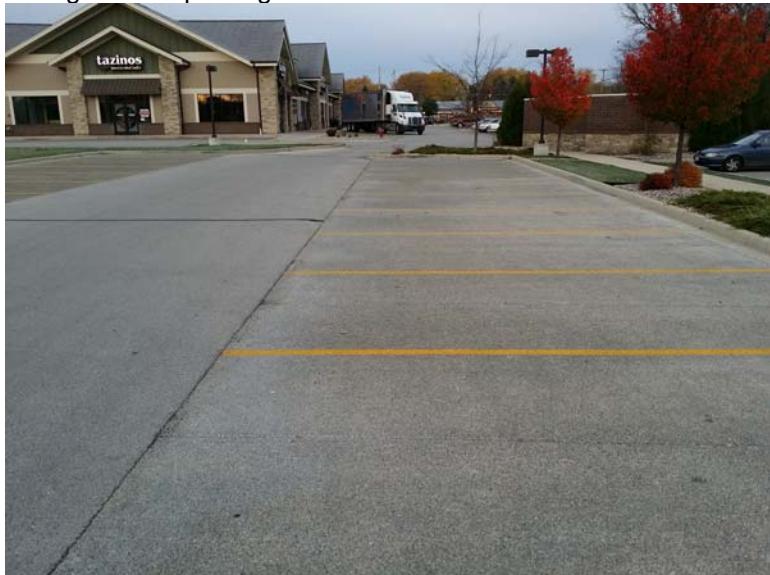
Photo 10: Minor surface spalling is present along the asphalt/concrete joint at numerous locations throughout the parking areas.

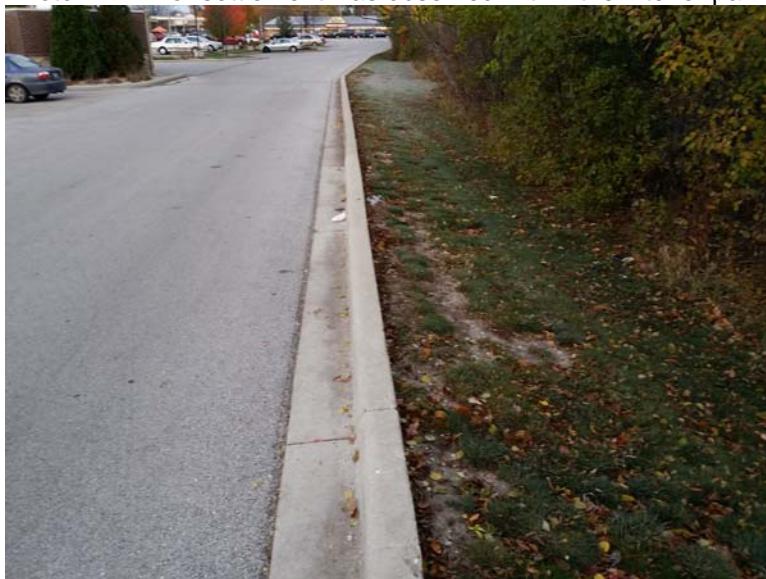
Photo 11: Minor settlement was observed within the interior parking lot landscape areas.

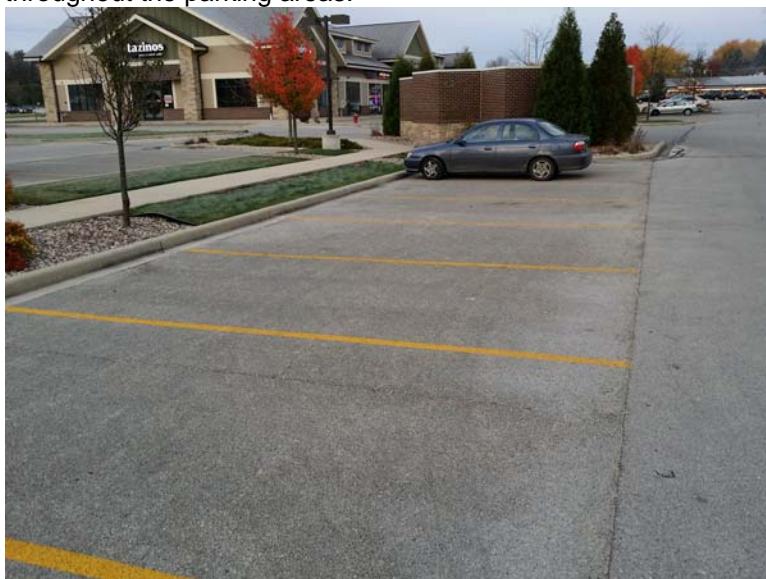
Photo 12: Minor surface spalling is present along the asphalt/concrete joint at numerous locations throughout the parking areas.
