STORMWATER MANAGEMENT FACILITIES OPERATION AND INSPECTION REPORT

Quarter Section NW 1/4 Sec. Name of Business/Subdivision Weimer Bearing
36-8-20
 Property Tax ID Number 0142999010 Address of Property W134 N5368 Campbell Dr.
 Date 5/29/2015

Location of Pond East side of property
 Pond ID: SWP36N003

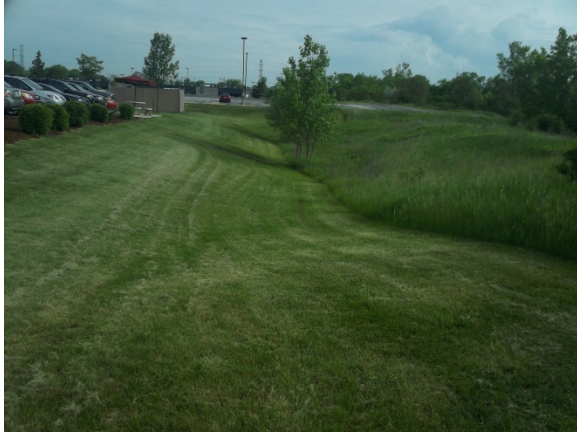
Figure 1: Looking North, Overview of Dry Pond

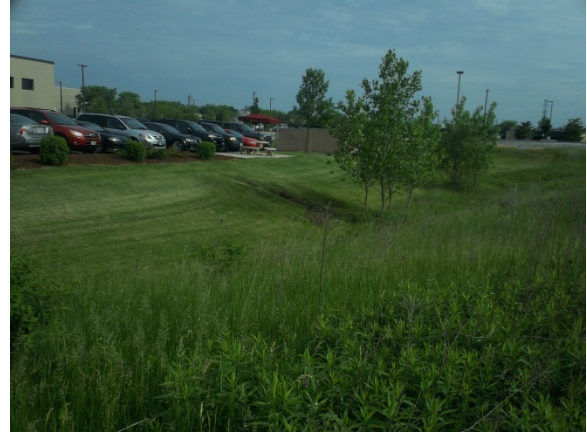
**Figure 4: Looking Northwest, Overview of Dry Pond
(Note: Two Groupings of Tree Growth)**

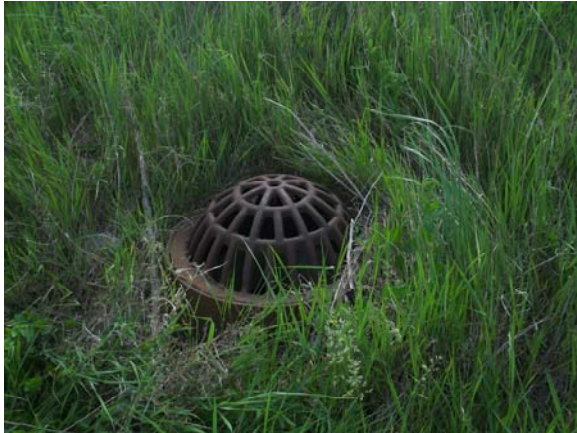
Figure 2: 24" Secondary Outlet for Outfall

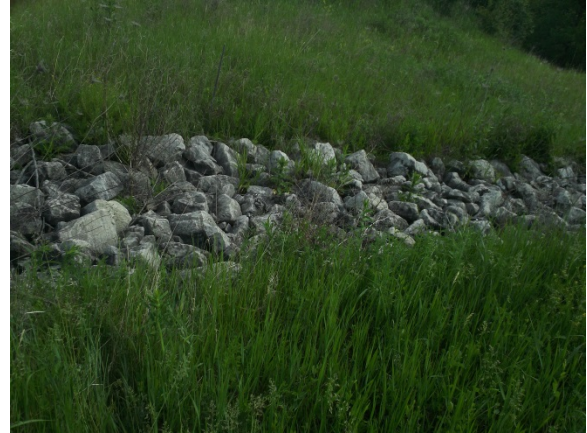
Figure 5: Emergency Spillway Located on the Northeast Portion of Pond

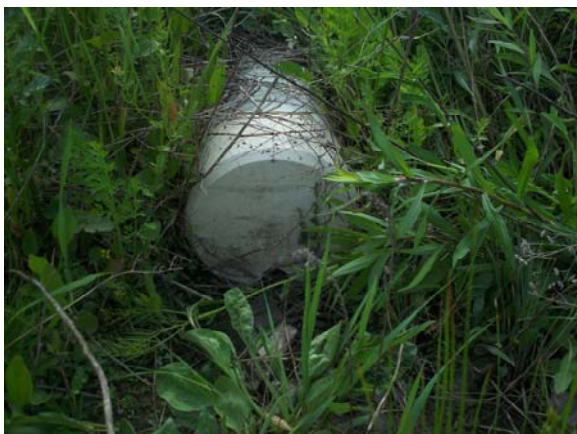
Figure 3: 1.6" Primary Outlet

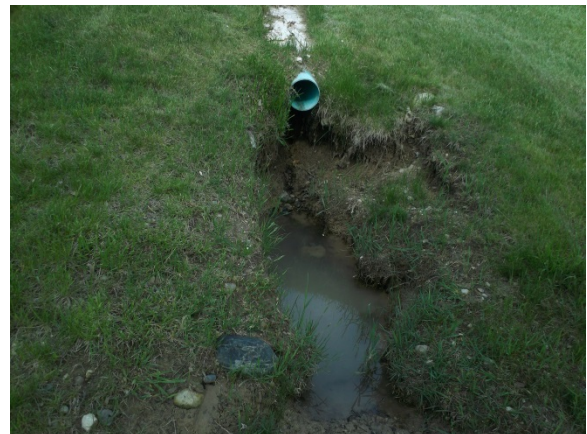
Figure 6: 6" PVC Outfall Located on the West Slope of Pond
