## STORMWATER MANAGEMENT FACILITIES OPERATION AND INSPECTION REPORT

Quarter Section NW 1/4 Sec Name of Business/Subdivision Pilgrim Glen Condominium Plat  
Property Tax ID Number 23-8-20 0090-996-126 Addendum No. 2  
Date 0090-996-167 Address of Property Amberleigh Circle  
6/25/15

Pond ID: SWP23N001

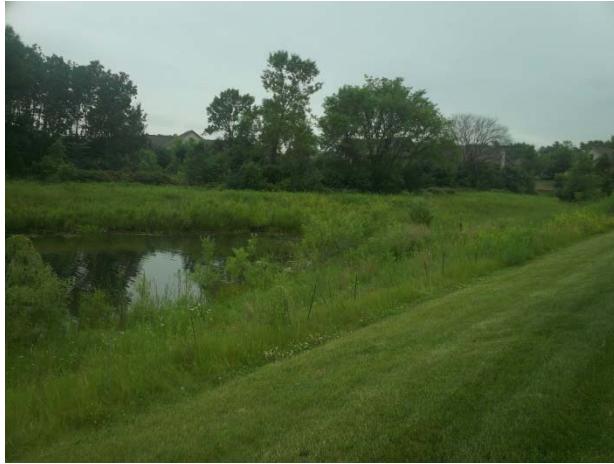
Figure 1: Overview of the West Portion of the Pond  
Looking Southwest

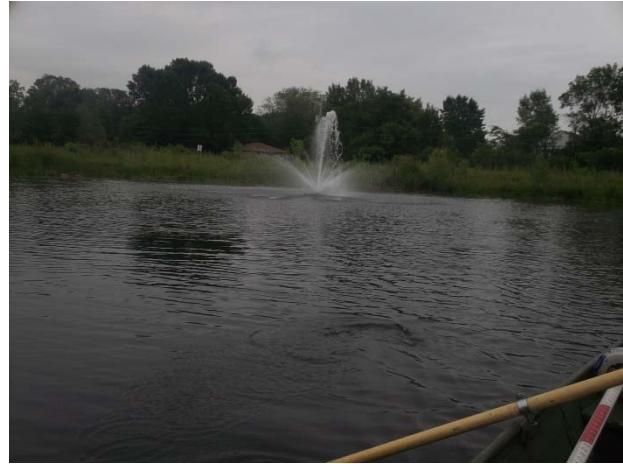
Figure 4: Photo from Center of Pond Looking East

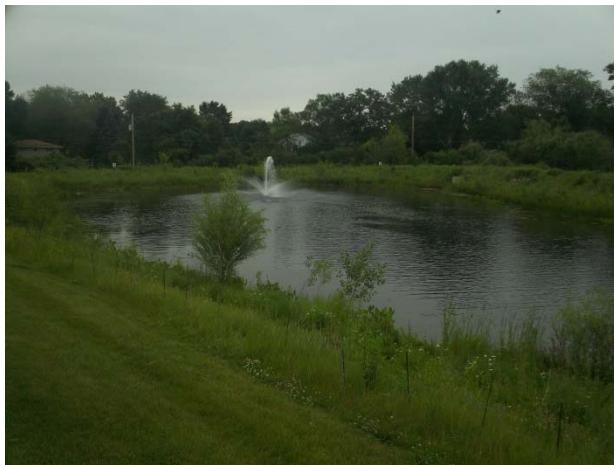
Figure 2: Overview of the East Portion of the Pond  
Looking East

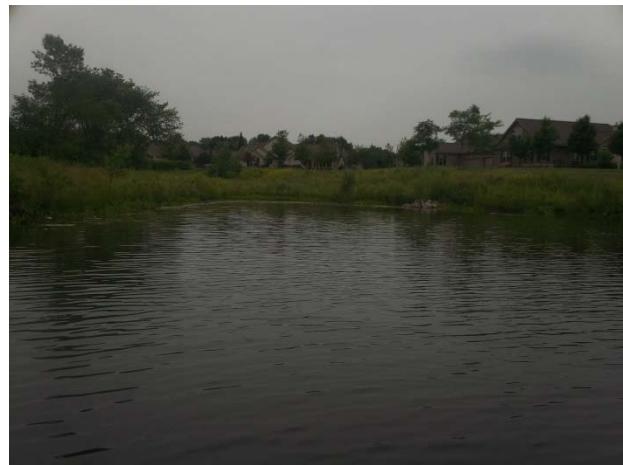
Figure 5: Photo from Center of Pond Looking West

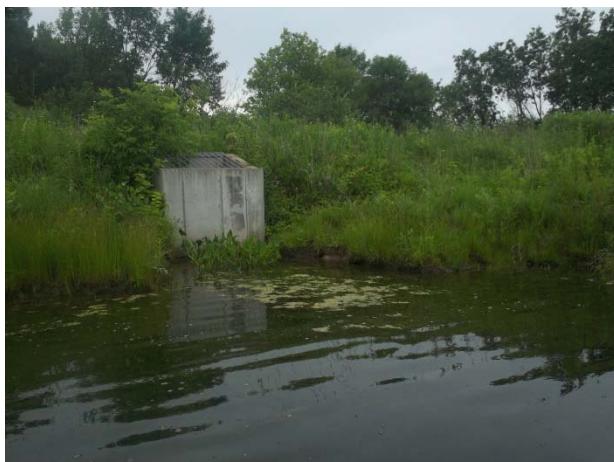
Figure 3: Photo of Outlet Structure Located on the  
Southeast Portion of the Pond

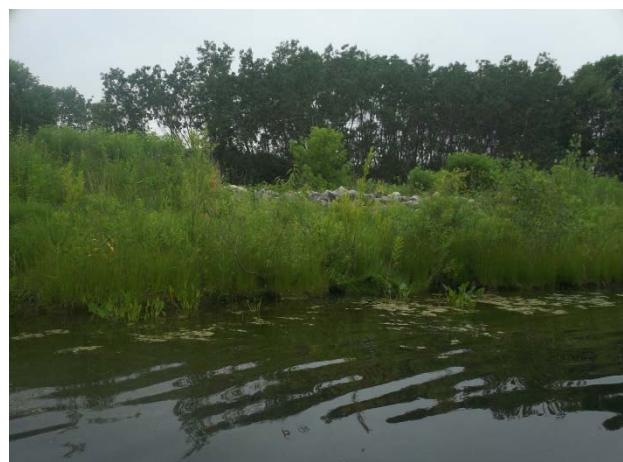
Figure 6: Photo of Emergency Spillway Located on the  
Southeast Portion of the Pond, West of the Outlet  
Structure
