STORMWATER MANAGEMENT FACILITIES OPERATION AND INSPECTION REPORT

Quarter Section	NW 1/4 Sec	Name of Business/Subdivision		Pilgrim Glen Condominium Plat
Property Tax ID Number	23-8-20	0090-996-066		Addendum No. 2
	thru			
Date	0090-996-125	Address of Property		Macallan Court
	7/8/2015

Dry Pond		Location of Pond	
Wet Pond	X	SE Quadrant of Property	
Other			
Pond ID: SWP23N003

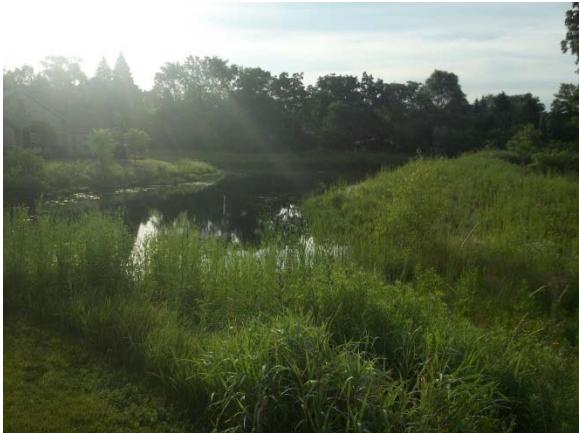
Figure 1: Overview of Pond, Looking East

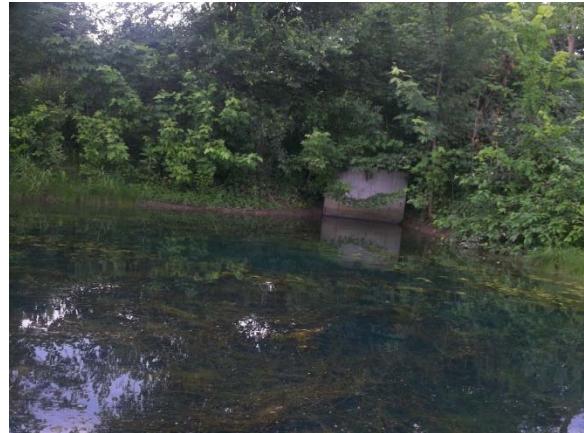
Figure 4: Overview of Outlet Structure located on the Southeast Portion of Pond, Looking East

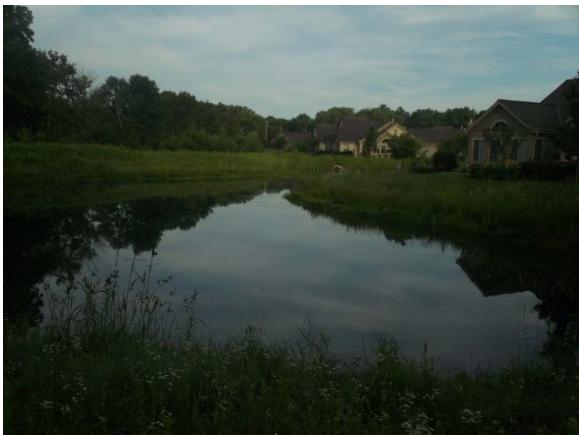
Figure 2: Overview of Pond, Looking West

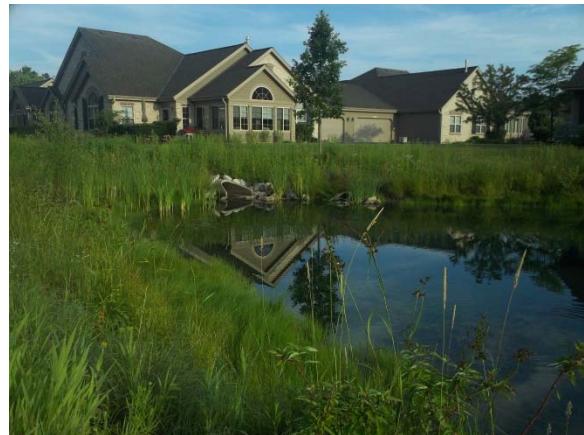
Figure 5: Overview of the two Outfalls on the West Portion of the Pond

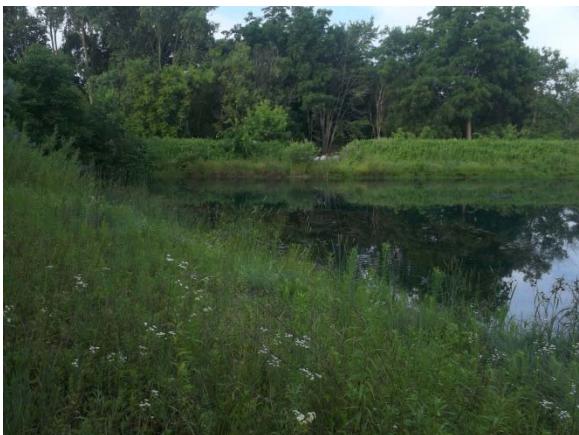
Figure 3: Overview of the Emergency Spillway, Looking East

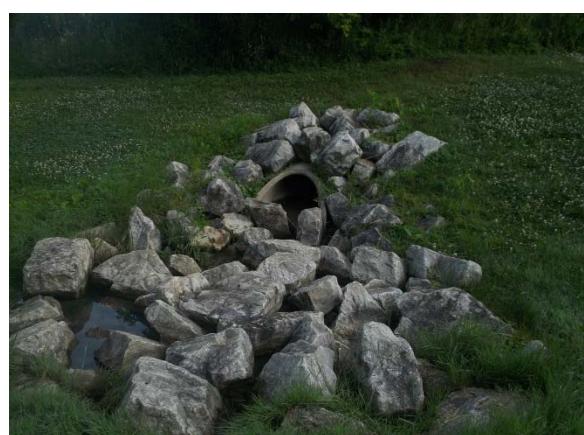
Figure 6: Overview of the Outfall Structure on the North Portion of the Pond
