STORMWATER MANAGEMENT FACILITIES OPERATION AND INSPECTION REPORT

Quarter Section NW 1/4 Sec Name of Business/Subdivision Pilgrim Glen Condominium Plat
 Property Tax ID Number 23-8-20 Addendum No. 2
0090-996-168
 thru
0090-996-197 Address of Property Tartan Circle
 Date 7/8/2015

Location of Pond SE Quadrant of Property
 Pond ID: SWP23N004

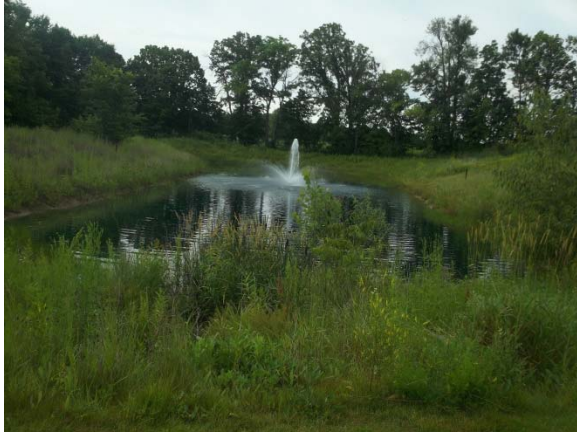
Figure 1: Overview of Pond, Looking to the South

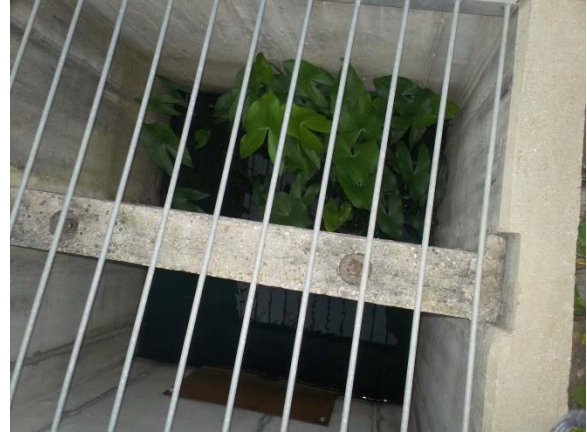
Figure 4: Top View of Outlet Structure (Note: Tree Growth in the Interior of the Structure)

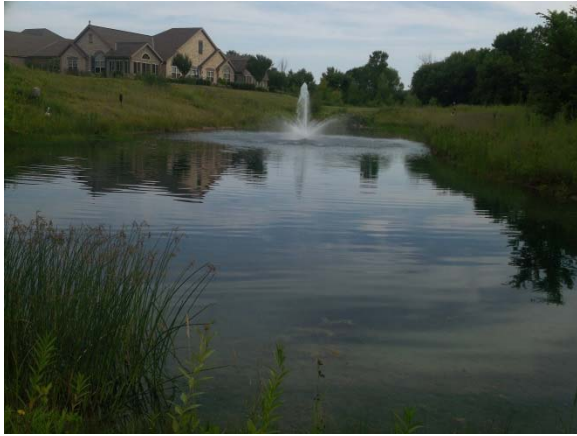
Figure 2: Overview of Pond, Looking to the North

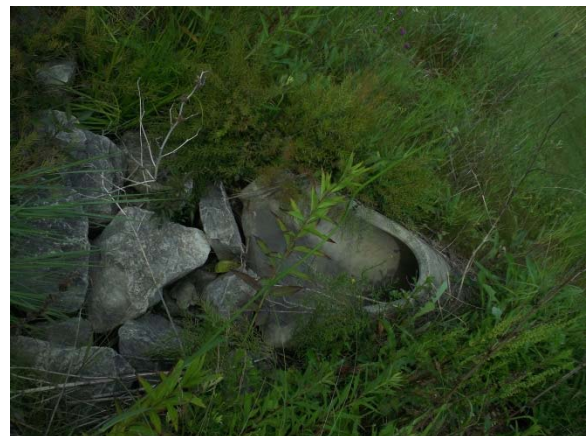
Figure 5: Overview of Outfall Located on the North Portion of the Pond

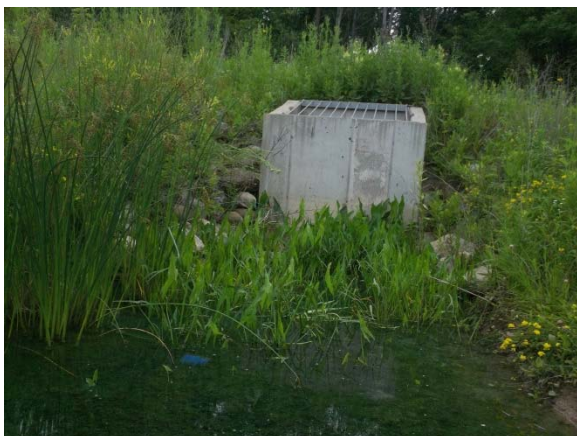
Figure 3: Overview of the Outlet Structure located in the Southeast Portion of the Pond, Looking to the Southeast

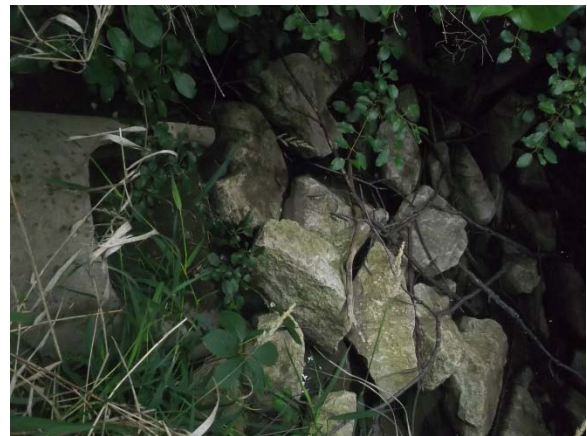
Figure 6: Outfall for the Pond Structure, Located Southeast of the Pond
