## STORMWATER MANAGEMENT FACILITIES OPERATION AND INSPECTION REPORT

SW ¼ SEC 26 Name of Business/Subdivision First Park  
V0103985 Address of Property W156 N5384 Pilgrim Road

Pond ID: Stormwater Pond  
Basin A

## FIRST INDUSTRIAL POND A SURVEY

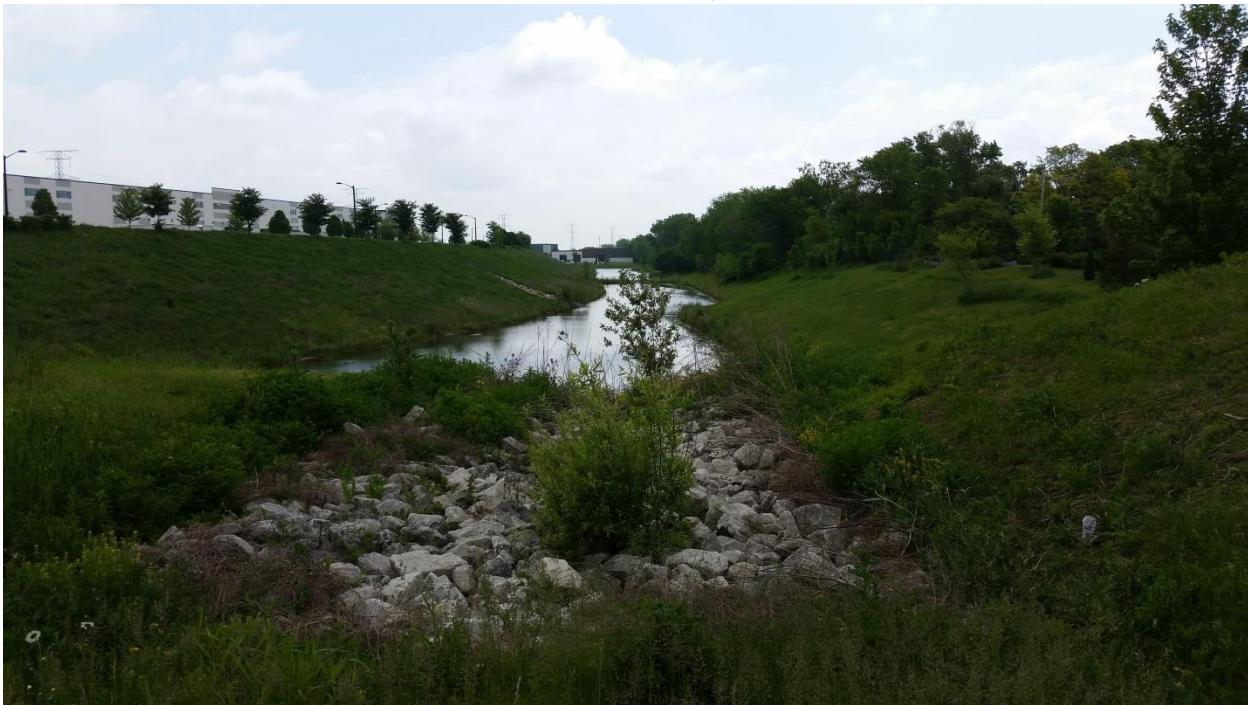
Photo 1: Vegetation along pond banks generally provides adequate cover. Photo taken from west side of pond looking east.

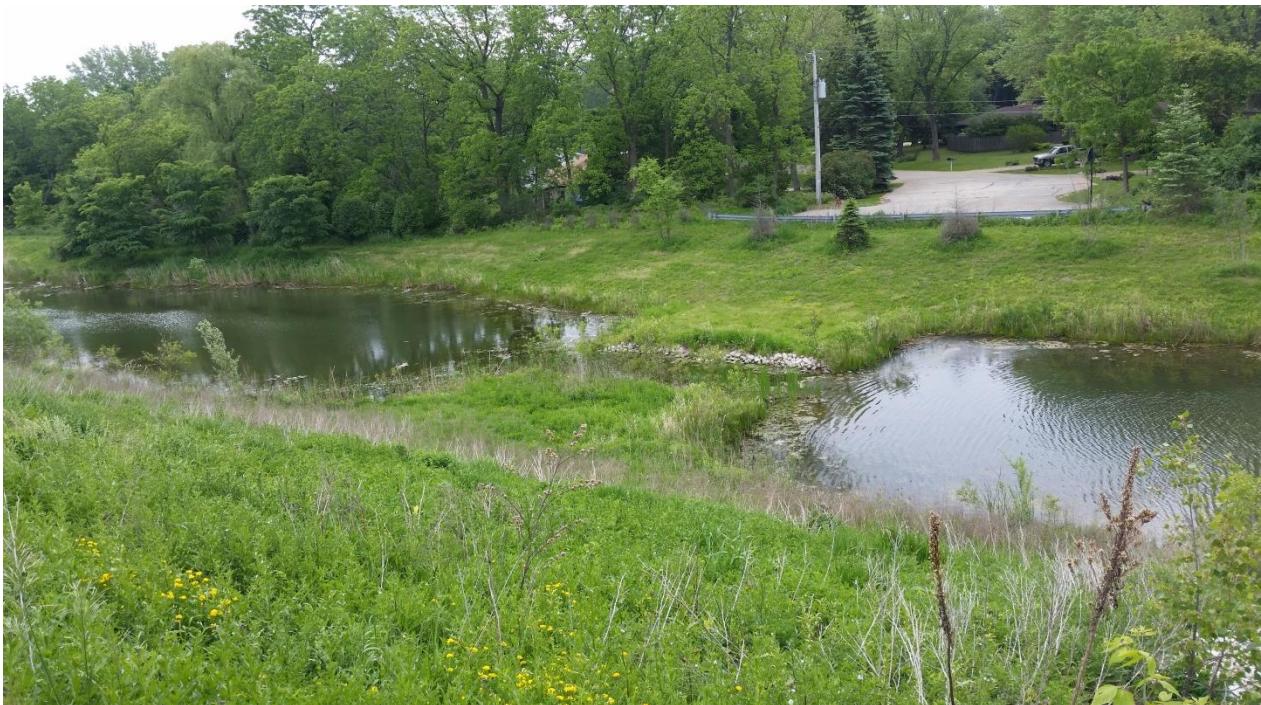
Photo 2: Herbicide spot treatment and/or mowing may be necessary to knock back areas of invasive species. Photo taken on north side of pond, near forebay spillway, looking south toward Vista Lane.

\* NOTE: The DNR's BMPs pertaining to NR 40 vegetative control management should be implemented by a licensed, professional landscape contractor as part of the pond's ongoing maintenance plan.

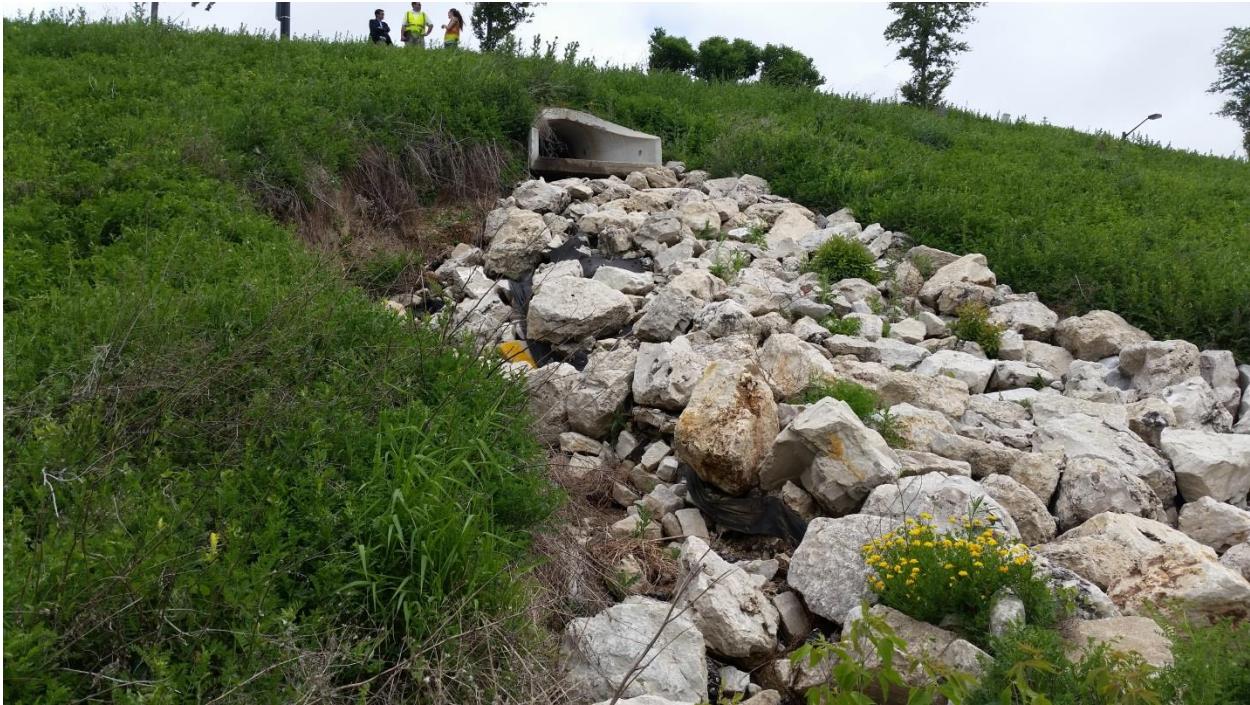
Photo 3: Erosion at northern pond inlet.

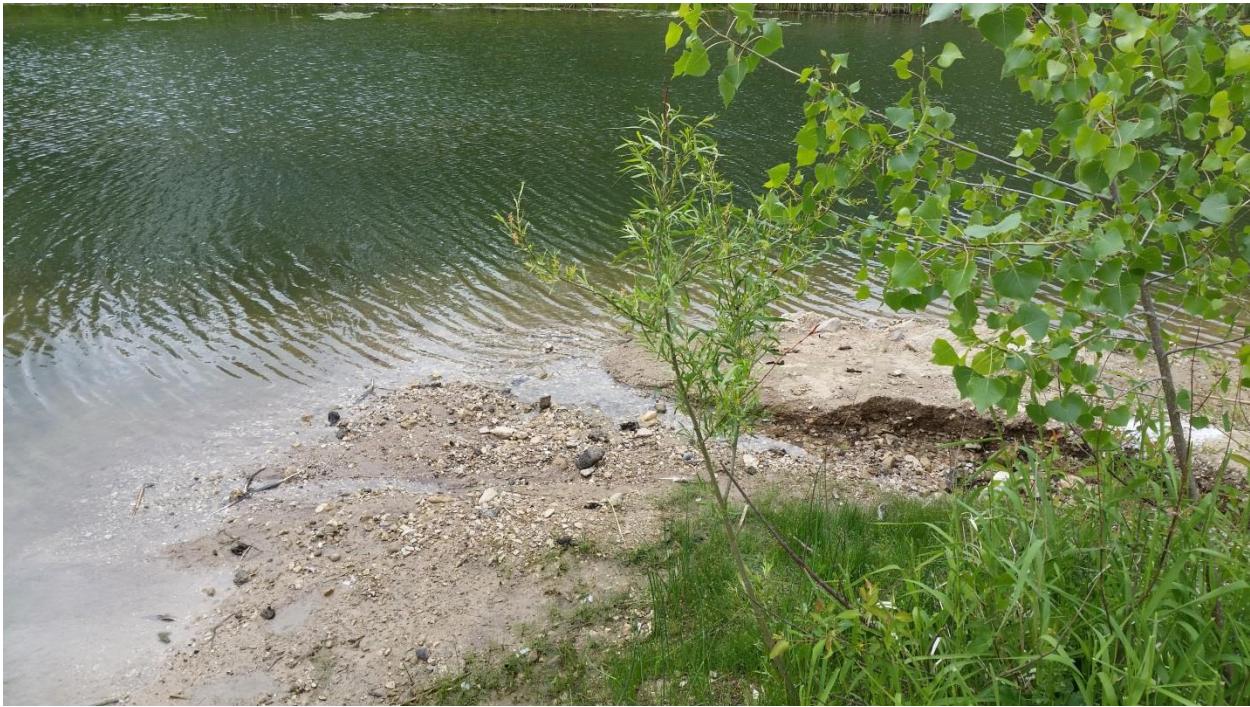
Photo 4: Deposition of sediment within basin of pond. \*NOTE: If removal of sediment within pond is planned, make sure to contact local (Village of Menomonee Falls) and State (Department of Natural Resources) regulators for any prior authorization/permitting which may be necessary. Sediment may need to be tested prior to transport to ensure proper precautions are taken for disposal.

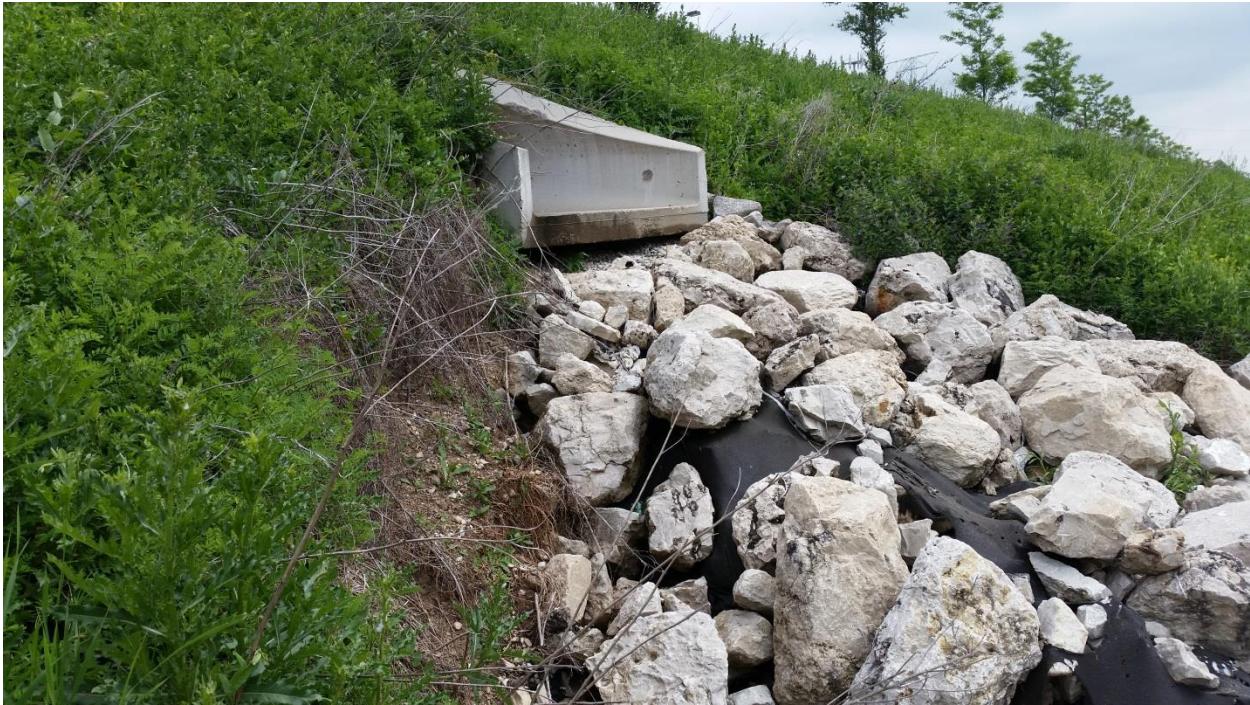
Photo 5: At pond inlets rip rap has become displaced, leaving geotextile fabric beneath exposed.

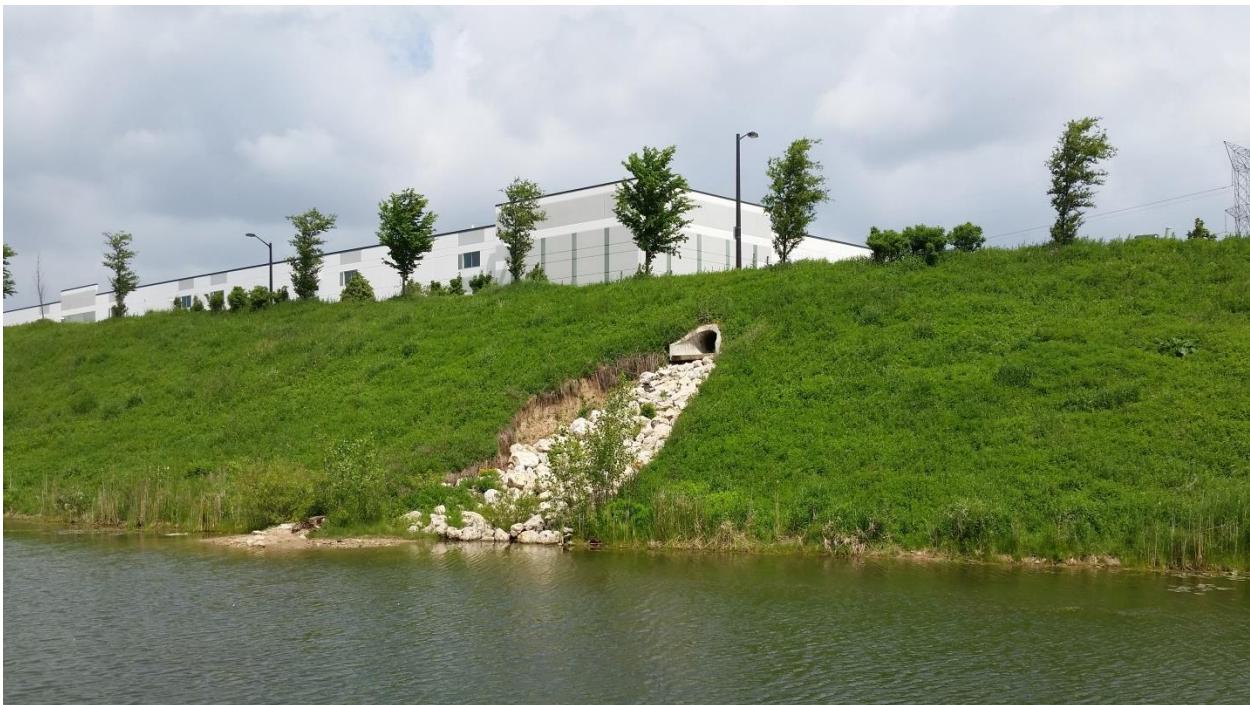
Photo 6: Flows carried downslope toward pond have led to some scouring along pond bank. Some additional rip rap underlain with geotextile fabric may be needed in areas where scour around existing rip rap has occurred. \*NOTE: In the event that land disturbance will occur as part of pond maintenance, please contact the Village to determine if an erosion control permit or any other permits will be needed.

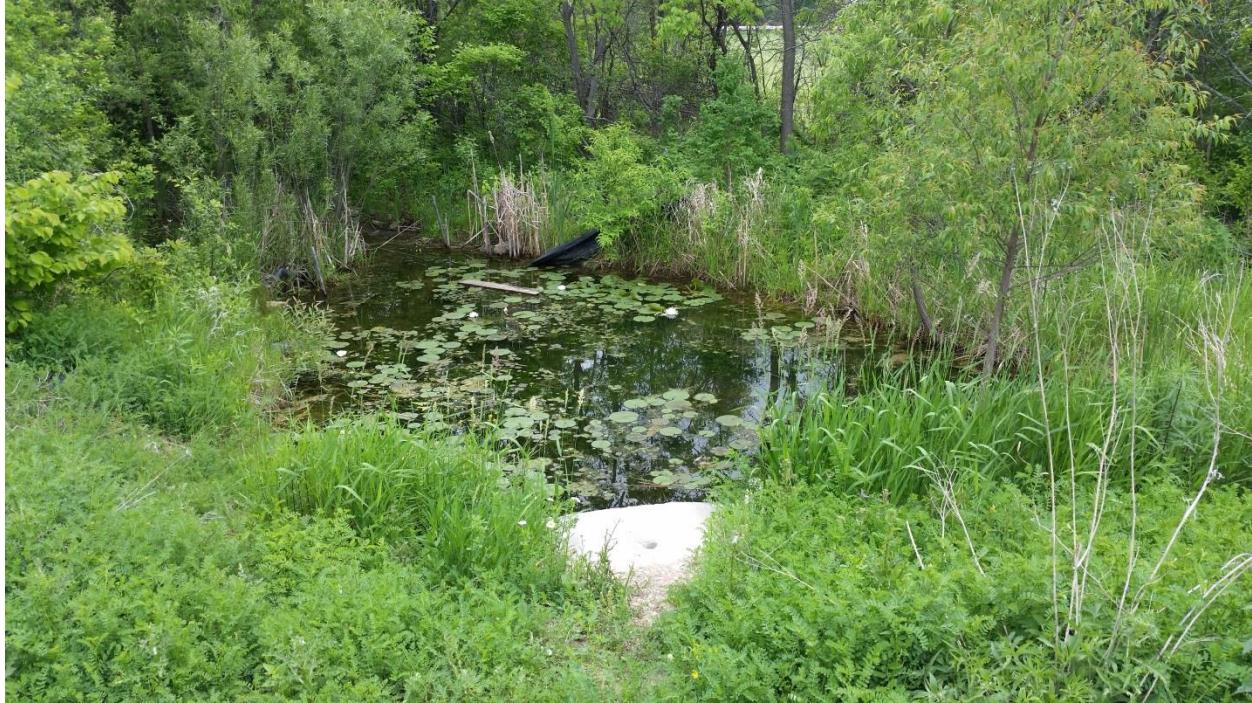
Compliance Verification	Design	Actual	Compliant Yes	No	Comments ( Condition of Structure)
<b>Primary Outlet Pipe</b>					Outlet Pipe Material
Opening Diameter (inches)	36 in.	36 in.	X		Reinforced concrete pipe in fine condition with no obstructions in outlet. Downstream of outlet is silt fence which had likely been placed with original development. It should be removed so it doesn't cause an obstruction.
Upstream Invert	780.89	780.82	X		
Downstream Invert	780.61	780.47	X		
Length (feet)	54.5 ft	47 ft.	X		
Slope (%)	1%	0.74%	X		
<b>Secondary Outlet Pipe</b>	(If Applicable)				Outlet Pipe Material
Opening Diameter (inches)	N/A				
Upstream Invert	N/A				
Downstream Invert	N/A				
Length (feet)	N/A				
Slope (%)	N/A				
<b>Riser</b>	(If Applicable)				Riser Material
Opening Diameter (inches)	N/A				
Elevation	N/A				
<b>Upper Discharge Control</b>	(If Applicable)				
Opening Diameter (inches)	22 in.	22 in.	X

Photo 7: Stormwater pond outlet structure located on southeast end of pond. Outlet is in fine condition, noted no obstructions in outlet. Downstream of outlet is silt fence which had likely been placed with original development. It should be removed so it doesn't cause an obstruction.

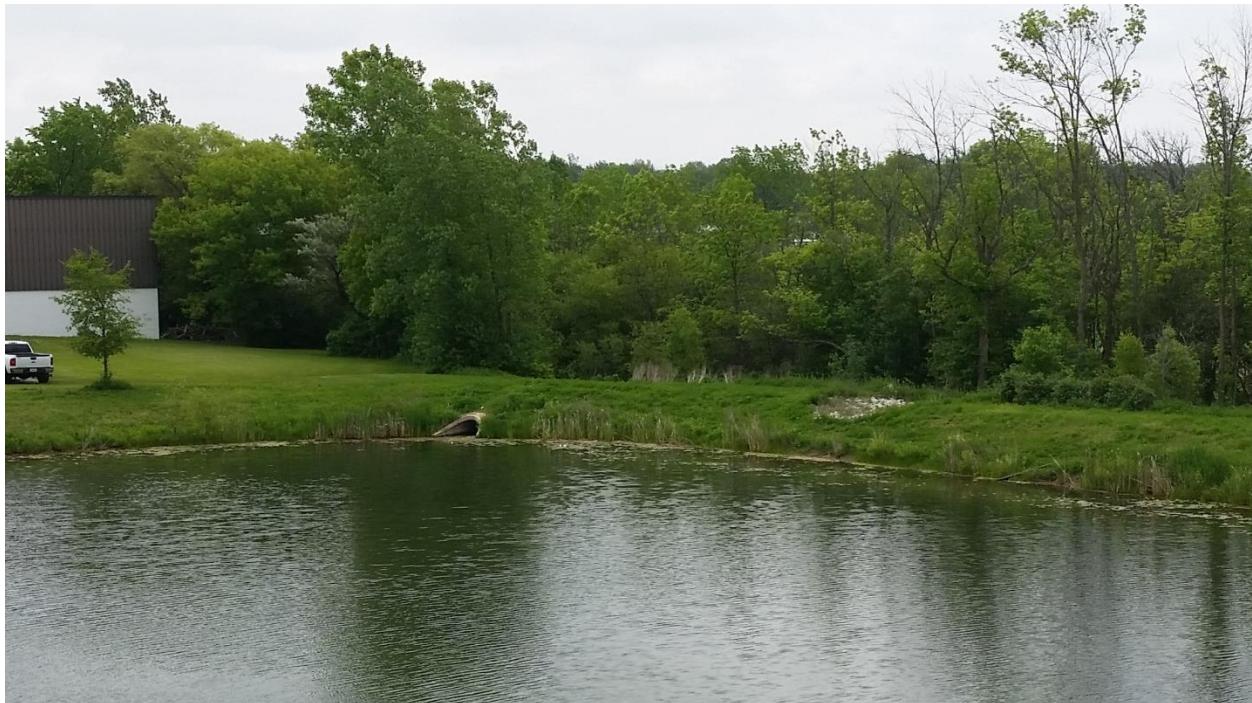
Photo 8: Noted no obstructions at outlet control structure or at emergency overflow spillway during inspection.
