## STORMWATER MANAGEMENT FACILITIES OPERATION AND INSPECTION REPORT

Quarter Section		SE 1/4 Sec 13-8-20		Name of Business/Subdivision			Heritage Reserve Holdings, LLC			
Property Tax ID Number		MNFV005 44052 & MNFV005 45002	19 Addre	Address of Property			Heritage Reserve			
Date		5/29/2015								
Dry Pond X					Loca Pond	ition of	Along the South portion of			
Wet Pond		D 014/D 400 5 5 5					MNFV0051944052 and along the			
Other Pond I		ID: SWF	D: SWP13S006				North portion of MNFV0051945002			
Year Pond Constructed	2	2005			of Last ication	-	Design data based on Stante 2014 Memo dated August 5, 2014 File No. 1938990300			
Compliance Verif	ication	Design	Actual	Com <sub>i</sub> Yes	pliant No		Comments ( Condition of Structure)			
Primary Outlet Pi	pe			1	110	Outlet F	Pipe Material			
Opening Diameter		18"	15"	Х			orced Concrete Pipe w/ a 6" restriction			
(inches)		10	13	^			device			
Upstream Invert		760.48	760.47	X						
Downstream Invert		759.66	759.81	Х						
Length (feet)		185'	184'	Х

Inspection Firm: JSD Professional Services, Inc Inspector Name: Ryder Fischer

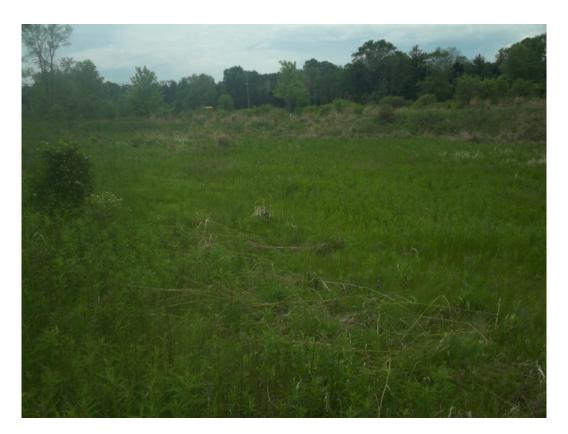
Figure 1: Overview of Pond Looking South

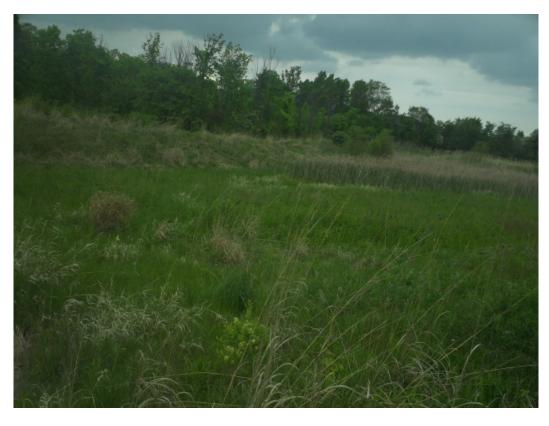
Figure 2: Overview of Pond Looking North

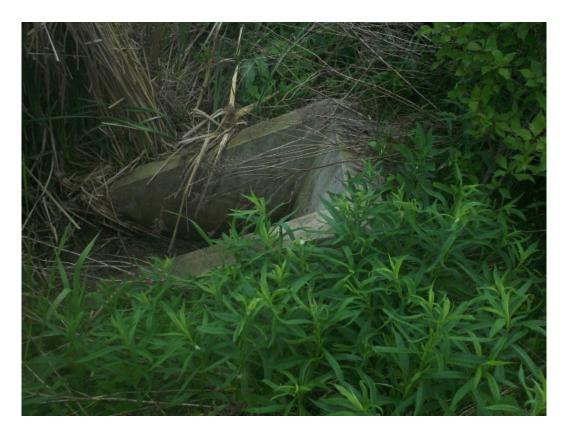
Figure 3: Overview of Outlet Structure

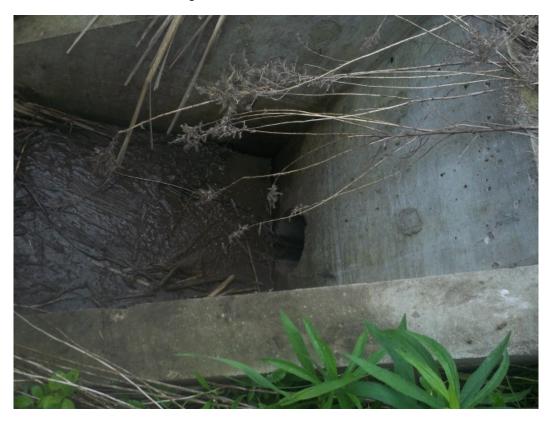
Figure 4: Top View of Outlet Structure

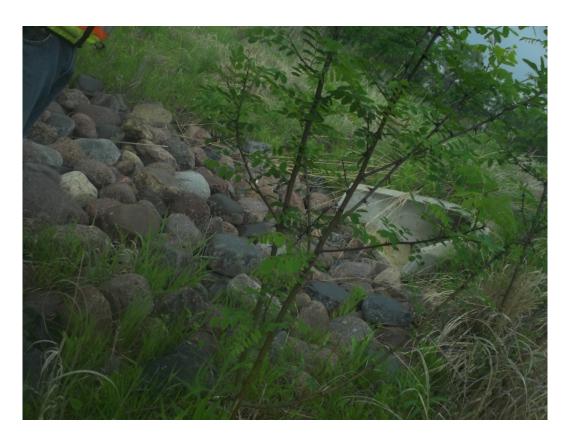
Figure 5: 24" RCP Outfall
