STORMWATER MANAGEMENT FACILITIES OPERATION AND INSPECTION REPORT

Quarter Section SE 1/4 Sec. Name of Business/Subdivision Heritage Reserve Holdings, LLC
13-8-20
 Property Tax ID Number MNFV00519 Address of Property Heritage Reserve
45002
 Date 5/29/2015

Location of Pond Southwest Portion of Property
 Pond ID: SWP13S008

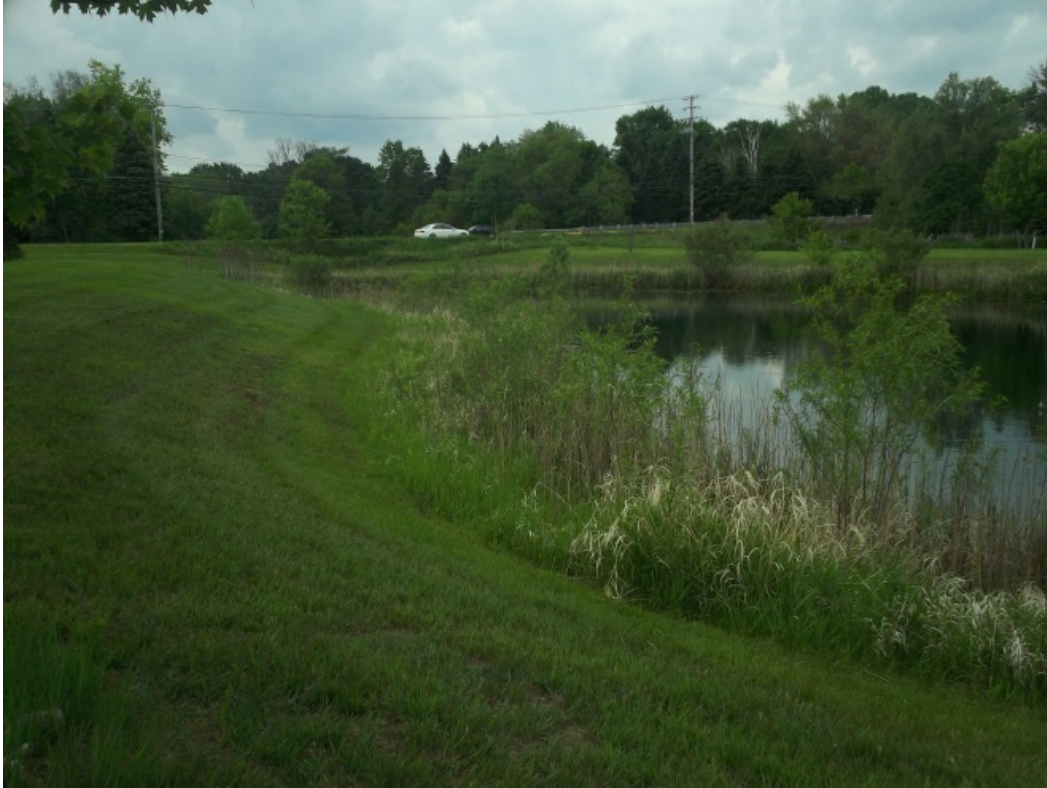
Figure 1: Overview of Pond Looking South

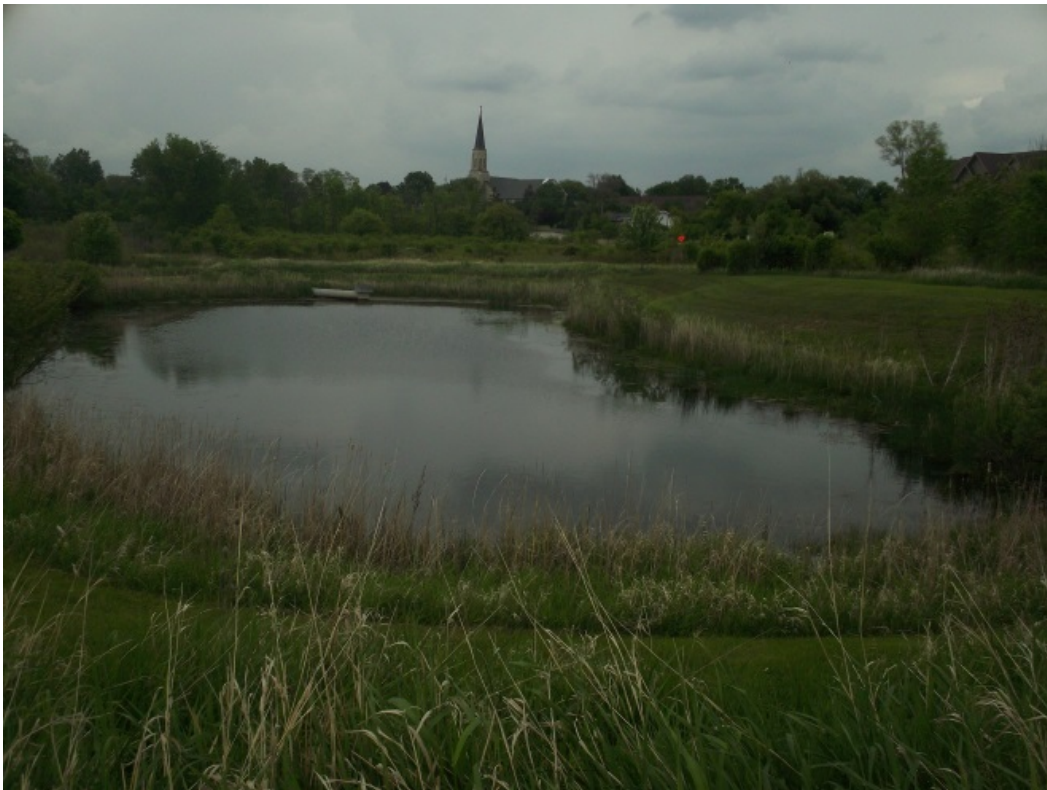
Figure 2: Overview of Pond Looking North

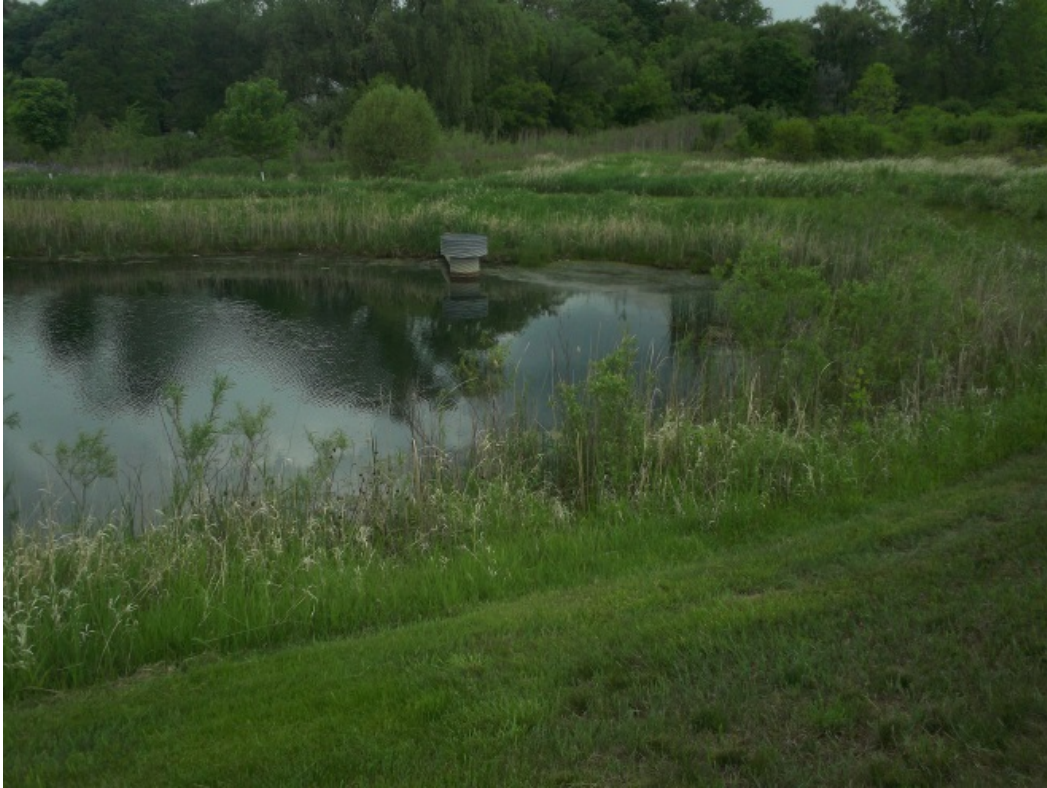
Figure 3: Outlet Structure Located on the North end of Pond

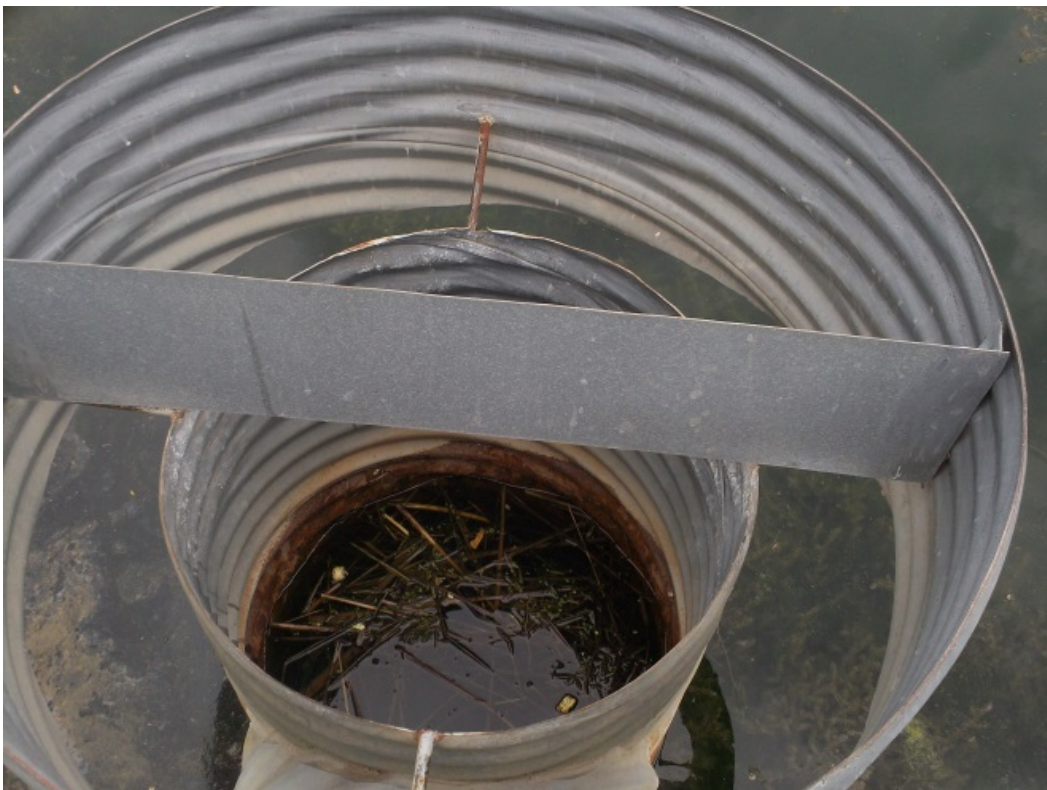
Figure 4: Top View of the Outlet Structure

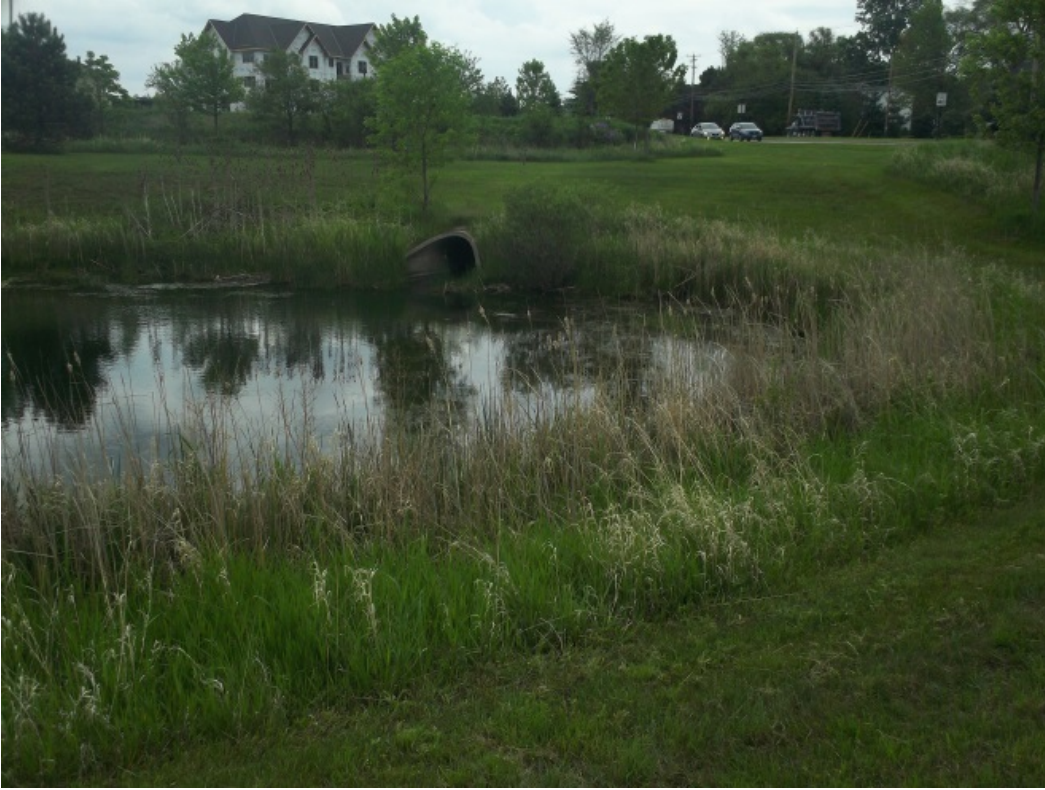
Figure 5: Outfall Located on the Southeast Portion of Pond
