STORMWATER MANAGEMENT FACILITIES OPERATION AND INSPECTION REPORT

Quarter Section SE 1/4 Sec.
13-8-20 Name of Business/Subdivision Heritage Reserve Holdings, LLC
 Property Tax ID Number MNFI00519
44052 Address of Property Heritage Reserve
 Date 6/2/15

Dry Pond	<input checked="" type="checkbox"/>	Pond ID: <u>SWP13S016</u>	Location of Pond	Located on the Northeast portion of the property, near Class road
Wet Pond	<input type="checkbox"/>			
Other	<input type="checkbox"/>

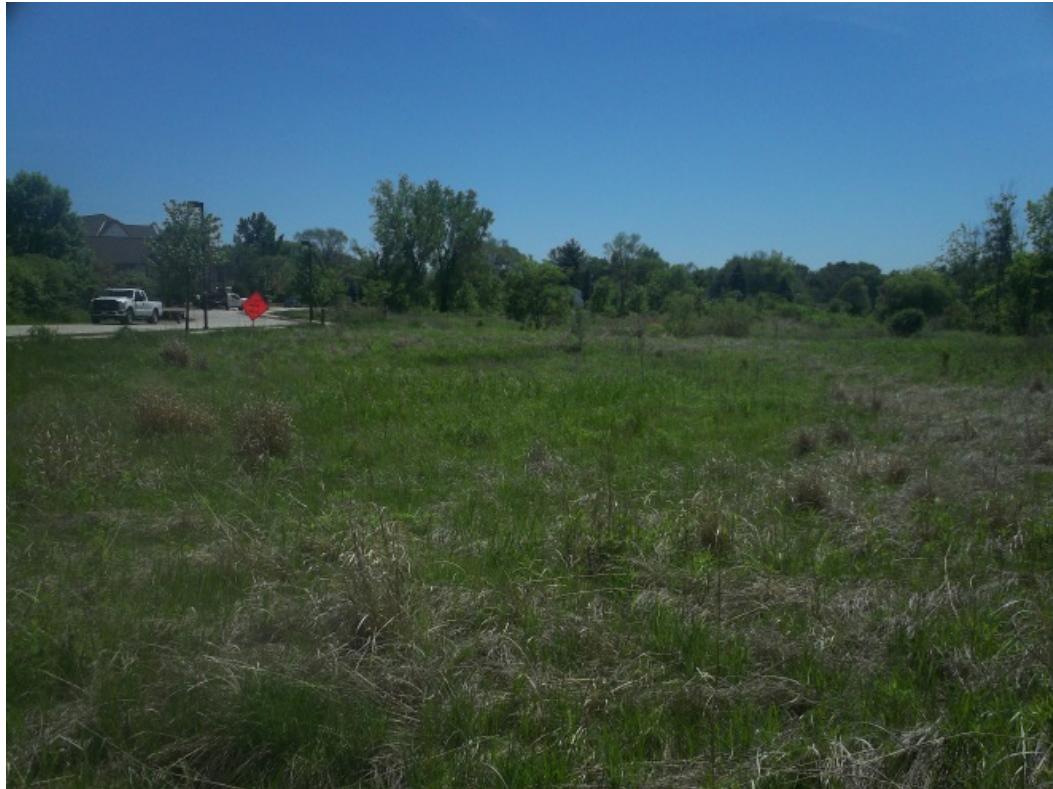
Figure 1: Overview of Pond Looking South

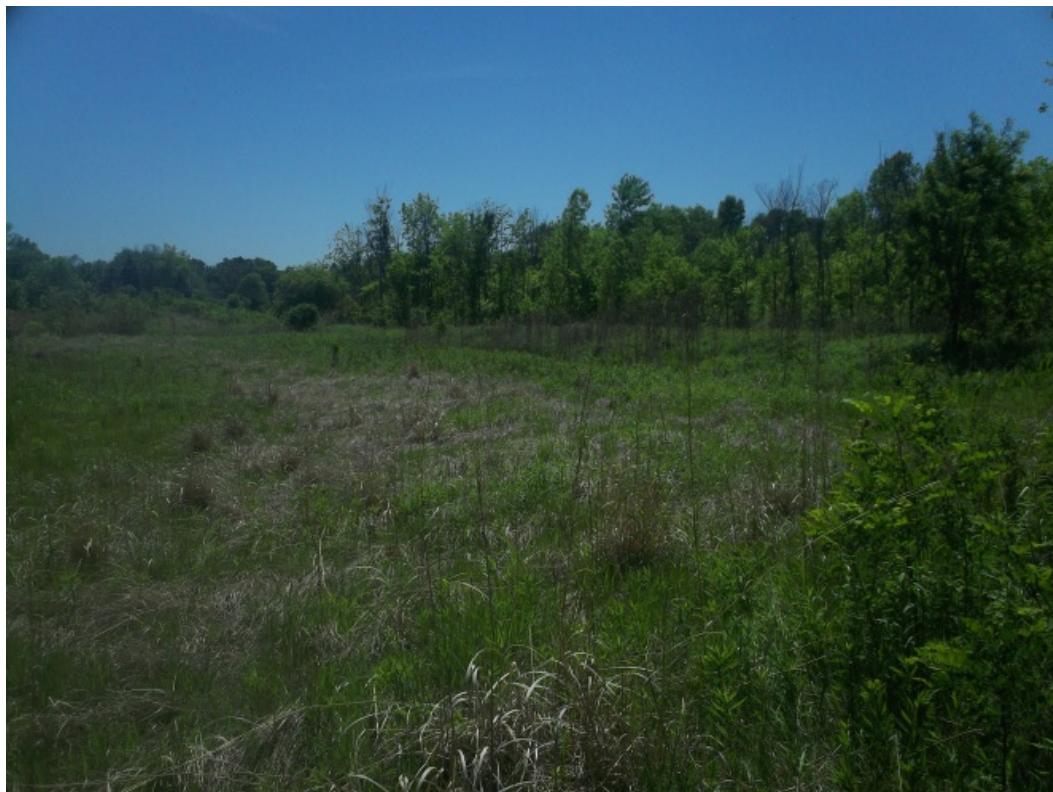
Figure 2: Overview of Pond Looking Southwest
