## STORMWATER MANAGEMENT FACILITIES OPERATION AND INSPECTION REPORT

Quarter Section SE 1/4 Sec. Name of Business/Subdivision Heritage Reserve Holdings, LLC  
13-8-20  
 Property Tax ID Number MNFV00519 Address of Property Heritage Reserve  
44002  
 Date 6/2/15

Location of Pond Located on the West Portion  
Property, East of Class Road  
 Pond ID: SWP13S018

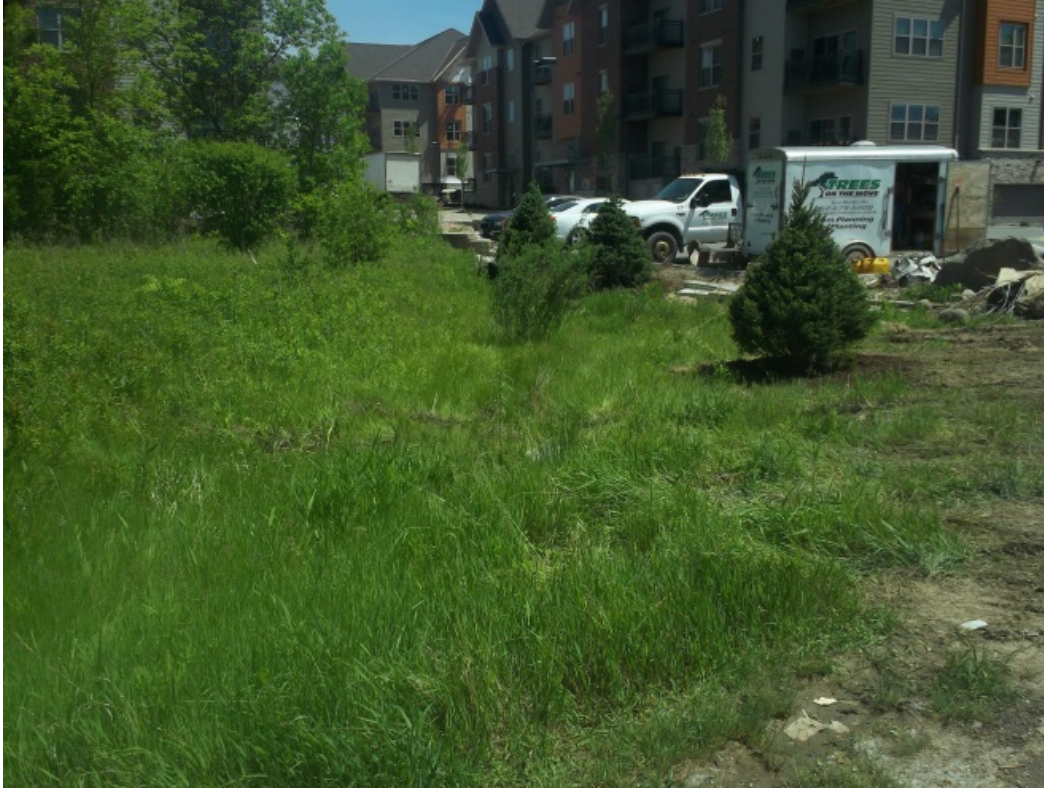
Figure 1: Overview of Pond Looking North

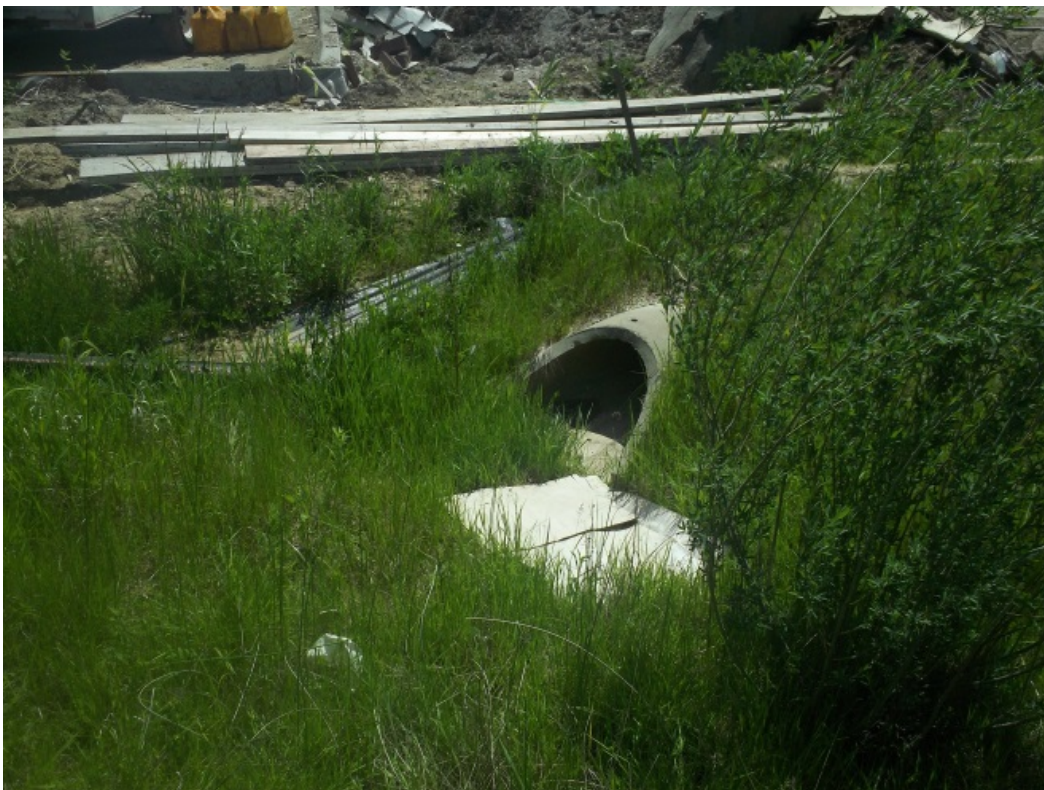
<p><i>Outlet Structure Sketch</i></p> <p><i>Outlet Structure is a Typical 15" Reinforced Concrete Pipe with End wall</i></p>	<p><i>See Attached Photo Document</i></p>
	<p><i>See Attached Photo Document</i></p>

Figure 2: 15" Reinforced Concrete Outfall Located on the Southeast Portion of Pond
