## STORMWATER MANAGEMENT FACILITIES OPERATION AND INSPECTION REPORT

Quarter Section SW 1/4 of Name of Business/Subdivision Zion Evangelical Lutheran  
Sec. 33 MNFV Congregation  
Property Tax ID Number Address of Property N48W18700 Lisbon Road  
0131991008  
Date August 2015 Menomonee Falls, WI 53051

| Other | | Pond ID: | SWP33s001 |

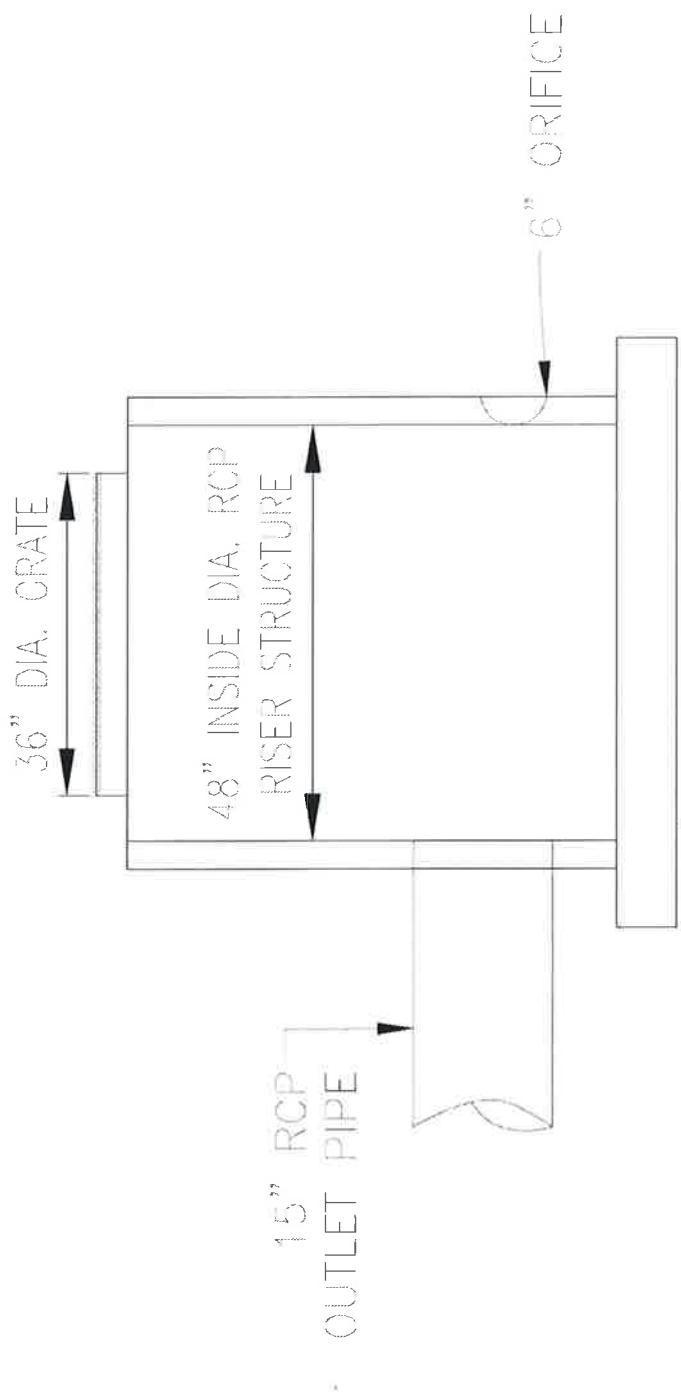
Riser Structure Sketch

| Compliance Verification | | Design | Actual | Compliant<br>Yes | No | Comments<br>( Condition of Structure) |
|---|---|---|---|---|---|--|
| Opening Diameter (inches) | 36" | 36" | X | | | Riser structure is RCP. |
| Elevation | 894.0 | 894.0 | X | | | Riser structure is in good condition, no clogging or cracking. |

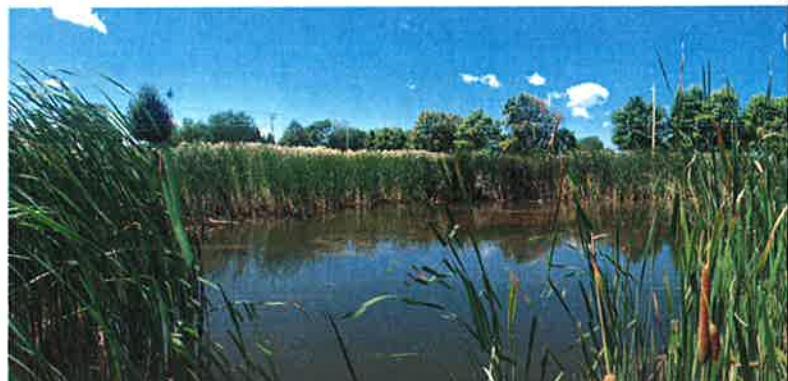
Pond

| Compliance Verification | Design | Actual | Compliant<br>Yes      No | | Comments |
|--|---|---|--|---|---|
| Opening Diameter (inches) | 6 | 6" | X | | *Normal water level was lower than design; presumed to be due to dry weather this summer. |
| Elevation | 891.0 | 890.9 | X | | Vegetation indicates typical water level is higher (near design). Continue to monitor. |
| Unauthorized Plantings, trees, or woody vegetation | | X | A lot of cattails, no other unauthorized vegetation. | | |

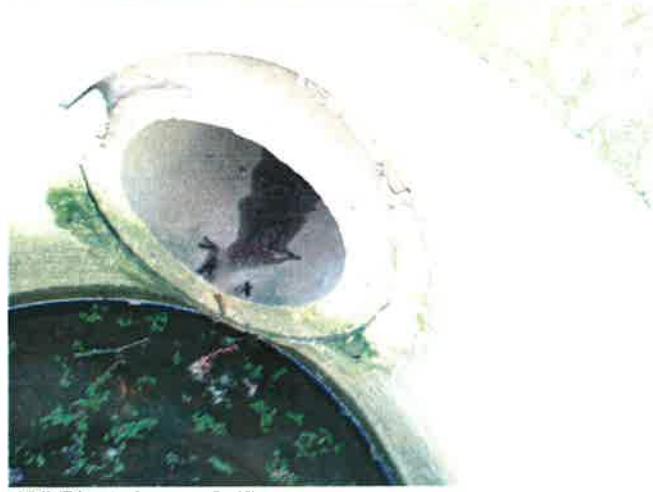
15" Riser Outlet Orifice

| Compliance Verification | | Design | Actual | Compliant<br>Yes | No | Comments<br>( Condition of Structure) |
|---|---|---|---|---|---|--|
| Opening Diameter (inches) | 15" | 15" | X | | | RCP |
