STORMWATER MANAGEMENT FACILITIES OPERATION AND INSPECTION REPORT

Quarter Section SE 1/4 Sec. Name of Business/Subdivision Heritage Reserve Holdings, LLC
13-8-20
 Property Tax ID Number MNFV00519
4002 &
MNFV00519
44052 Address of Property Heritage Reserve
 Date 5/29/2015

Location of Pond Southeast Portion of
MNFV005194002 and Southwest
Portion of MNFV0051944052
 Pond ID: SWP13S005 &
SWP13S007

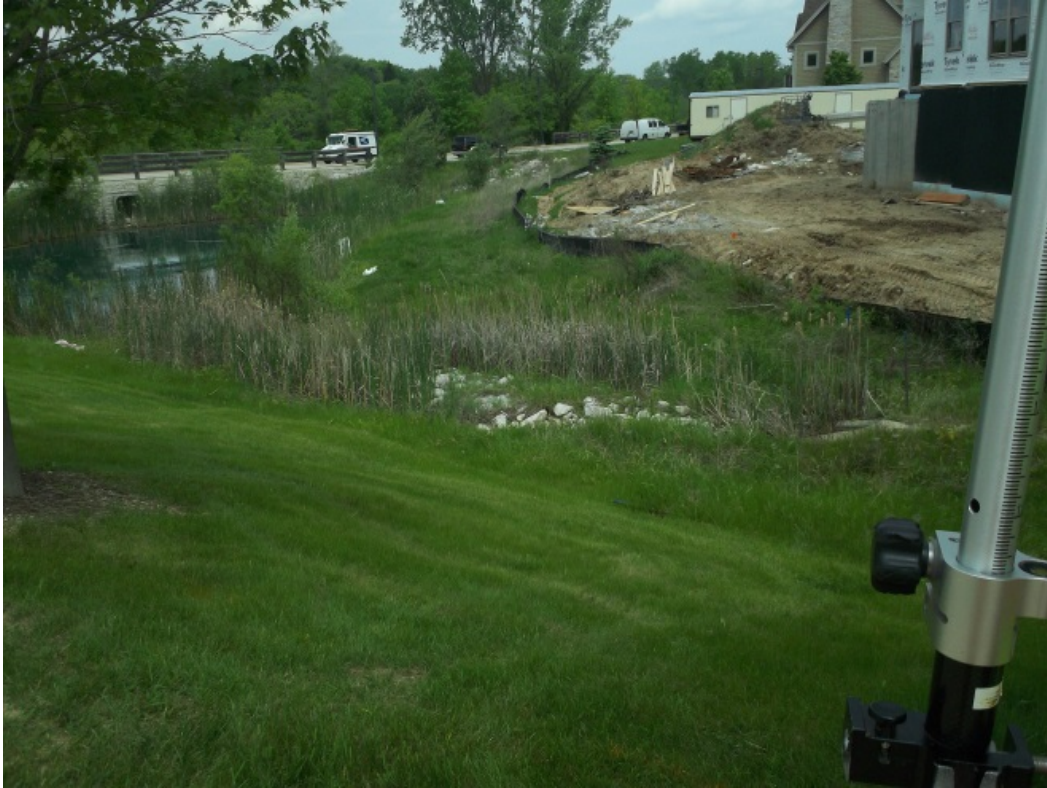
Figure 1: Overview of the Pond Looking in the Northeast Direction

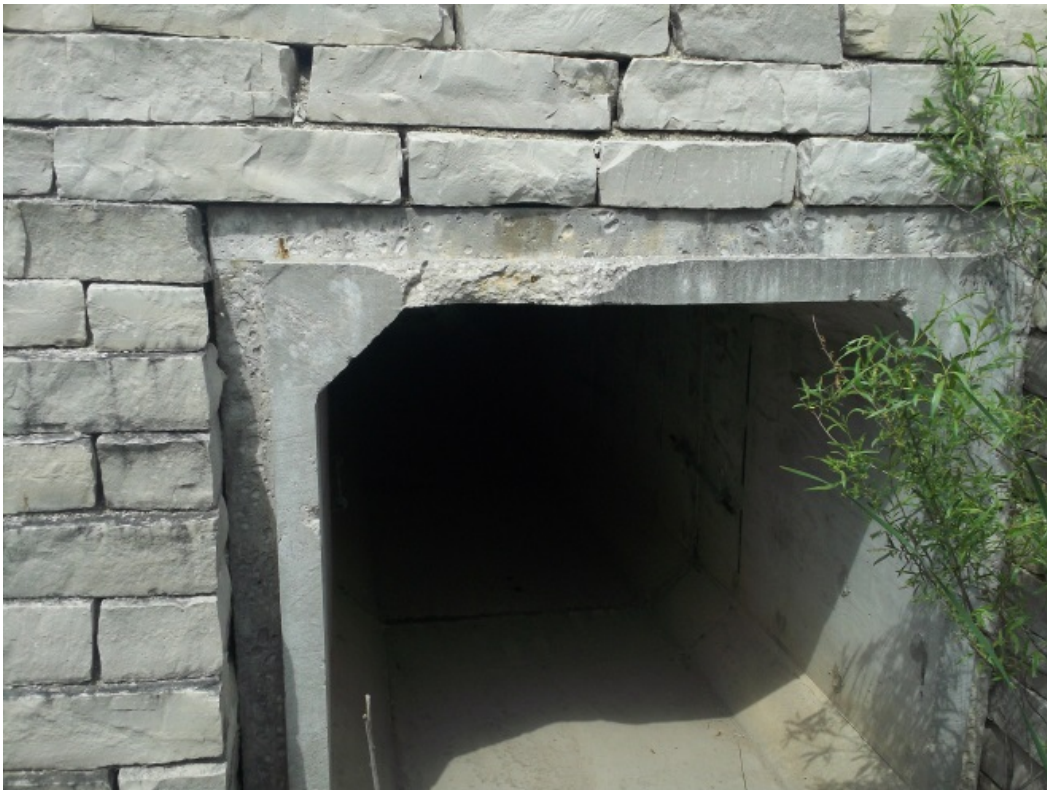
Figure 2: Image of the Equalization Structure

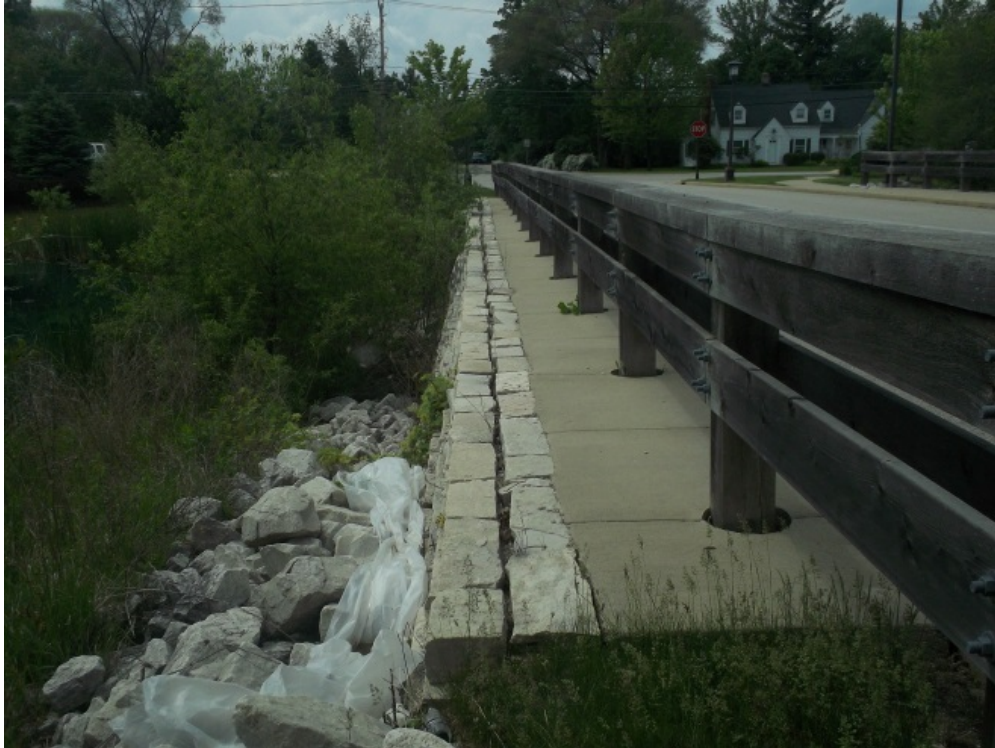
Figure 3: Photo of the Retaining Wall Looking South

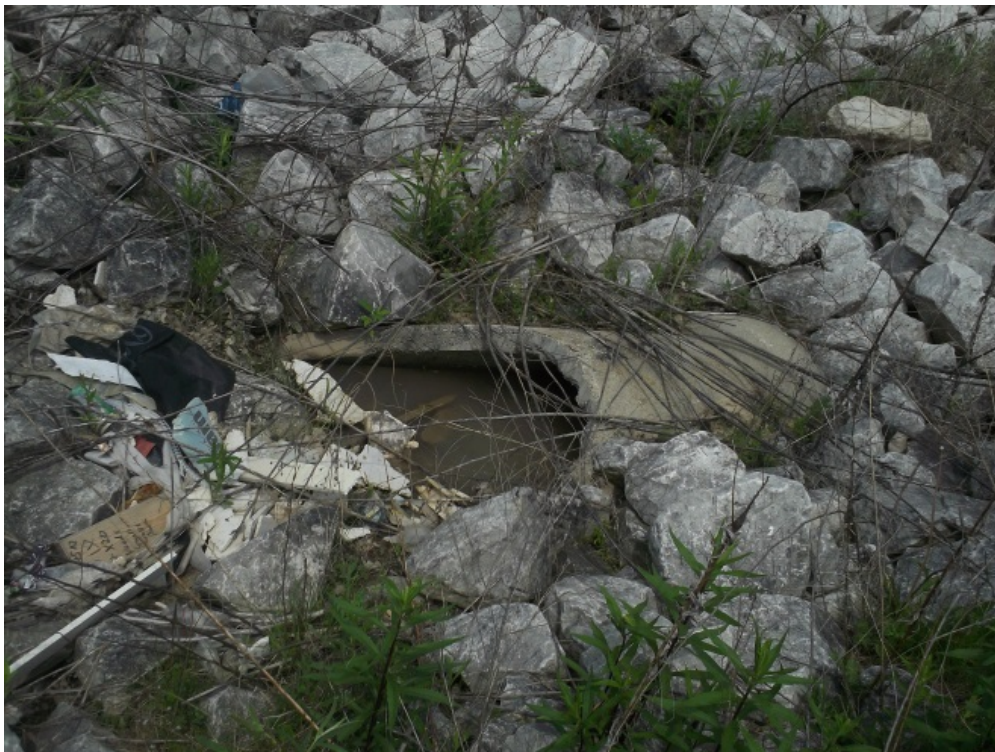
**Figure 4: North 24" RCP
(Outfall the debris)**

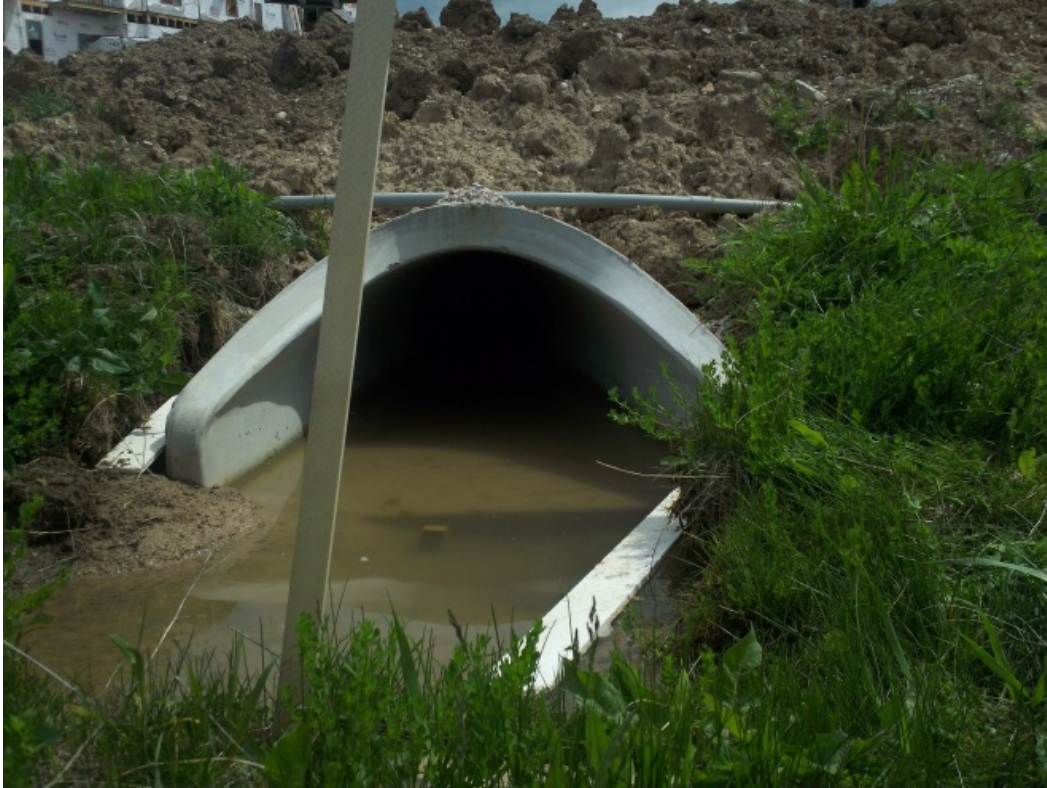
Figure 5: East 18" RCP Outfall

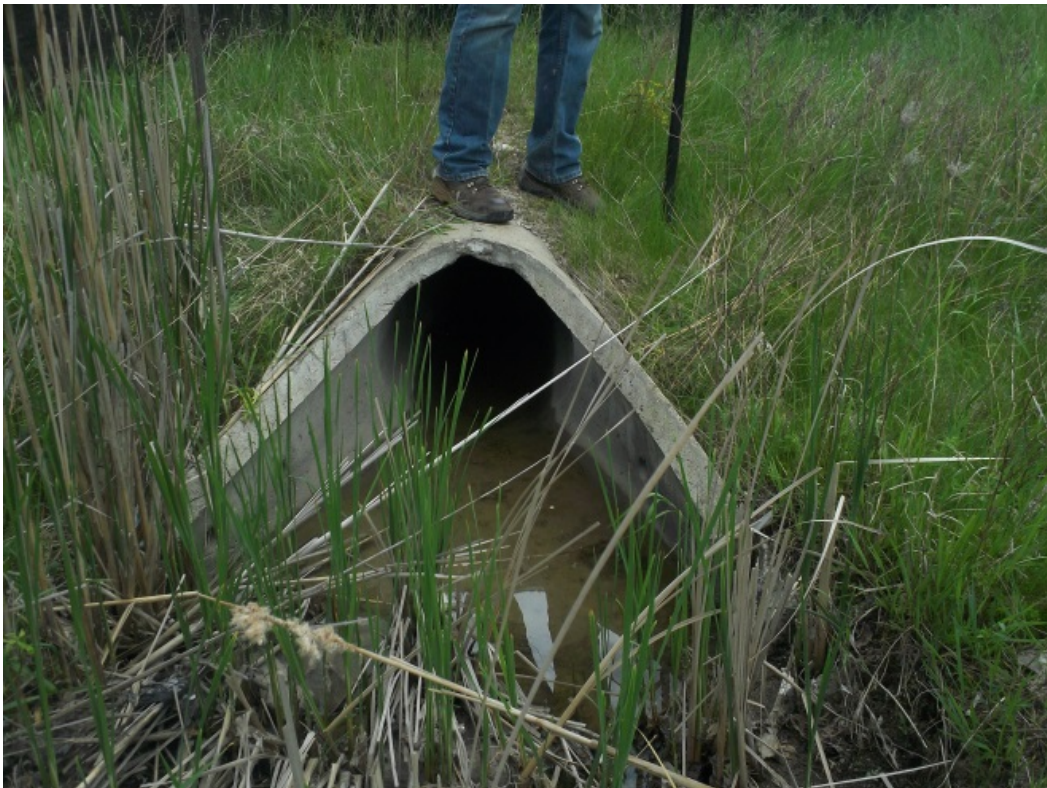
Figure 6: Southeast 18" RCP Outfall

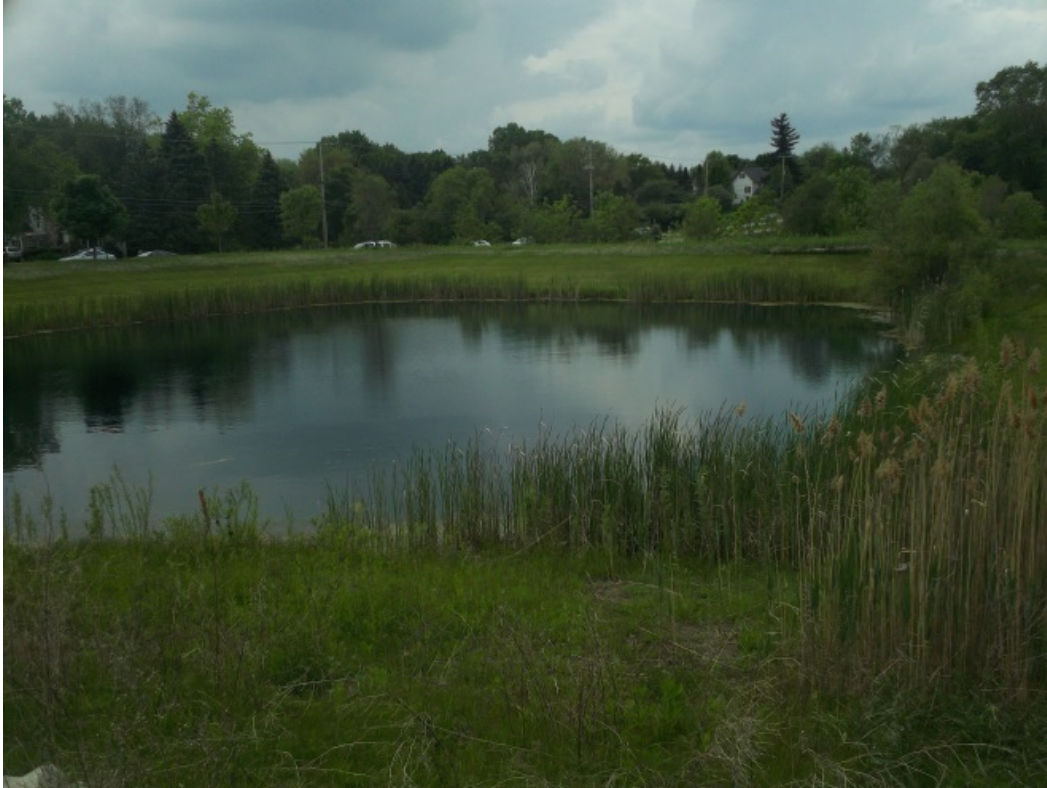
Figure 1- Overview of Pond Looking Southwest

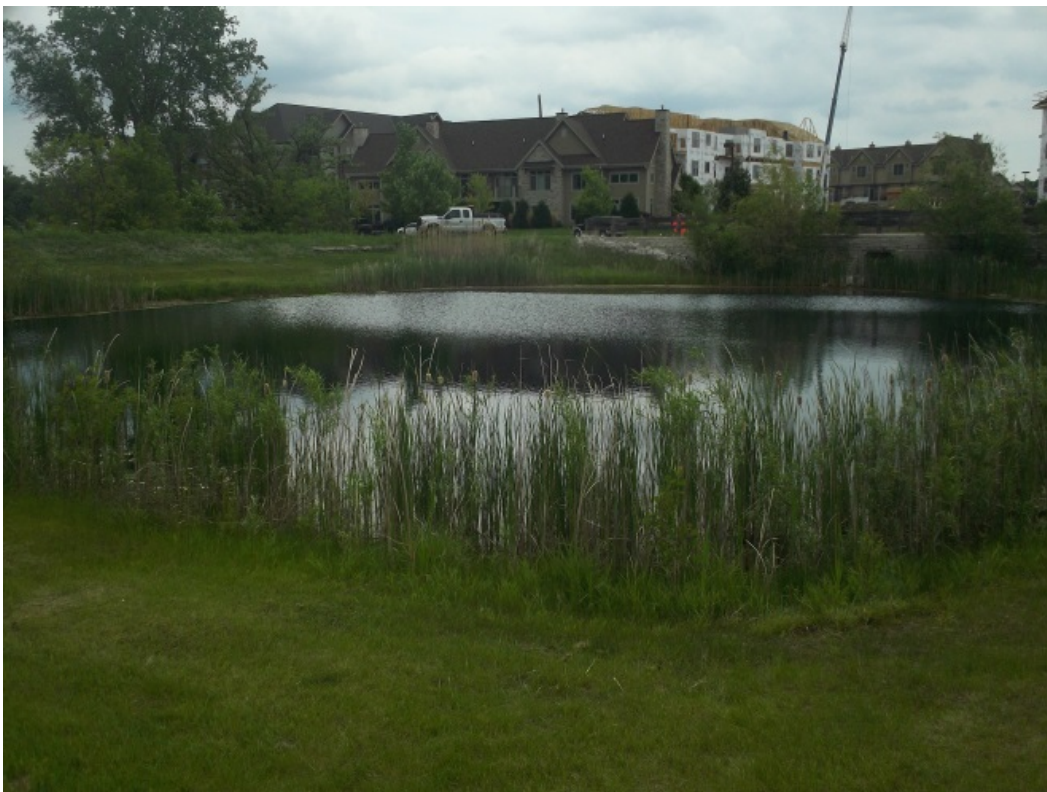
Figure 2- Overview of Pond Looking Northeast

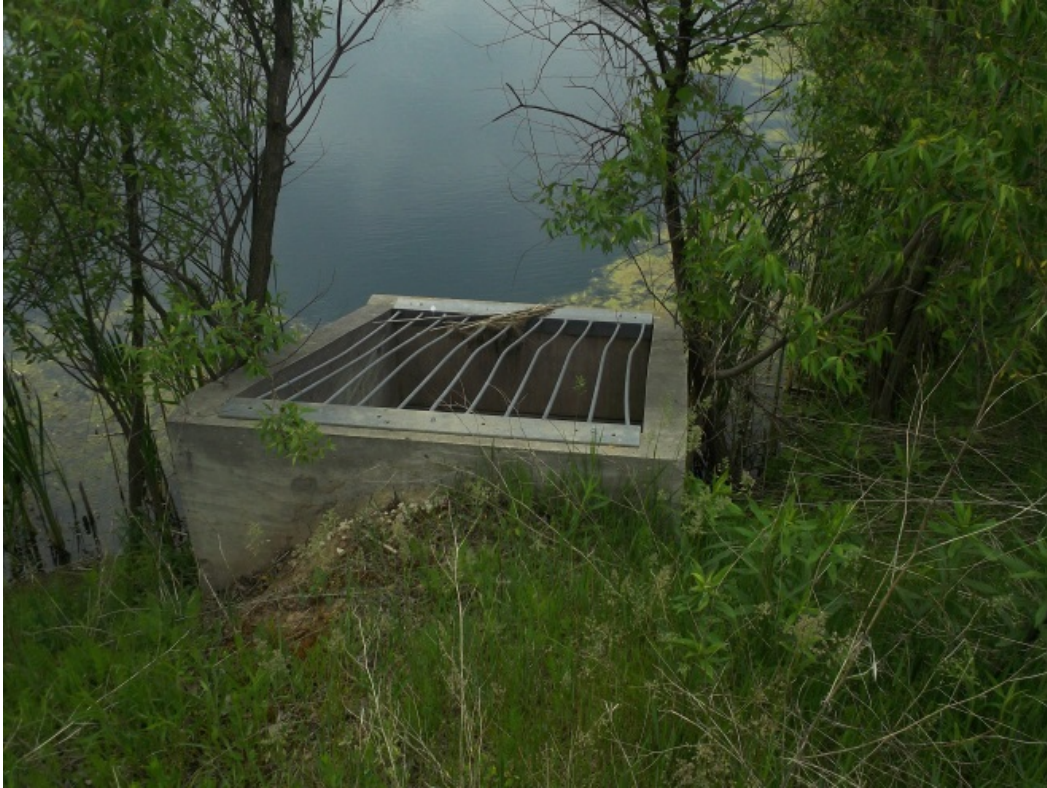
Figure 3- View of the Outlet Structure

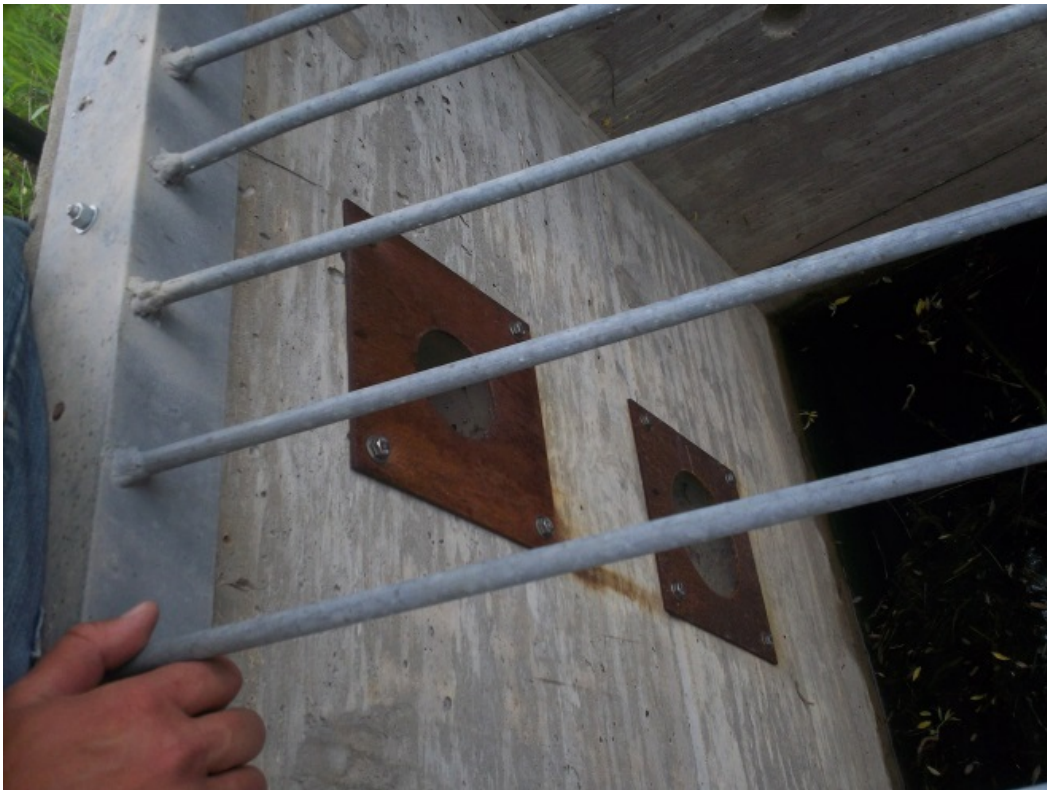
Figure 4- Image of the Interior of the Outlet Structure

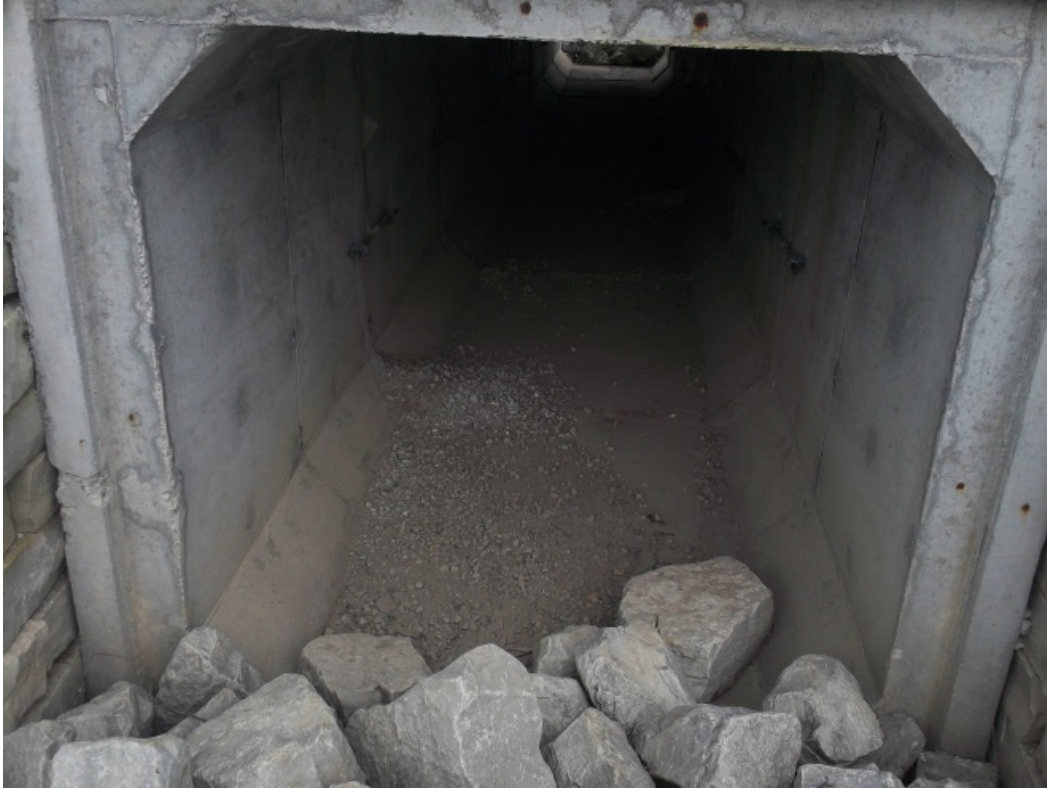
Figure 5- Equalization Pipe between SWP13S007 and SWP13S005

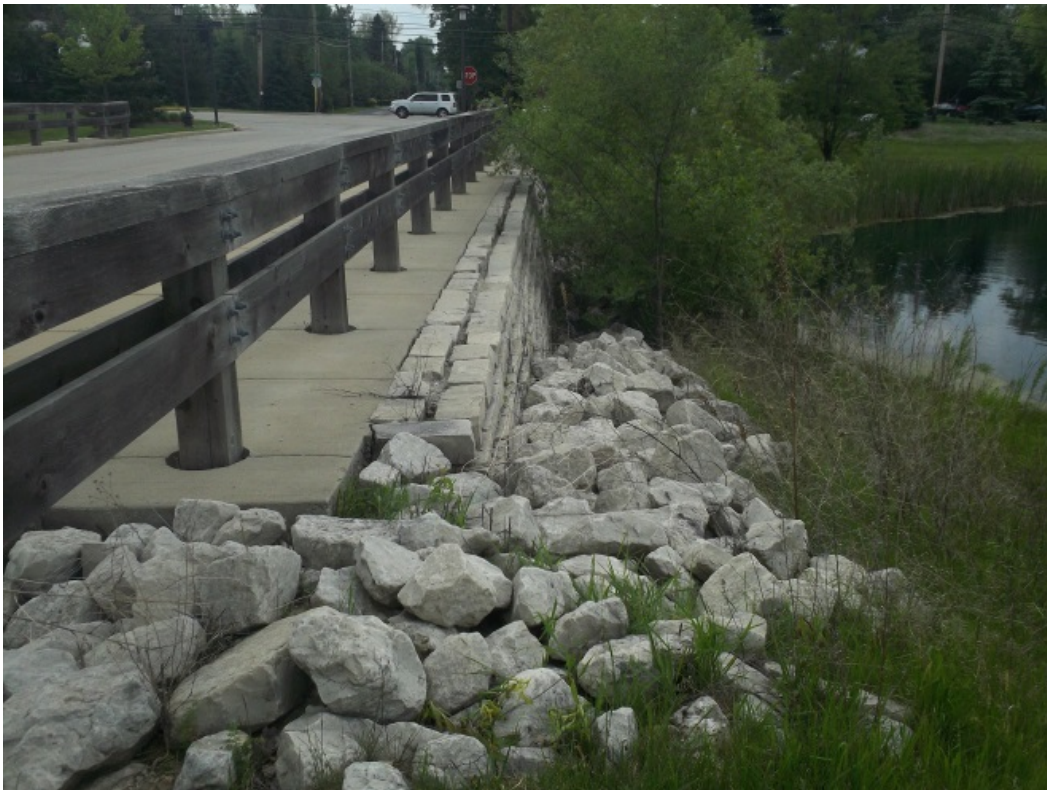
Figure 6- Photo of Retaining Wall Looking South
