Reference: Carter's Crossing Pond Inspection

We have completed our inspection of Basins 1, 2, 3 and 3a at Carter's Crossing (see attached figure). Stantec completed previous inspections of these basins in 2011. At that time, calculations demonstrating that the ponds meet post-construction requirements were submitted to the Village.

STORMWATER MANAGEMENT FACILITIES OPERATION AND INSPECTION REPORT

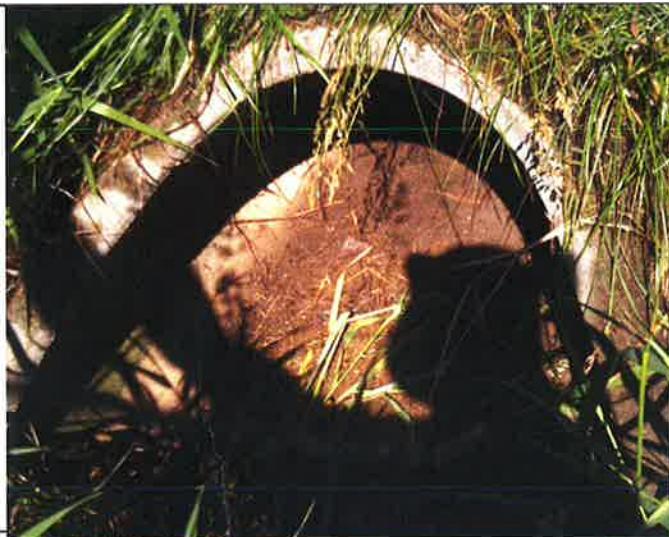
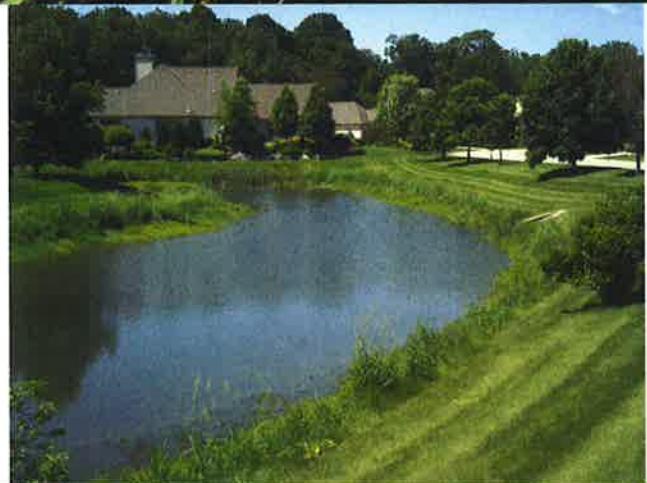
Sketch Outlet or Attach to Document

4. At Basins 3 the outfall requires repair. Seepage is occurring causing the water level to drop below the safety shelf. The source of seepage around the structure needs to be identified and repaired to eliminate seepage and the outlet structure backfill replaced and properly compacted.

Dry Pond		Location of Pond	Outlot #2 & Outlot #4
Wet Pond	X		
Other		Pond ID: <u>Basin #3</u>

Compliance Verification	Design	Actual	Compliant Yes	Comments (Condition of Structure)
Primary Outlet Pipe			X	Outlet Pipe Material
Opening Diameter (inches)	18"	18"	X	Modeling submitted with 2011 certification demonstrating compliance with post-construction requirements.
Upstream Invert	834	834.03	X	Outfall requires repair. At Basin 3 the source of seepage around the structure needs to be identified and repaired to eliminate seepage and the outlet structure backfill replaced and properly compacted. At Basin 3A, the pipe end section should be reset and strapped to prevent drifting.
Downstream Invert	833.80	833.68	X	
Length (feet)	44	44	X	
Slope (%)	0.5	0.8	X	Note: Because of its condition, the outlet structures are not compliant.
Secondary Outlet Pipe	(If Applicable)			Outlet Pipe Material
Opening Diameter (inches)				
Upstream Invert				
Downstream Invert				
Length (feet)				
Slope (%)				
Riser	(If Applicable)			Riser Material

5. At Basins 3A the outfall requires repair. The pipe end section should be reset and strapped to prevent drifting.
6. At Basin 3 animal burrows were found. If left unchecked animal burrows could cause destabilization and failure of the pond bank. The owner should consult with a professional pest control expert to eradicate any burrowing animals from the pond area.

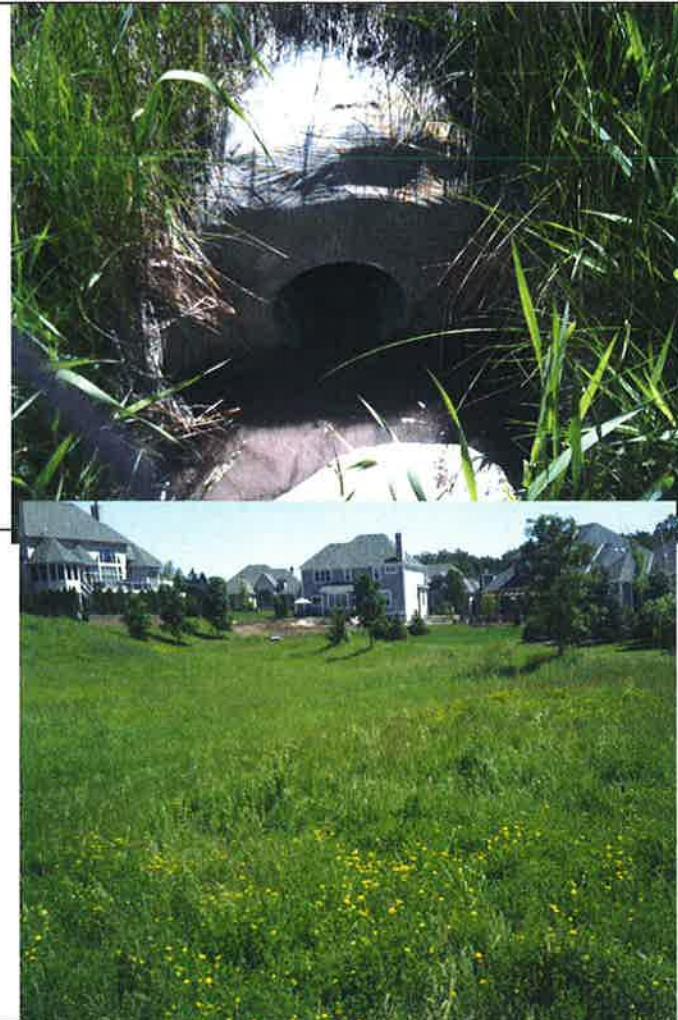
Sketch Outlet or Attach to Document

Dry Pond	X	Location of Pond	Outlet #2
Wet Pond			
Other		Pond ID: <u>Basin #2</u>

Compliance Verification	Design	Actual	Compliant Yes No		Comments
Lower Discharge Control	(If Applicable)				
Opening Diameter (inches)					
Elevation					
Other (Description)					
Opening Type and Size (inches)					
Elevation					
Emergency Spillway					
Elevation	-	843.66	X		
Length of spillway (feet)	-	38'	X		
Embankment	Present Yes no		Comments/Maintenance Requirements		
Unauthorized Plantings, trees, or woody vegetation	X		Remove trees		
Animal burrows or slope erosion		X			
Storm Sewer Outfalls	Type & Size		Location		Comments
Outfall 1					
Outfall 2					
Outfall 3					
Storage Properties	Design	Actual	Compliant Yes No	Not Applicable	Equipment Used
Normal Water Elevation (Wet Ponds)	-	-	X		
Design High Water Elevation	842.89	843.66	X		
Area at Normal Water Elevation (Ac) (Wet Ponds)	-	-	X		
Area at Design High Water Elevation (Ac)	0.683	0.767	X		
Active Storage Available (Ac-Ft)*	1.006	1.005	X		
Lowest Elevation at Top of Embankment (If Applicable)	-	843.66	X

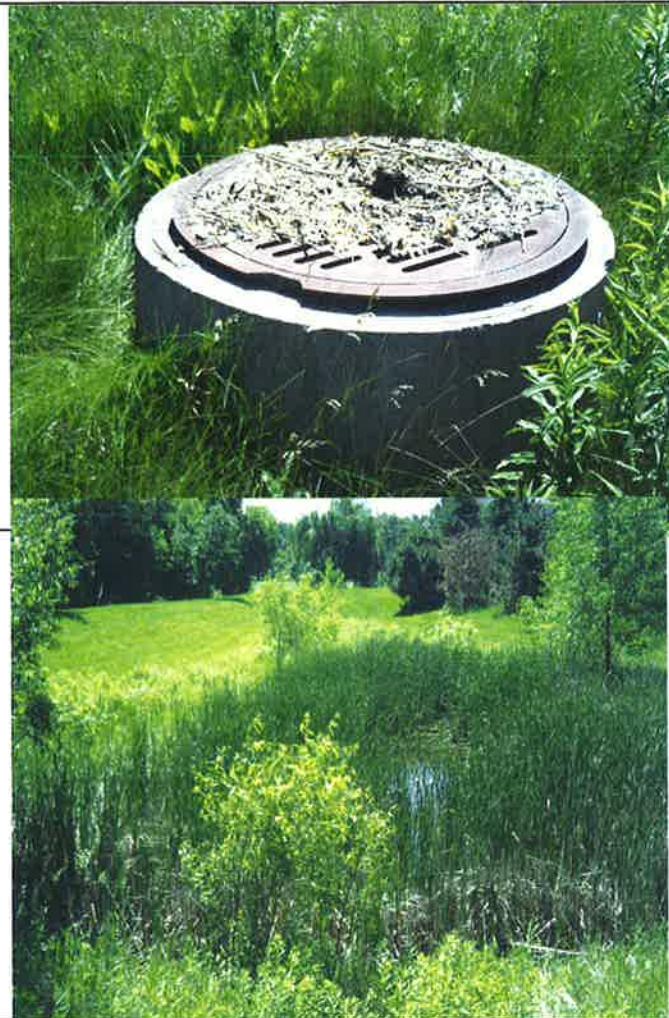
Sketch Outlet or Attach to Document

1. At Basin 1 the permanent pool has reached a depth of less than three feet and requires dredging to establish a depth that encourages settling of solids. The Wisconsin Department of Natural Resources recommends a permanent pool depth of 5 feet: 3 feet for settling of solids and 2 feet for storage of solids. Basin 1 should be dredged to a permanent pool depth of 5 feet.

Dry Pond		Location of Pond	Outlot #5
Wet Pond	X		
Other		Pond ID: <u>Basin #1</u>

Compliance Verification	Design	Actual	Compliant Yes	Non-Compliant No	Comments (Condition of Structure)
Primary Outlet Pipe					Outlet Pipe Material
Opening Diameter (inches)	12" w/ 10" Opening	12"	X		Modeling submitted with 2011 certification demonstrating compliance with post-construction requirements.
Upstream Invert	840	839.93	X		
Downstream Invert	837	838.06	X		
Length (feet)	80'	61'	X		
Slope (%)	3.75	3.07	X		
Secondary Outlet Pipe	(If Applicable)				Outlet Pipe Material
Opening Diameter (inches)					
Upstream Invert					
Downstream Invert					
Length (feet)					
Slope (%)					
Riser	(If Applicable)			X	Riser Material
Opening Diameter (inches)	36"	36"	X		Remove debris accumulated on riser.
Elevation	842	842	X		Note: Because of its condition, the riser is not compliant.
Upper Discharge Control	(If Applicable)				
Opening Diameter (inches)					
Elevation

Compliance Verification	Design	Actual	Compliant Yes No	Comments	
Lower Discharge Control	(If Applicable)				
Opening Diameter (inches)	2"	3.5"	X		
Elevation	840	839.67	X		
Other (Description)					
Opening Type and Size (inches)					
Elevation					
Emergency Spillway					
Elevation	844.6	844.21	X		
Length of spillway (feet)	20'	22'	X		
Embankment	Present Yes no		Comments/Maintenance Requirements		
Unauthorized Plantings, trees, or woody vegetation	X		Remove trees. Note: Because of its condition, the embankment is not compliant.		
Animal burrows or slope erosion		X			
Storm Sewer Outfalls	Type & Size		Location		Comments
Outfall 1					
Outfall 2					
Outfall 3					
Storage Properties	Design	Actual	Compliant Yes No	Not Applicable	Equipment Used
Normal Water Elevation (Wet Ponds)	840	839.67	X		The permanent pool has reached a depth of less than three feet and requires dredging to establish a depth that encourages settling of solids. The Wisconsin Department of Natural Resources recommends a permanent pool depth of 5 five feet: 3 feet for settling of solids and 2 feet for storage of solids. Basin 1 should be dredged to a permanent pool depth of 5 feet. Note: Because of its condition, the wet pond depth is not compliant.

2. At Basin 1 debris should be removed from the riser.
3. At Basin 1, woody vegetation within the pond footprint should be removed unless permitted by the Village.
