STORMWATER MANAGEMENT FACILITIES OPERATION AND INSPECTION REPORT

NW 3, 8-20 Name of Business/Subdivision STEINHAFELS FURNITURE
0010-971 Address of Property N93W16677 RICHFIELD WAY
MENOMEE FALLS, WI

Dry Pond		Location of Pond	Behind Steinhafels Building
Wet Pond	X		
Other		Pond ID: <u>SWP3N001</u>

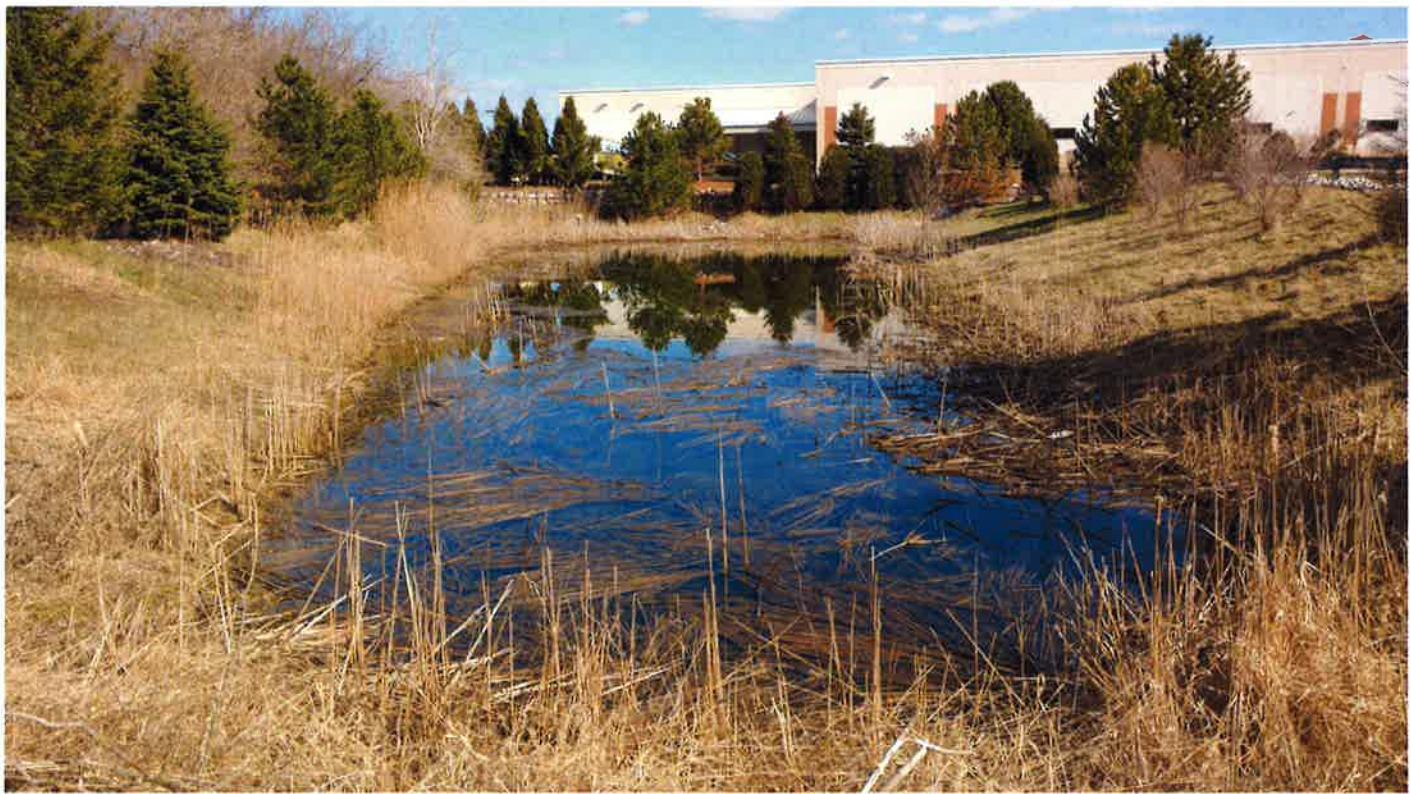
Pond SWP3N001 – Looking Northeast from Outlet Structure

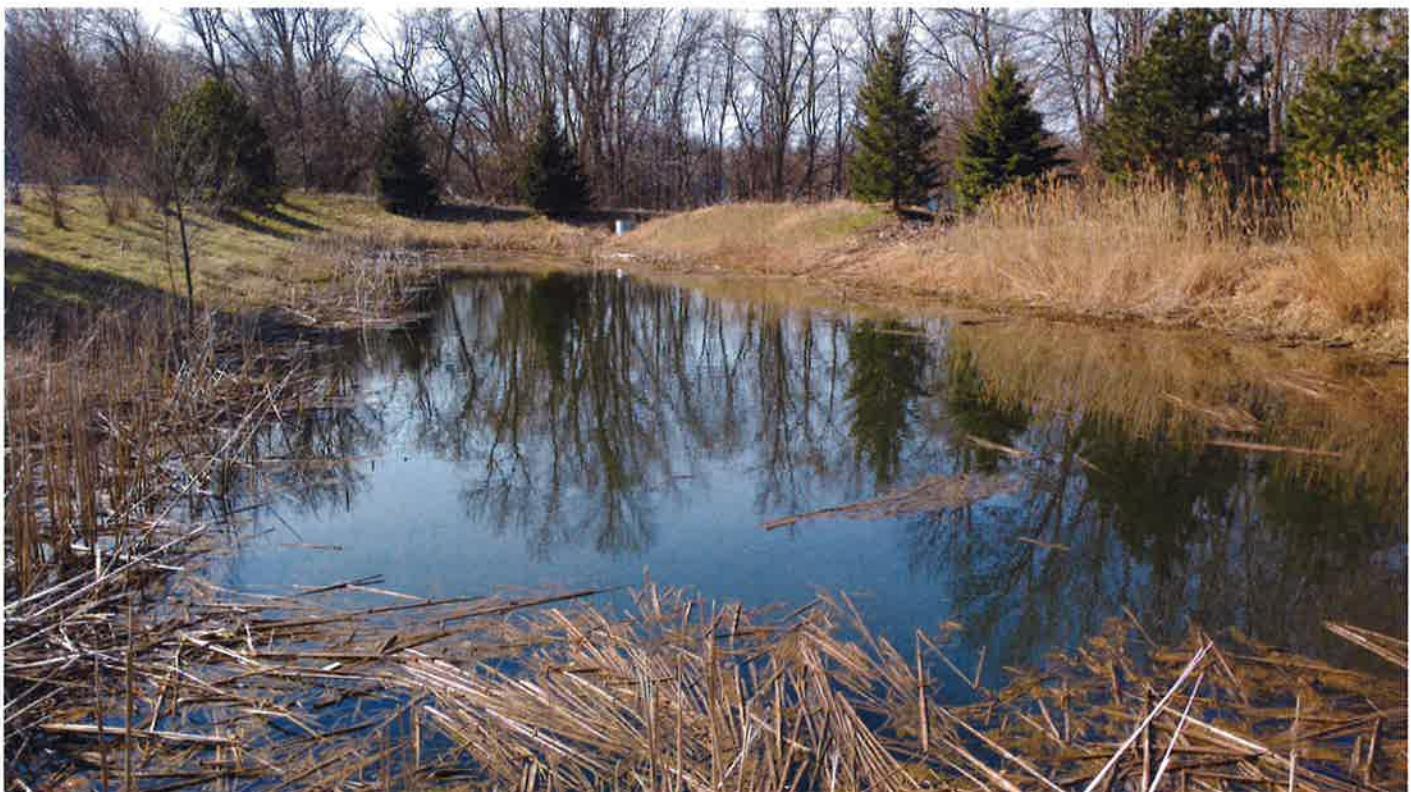
Pond SWP3N001 – Looking Southwest towards Outlet Structure

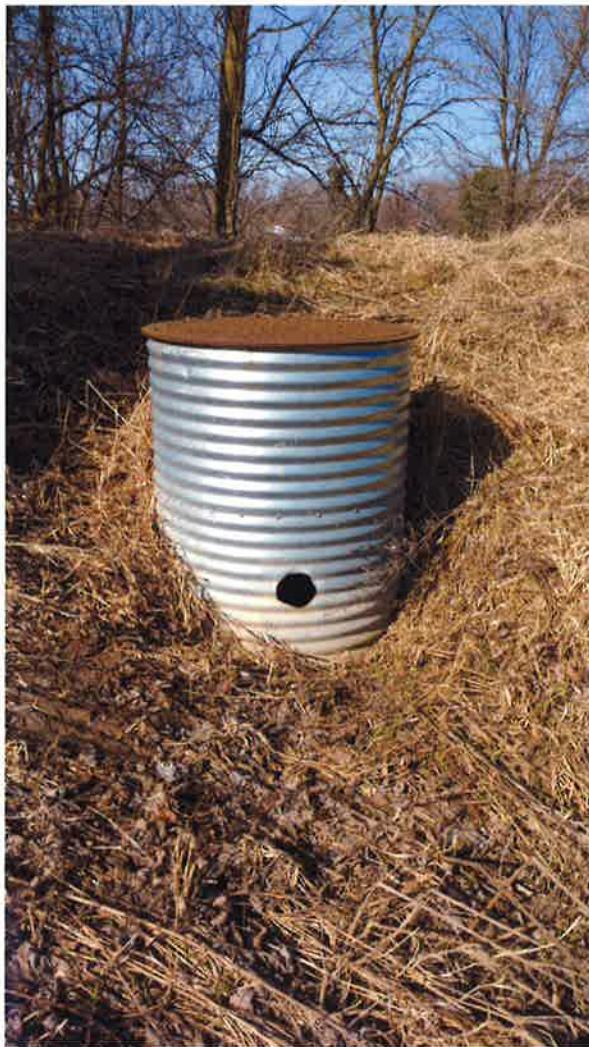
Pond SWP3N001 – 42" CMP Outlet Structure

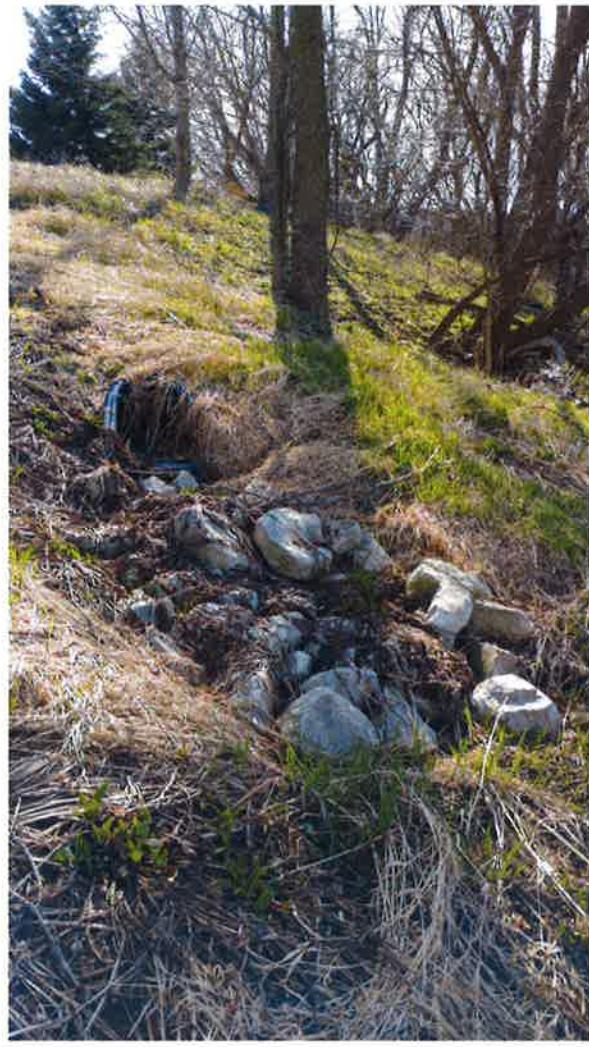
Compliance Verification	Design	Actual	Compliant Yes	No	Comments (Condition of Structure)
Primary Outlet Pipe					Outlet Pipe Material: Corrugated Plastic Pipe
Opening Diameter (inches)	12"	12"	X		Pipe is in good shape. No sediment present inside of the pipe.
Upstream Invert	840.40	840.08	X		
Downstream Invert	839.97	839.65	X		
Length (feet)	43'	44.5	X		
Slope (%)	1.00%	0.97%	X		
Secondary Outlet Pipe	(If Applicable)			Outlet Pipe Material	
Opening Diameter (inches)					
Upstream Invert					
Downstream Invert					
Length (feet)					
Slope (%)					
Riser	(If Applicable)			Riser Material : Corrugated Metal Pipe	
Opening Diameter (inches)	42"	42"	X		With the low water levels the entire outlet structure was viewable for inspection. Some minor settlement has occurred around the front structure. May want to add some light riprap around the structure. Otherwise structure is in good shape.
Elevation	846.50	846.63	X		Water elevation on April 11, 2016 surveyed at 841.44

Pond SWP3N001 – 12" Outlet Discharge End

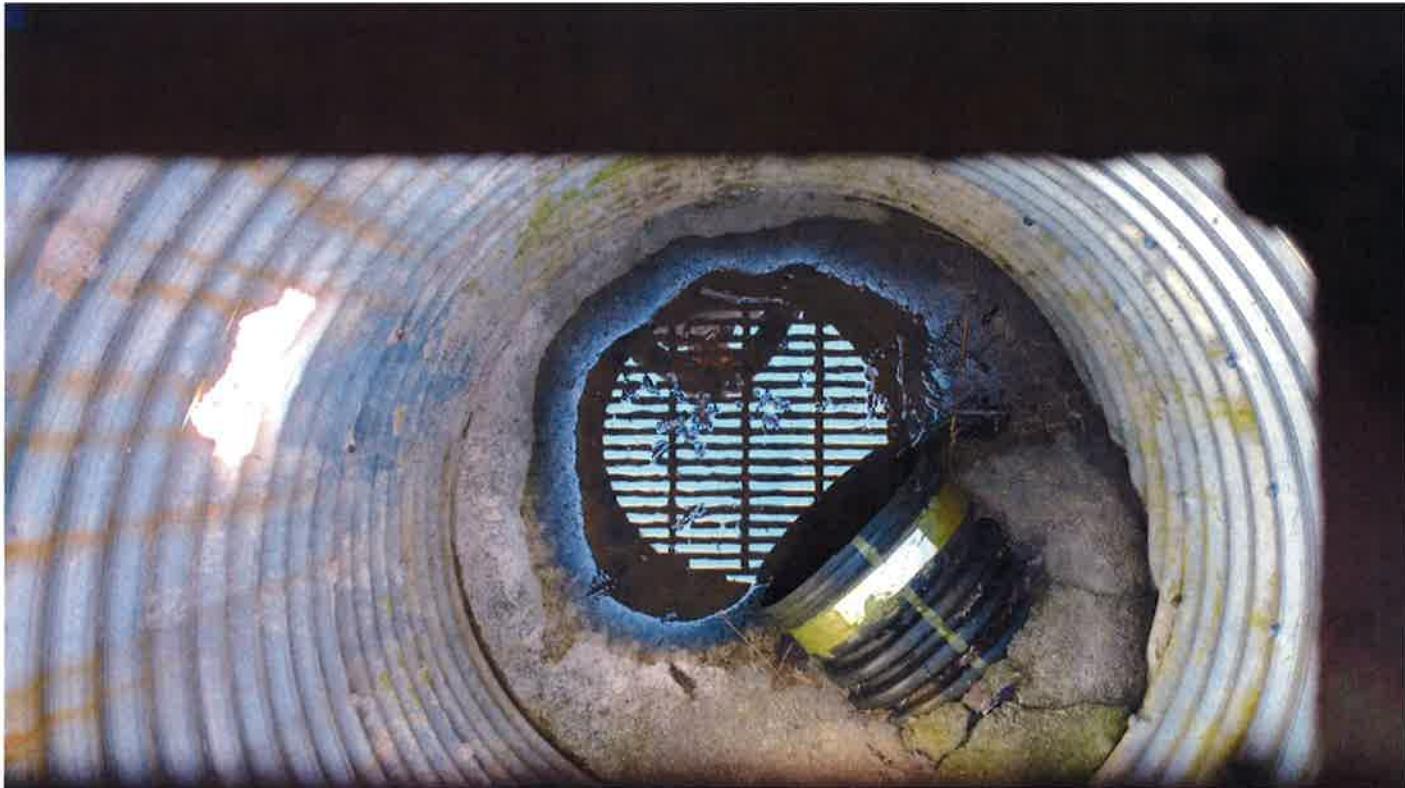
Pond SWP3N001 – Looking inside 42" CMP Outlet Structure

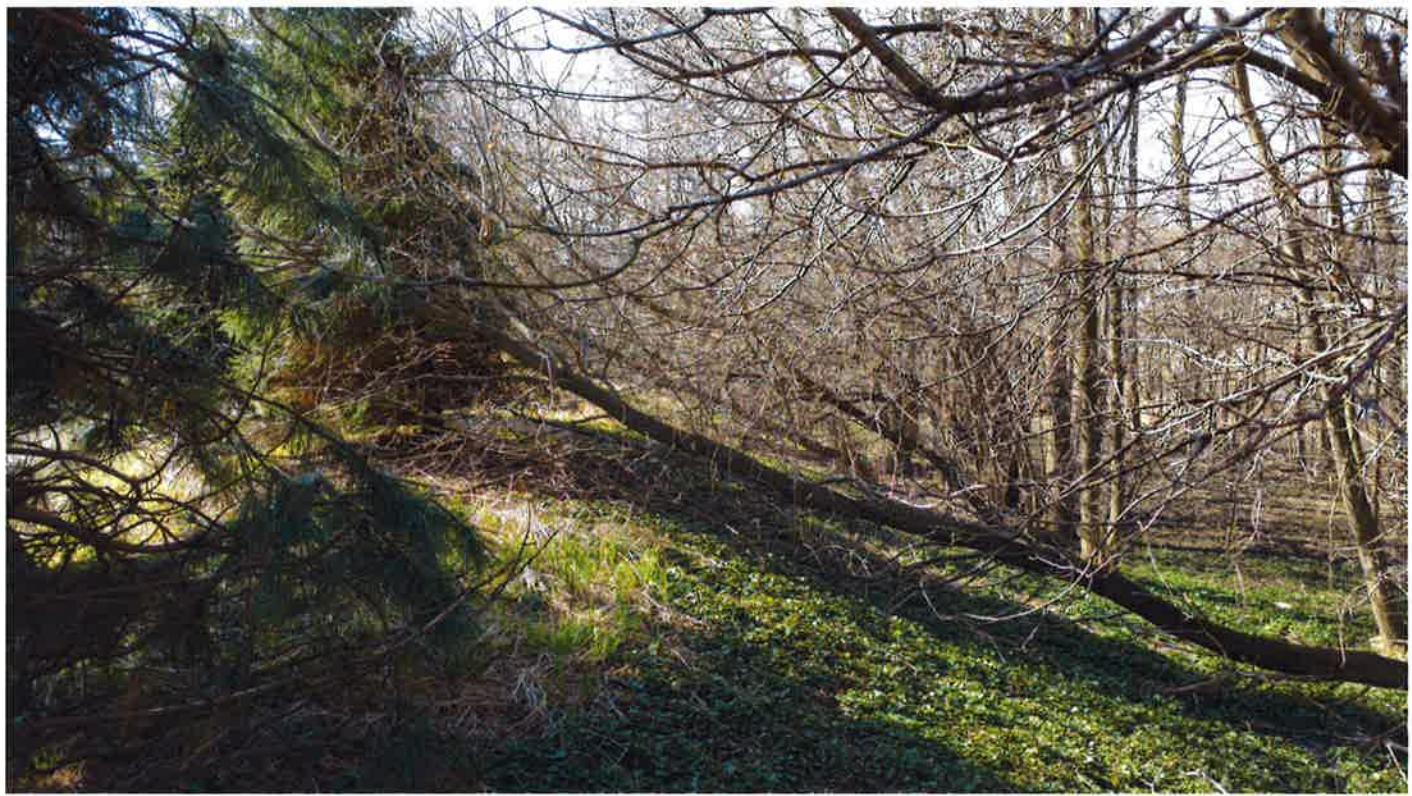
Compliance Verification	Design	Actual	Compliant Yes	No	Comments
Lower Discharge Control	(If Applicable)				
Opening Diameter (inches)					
Elevation					
Other (Description)					
Opening Type and Size (inches)					
Elevation					
Emergency Spillway					
Elevation	846.50	845.87	X		Numerous trees have fallen down on the outside of the northern berm around the emergency spillway. These should be removed.
Length of spillway (feet)	18'x17'	24'x12'	X		
Embankment	Present Yes no		Comments/Maintenance Requirements		
Unauthorized Plantings, trees, or woody vegetation	X		There are 2 small trees growing at the edge of the pond water that should be removed.		
Animal burrows or slope erosion	X		There is 1 animal burrow in the north bank that should be filled.		
Storm Sewer Outfalls	Type & Size		Location		Comments
Outfall 1					
Outfall 2					
Outfall 3					
Storage Properties	Design	Actual	Compliant Yes	No	Equipment Used

Pond SWP3N001 – Numerous trees have fallen along the Northern berm near the Emergency Spillway

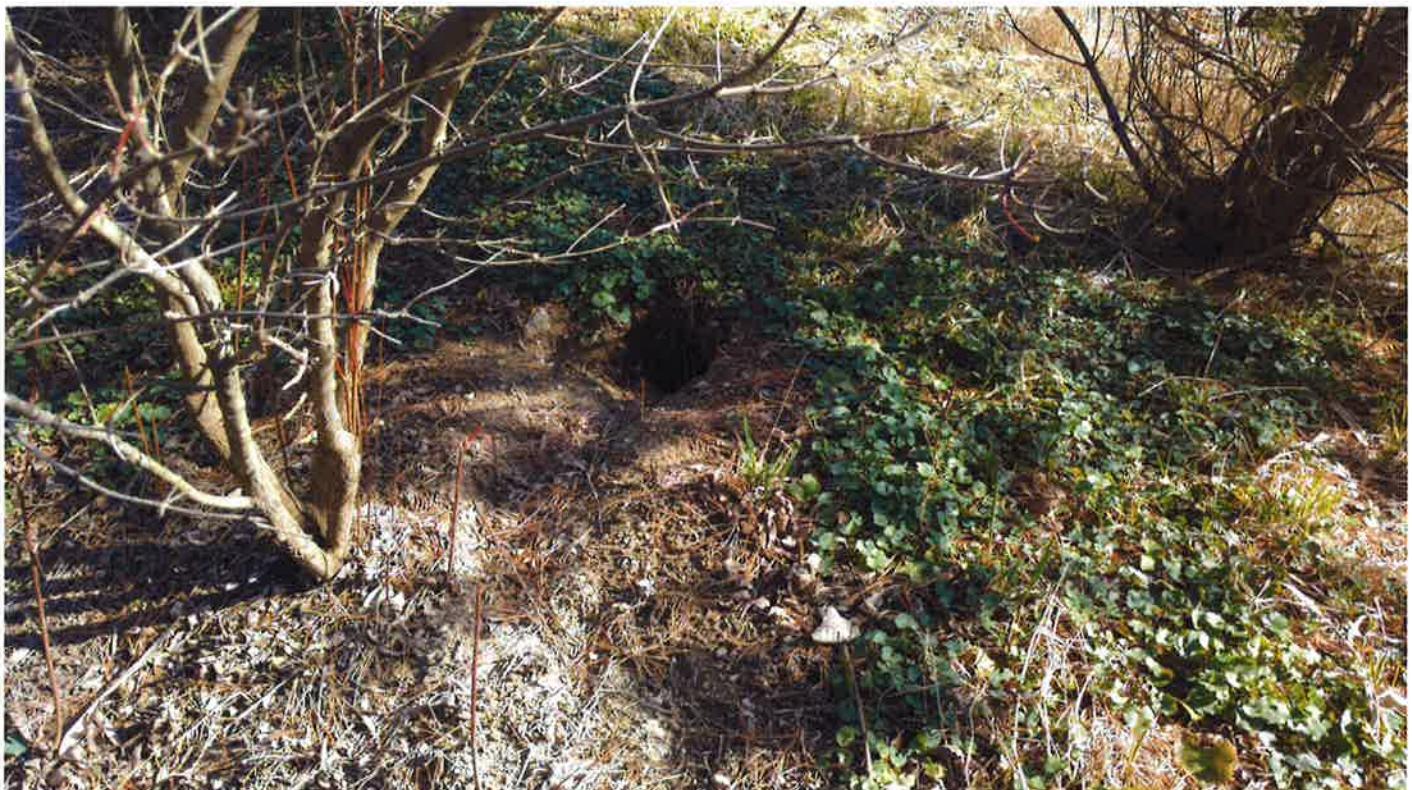
Pond SWP3N001 – Rodent burrow along the Northern berm west of the Emergency Spillway

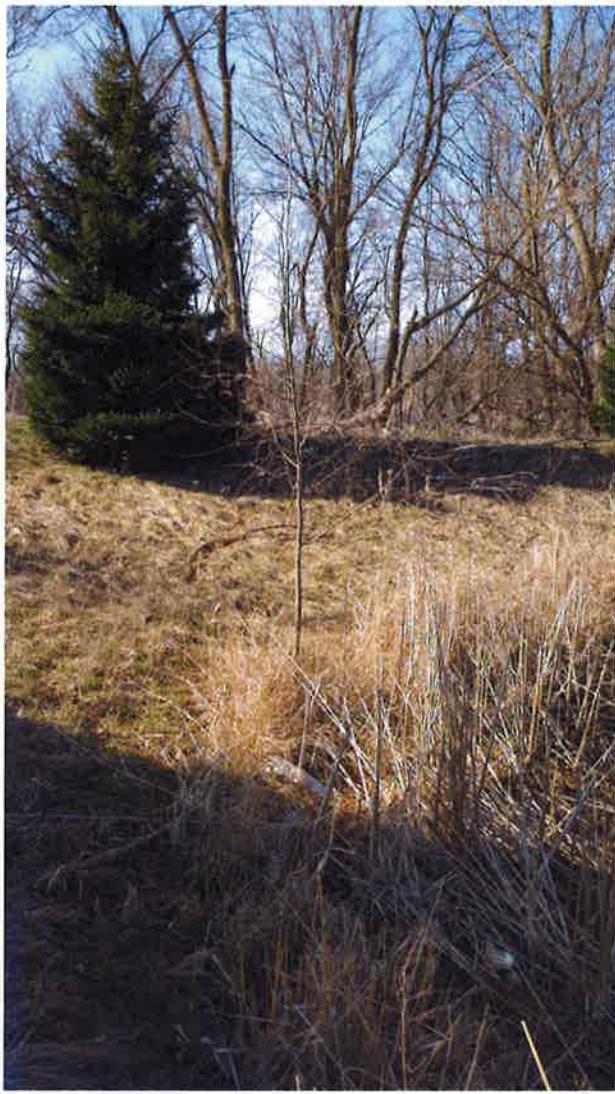
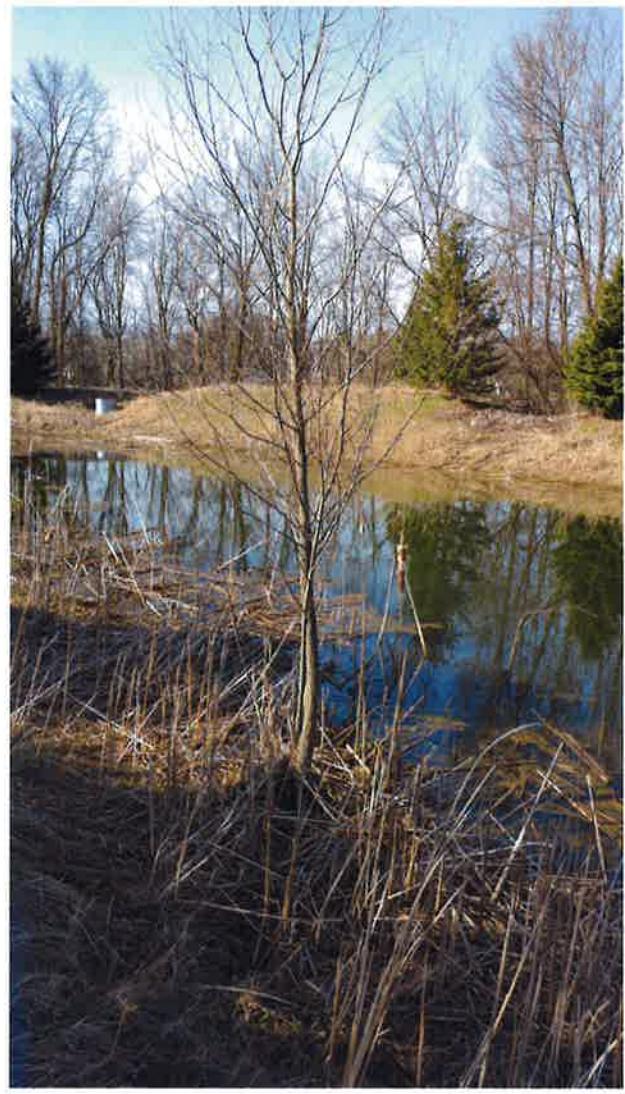
Pond SWP3N001 – Two Small Trees growing along the Southern edge of water

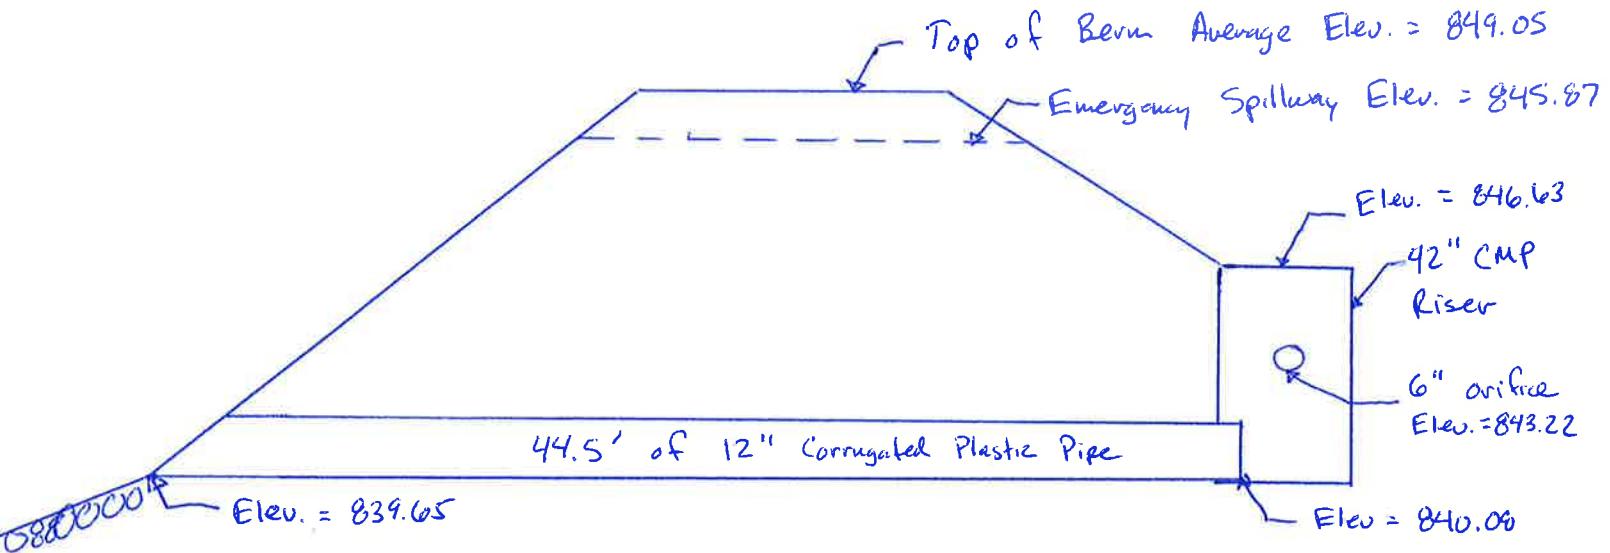
Outlet Structure Sketch

Upper Discharge Control	(If Applicable)			One 6" orifice hole in the CMP Riser Structure	
Opening Diameter (inches)	6"	6"	X		
Elevation	840.40	843.22	X
