Stormwater Management Facilities Operation and Inspection Report Porous Pavement

Location of Device: North parking area in front of building A and B

Re: Permeable Pavement Infiltration Testing at Pilgrim Spring Marketplace
MARS Project Number: 1737

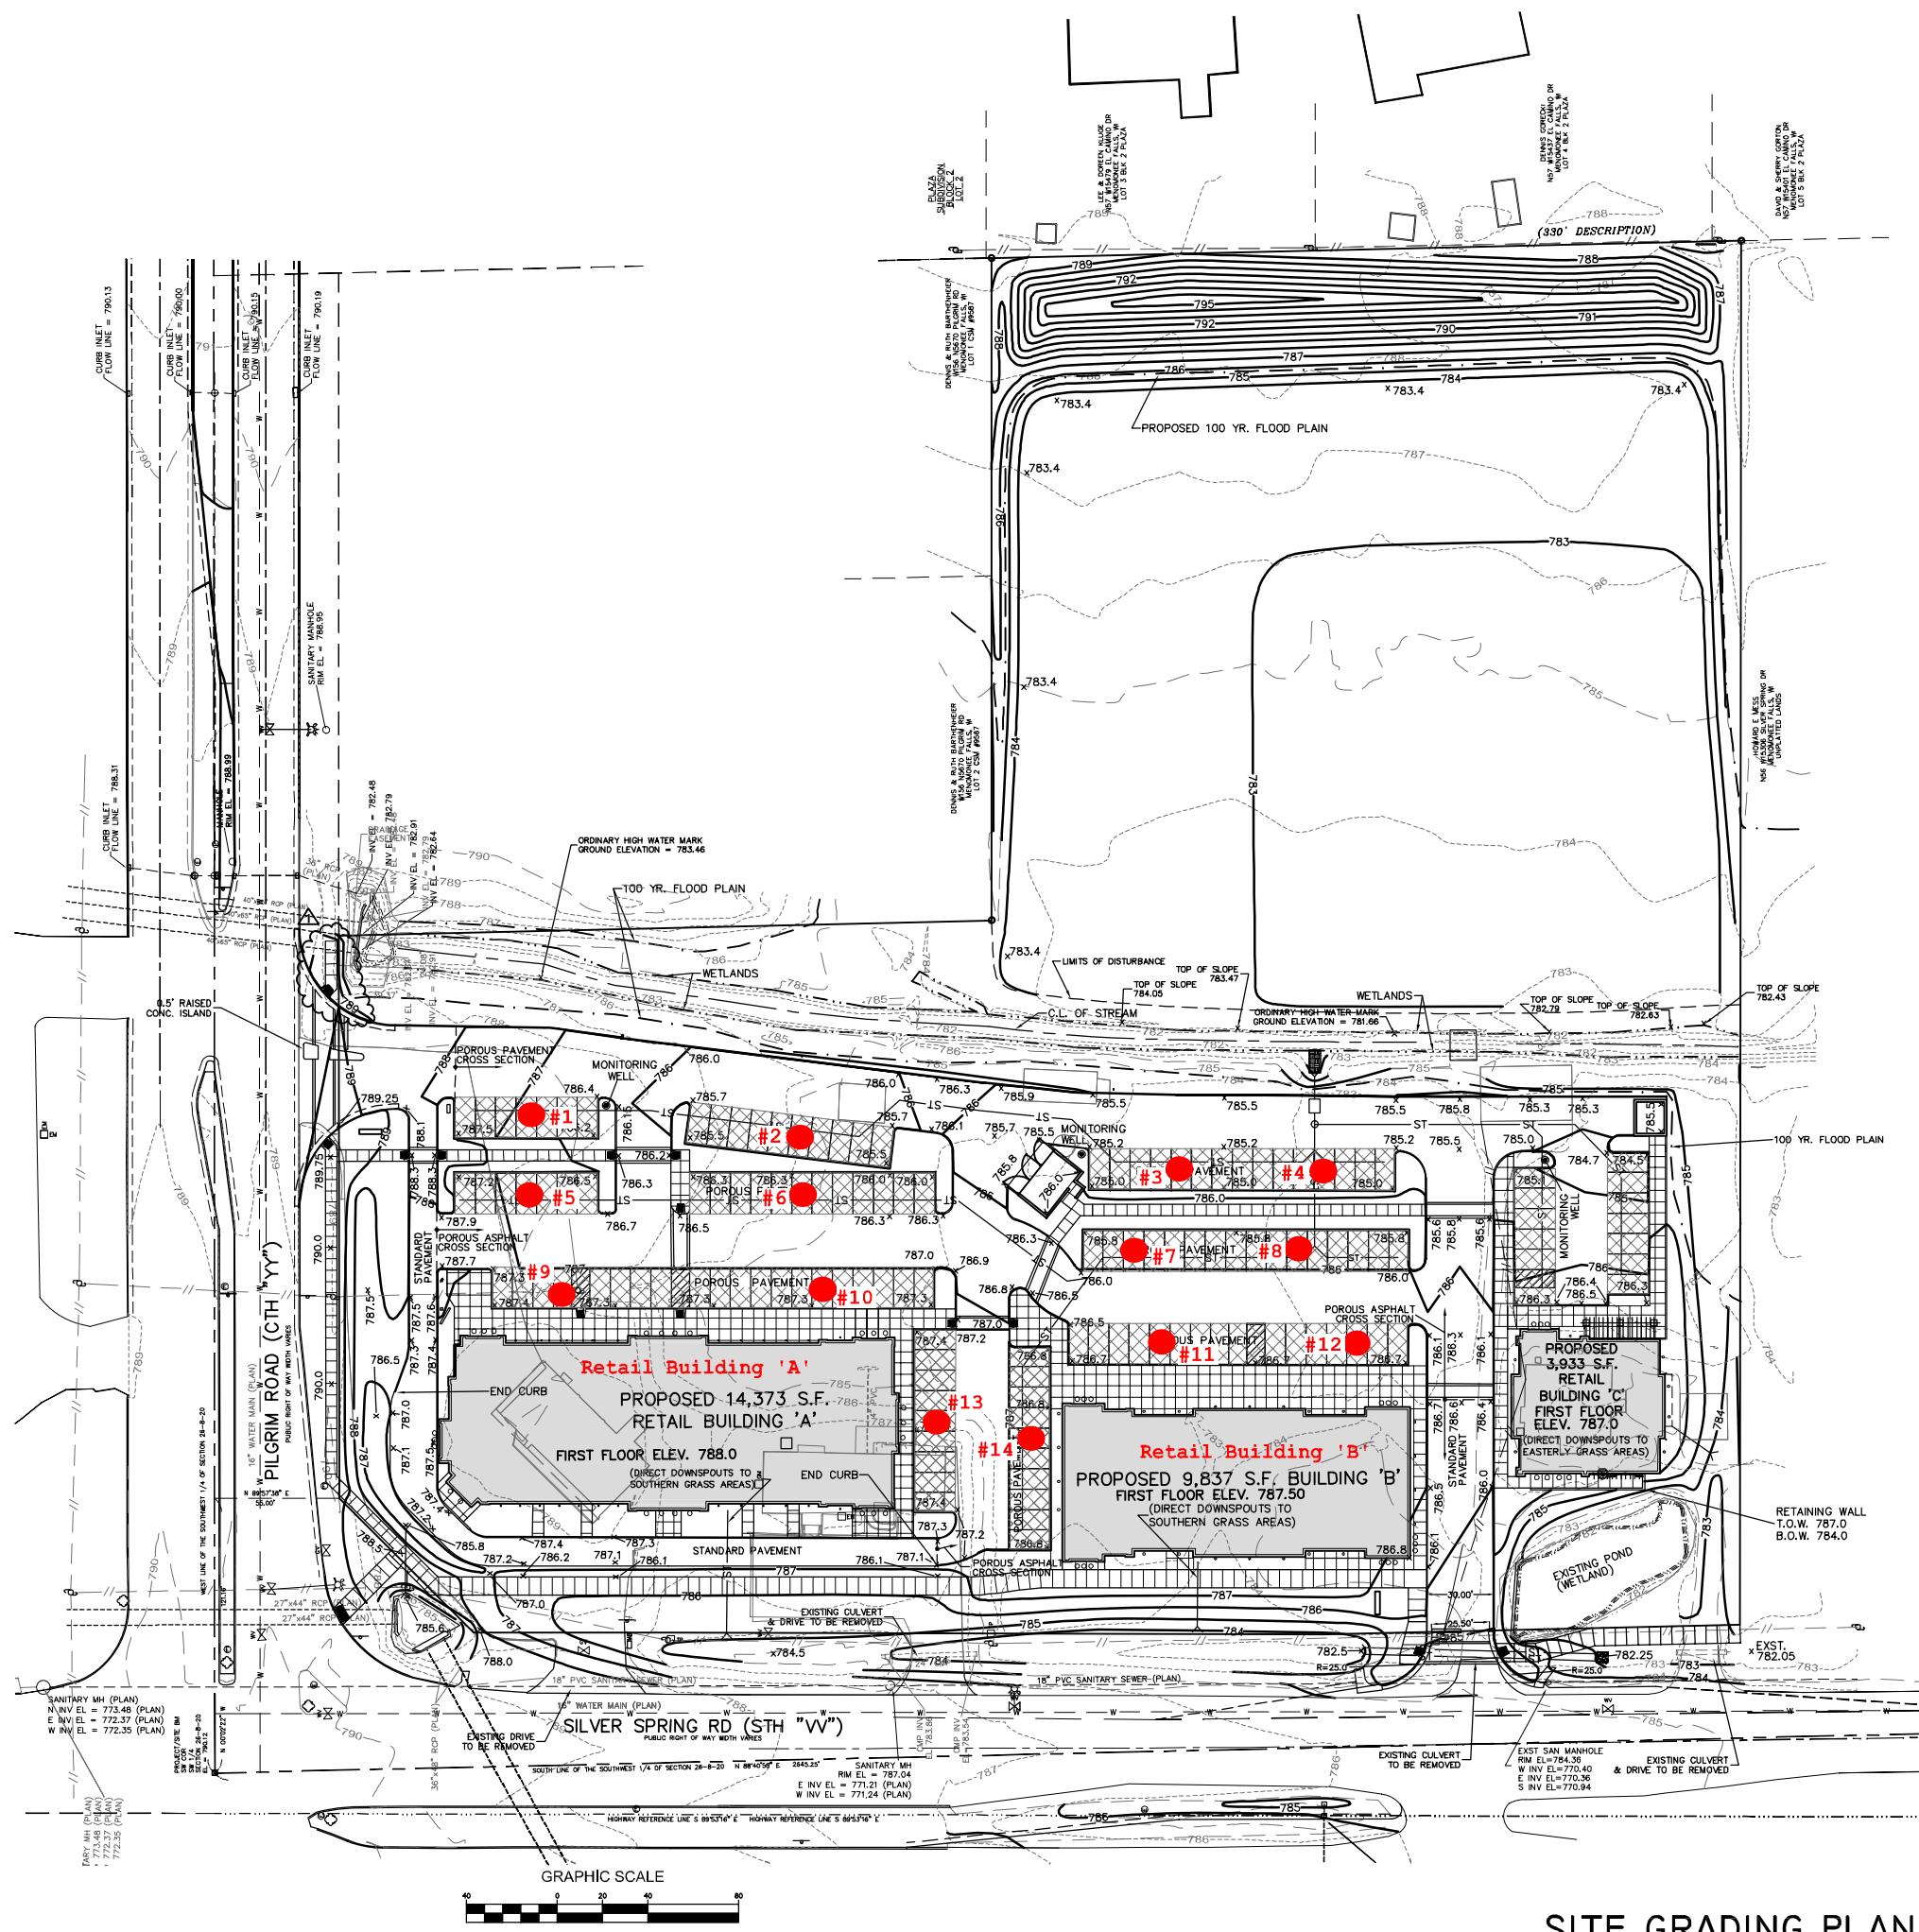
C1.0

Fourteen locations in the ten parking banks at Pilgrim Spring Marketplace were investigated on Monday May 10, 2016 (See attached Site Plan). Infiltration testing was performed according to ASTM C1701. This effort involves adhering a 12-inch diameter infiltration ring to the pavement with an impermeable sealant, pre-wetting the pavement within the ring with water per the ASTM standard, and measuring the amount of time it takes for a known volume of water to pass through the pavement. Per discussions on site prior to testing, tests were abandoned if the pre-wetting portion of the test exceeded thirty minutes. generally speaking, this indicates that the pavement surface infiltration rate, and not the infiltration capacity of the storage layer media, is the limiting factor in infiltration performance.

Ten of the fourteen tests performed were abandoned due to poor performance in the pre-wetting portion of the procedure. These tests were located in the parking stalls north of Retail Building 'A' (tests 1, 2, 5, 6, 9 and 10) and the parking stalls between Retail Building 'A' and Retail Building 'B' (tests 13 and 14). These tests were located in areas that generally experience high traffic. Portions of the pavement in this area showed significant spalling and portions of the pavement in this area appeared to be sealed with a cement-like surface film. In addition, the tests located in the parking stalls adjacent to Retail Building 'B' (tests 11 and 12) were abandoned due to poor pre-wetting. Abundant angular, granular particles were observed on the pavement surface in these areas.

Tests conducted in the parking stall north of Retail Building 'B' (tests 3, 4, 7 and 8) were completed and yielded a wide range of infiltration rates, varying from approximately 3.0 inches per hour to 556.7 inches per hour. Test numbers 4 and 7 yielded infiltration rates of several hundred inches per hour while test numbers 3 and 8 yielded infiltration rates less than 10 inches per hour.

Corrective Action Needed	Due Date
Vacuum areas that failed infiltration test with a suitable vacuum	
sweeper (A "pure vacuum sweeper or a high volume air blast	
vacuum sweeper")and re-test areas
