## STORMWATER MANAGEMENT FACILITIES OPERATION AND INSPECTION REPORT

| Quarter Section | 15 NE | Name of Business/Subdivision | HUNTER'S RIDGE ESTATES |

| Description: <span style="border-bottom: 1px solid black;">SWP15N005</span><br><span style="border-bottom: 1px solid black;">P-0065B, U-0261</span> | Location Of<br>Pond <span style="border-bottom: 1px solid black;">SOUTHWEST OF</span><br><span style="border-bottom: 1px solid black;">PILGRIM RD &amp;</span><br><span style="border-bottom: 1px solid black;">COUNTRYSIDE DR</span> |

Hunter's Ridge Estates (Pilgrim Rd & Countryside)  
Retention Pond - SWP15N005

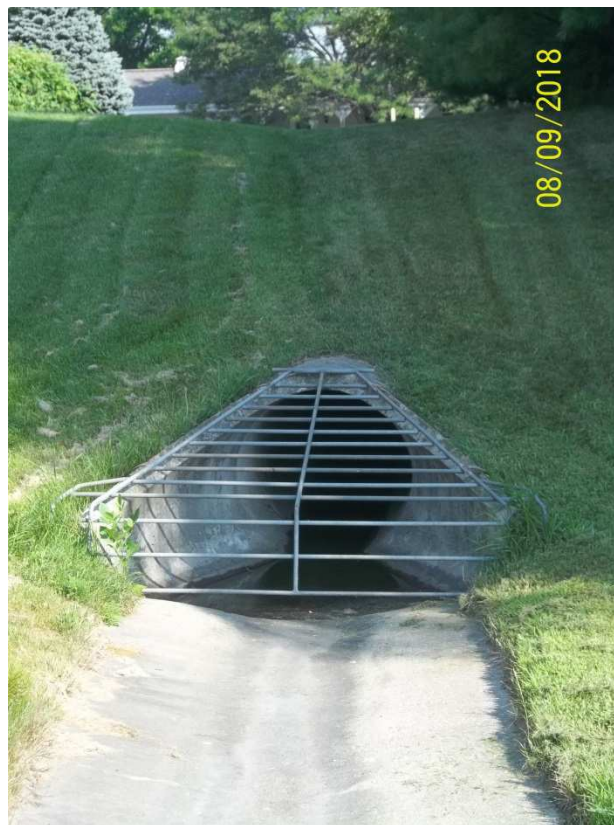
ST006016

| Compliance Verification | Design | Actual | Compliant<br>Yes    No | | Comments | |
|---|---|---|---|---|---|---|
| Outfall 1 (ST006016) | RCP - 36" | | NORTHWESTERLY EMBANKMENT | | RCP IN GOOD CONDITION | |

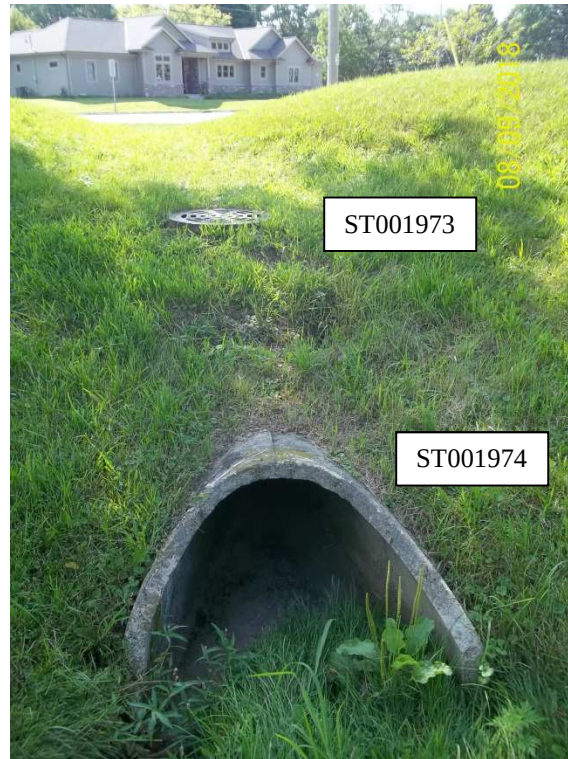
ST001973, ST001974, & Emergency Spillway

| Compliance Verification | Design<br>(Non-AsBuilt) | Actual<br>(GPS) | Compliant<br>Yes No | Comments<br>( Condition of Structure) |
|---|---|---|---|---|
| Opening Diameter<br>(inches) | 18" RCP | 18" RCP | - - | 18" RCP IN GOOD CONDITION,<br>REPAIR GAP/SMALL SINK HOLE @ JOINT |

| Compliance Verification | Design | Actual | Compliant<br>Yes    No | | Comments | |
|---|---|---|---|---|---|---|
| Elevation | 842.00 | 841.68 | | | | |
| Length of spillway (feet) | 10.0 FT | 3.0 FT | | | | |

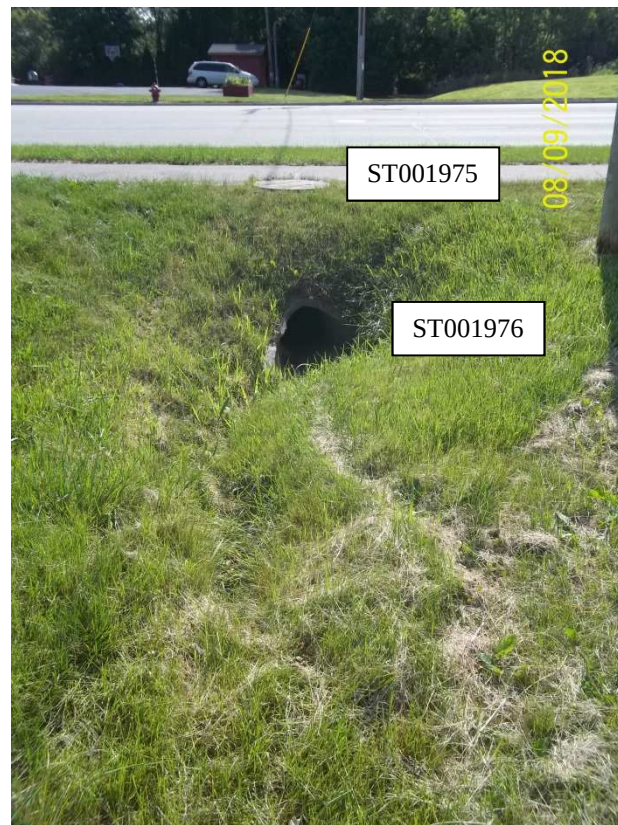
Emergency Spillway Inlet ST001976 & Manhole ST001975

| Compliance Verification | Design<br>(Non-AsBuilt) | Actual<br>(GPS) | Compliant<br>Yes No | Comments<br>( Condition of Structure) |
|---|---|---|---|---|
| Opening Diameter<br>(inches) (ST001976) | 15" RCP | 15" RCP | - - | 15" RCP IN GOOD CONDITION |

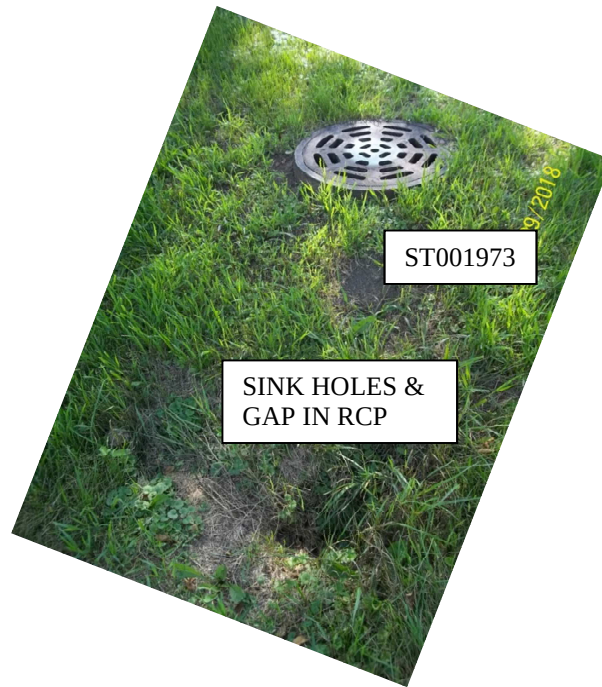
Repairs Needed (8/2018)

- 1) Fix top of RCP
- 2) Fill Sink Hole

| Compliance Verification | Design | Actual | Compliant<br>Yes    No | | Comments | |
|---|---|---|---|---|---|---|
| Unauthorized Plantings, trees, or woody vegetation | - | N | 1) REPAIR JOINT GAP/SINK HOLE @ OUTLET PIPE<br>2) REMOVE DEBRIS FROM CONCRETE CHANNEL | | | |

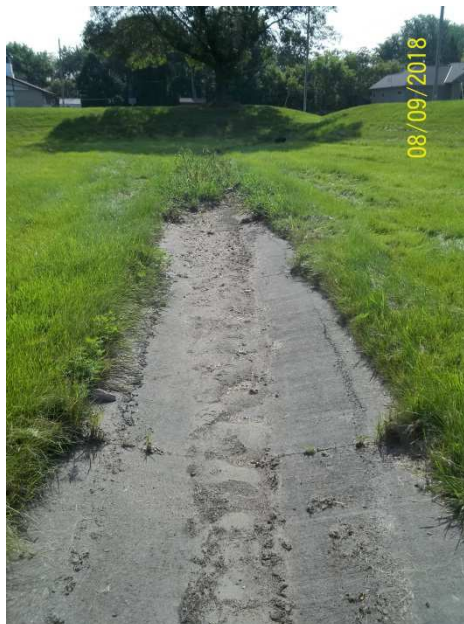
- 3) Remove Gravel, Grass, Leaves, Sediment form Concrete Channel
