## STORMWATER MANAGEMENT FACILITIES OPERATION AND INSPECTION REPORT

Quarter Section 14 NW Name of Business/Subdivision PHEASANT HILLS II & III  
Property Tax ID Number 0054245 & Address of Property  
0054315

Location Of Pond SOUTHWEST CORNER OF  
CROSSWAY DR &  
COUNTRYSIDE DR

# Pheasant Hills II & III (Crossway & Countryside) Retention Pond - SWP14N004

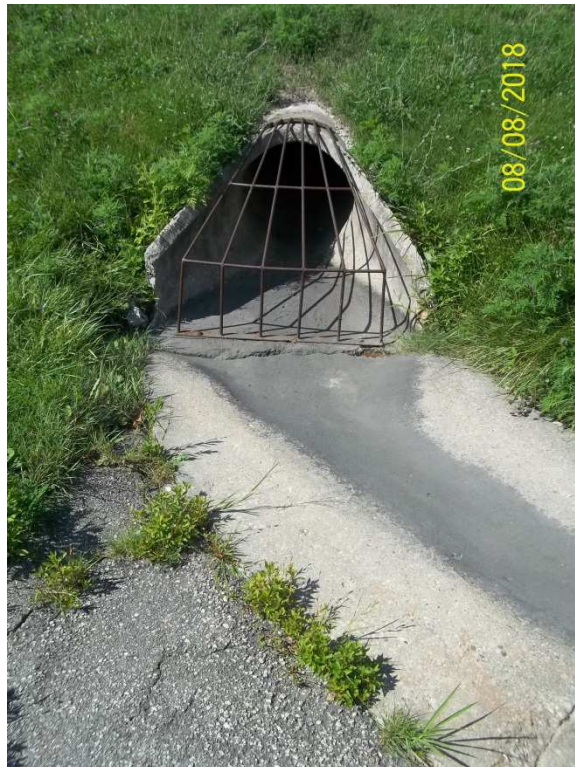
## ST003127

| Compliance Verification | Design | Actual | Compliant<br>Yes    No | | Comments | |
|---|---|---|---|---|---|---|
| Outfall 1 (ST003127) | RCP - 30" | | NORTHWEST CORNER | | 30" RCP IN GOOD CONDITION, GRATE IN PLACE | |

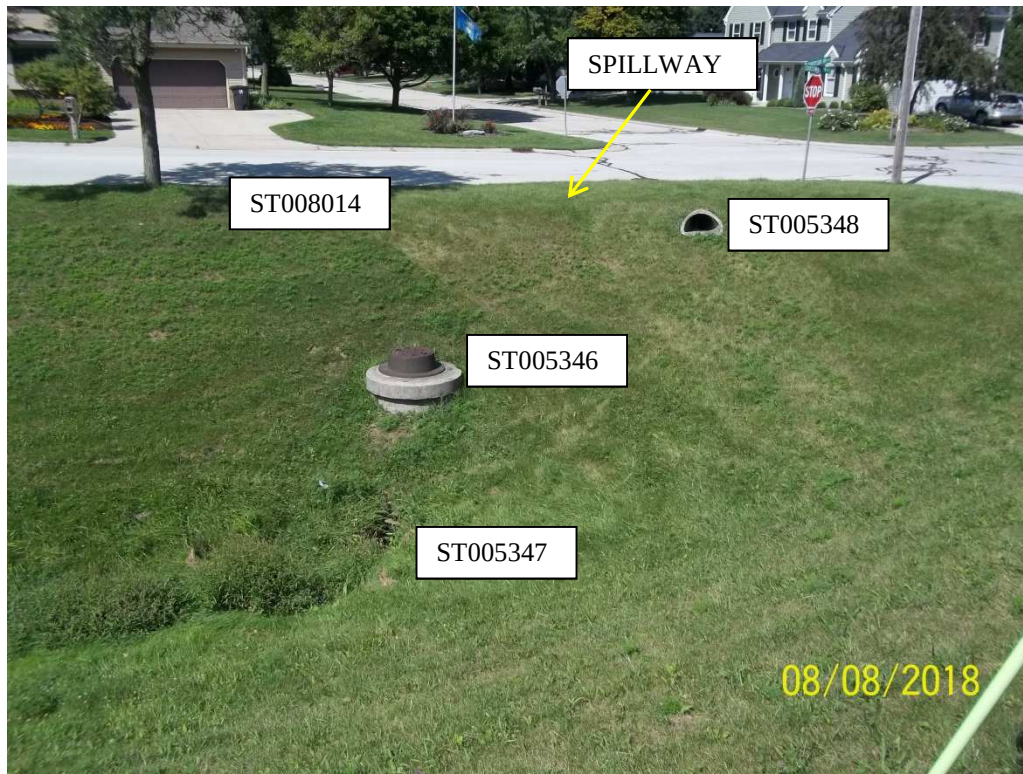
ST008014, ST005346, ST005347, & ST005348

| Compliance Verification | Design (Non-AsBuilt) | Actual (GPS) | Compliant Yes | No | Comments (Condition of Structure) |
|---|---|---|---|---|---|
| Opening Diameter (inches) | 12" RCP | 12" RCP | - | - | 1) 12" RCP IN GOOD CONDITION,<br>2) REMOVE DEBRIS FROM CONC. CHANNEL<br><br>ELEVATIONS TO VARY SLIGHTLY FROM YEAR TO YEAR DUE TO GPS TECHNOLOGY |
| Opening Diameter (inches) (ST005348) | 12" RCP | 12" RCP | - | - | 12" RCP IN GOOD CONDITION |

| Compliance Verification | Design | Actual | Compliant<br>Yes    No | | Comments | |
|---|---|---|---|---|---|---|
| Unauthorized Plantings, trees, or woody vegetation | - | N | 1) CONCRETE CHANNEL IN GOOD CONDITION<br>2) REMOVE DEBRIS FROM CONCRETE CHANNEL | | | |

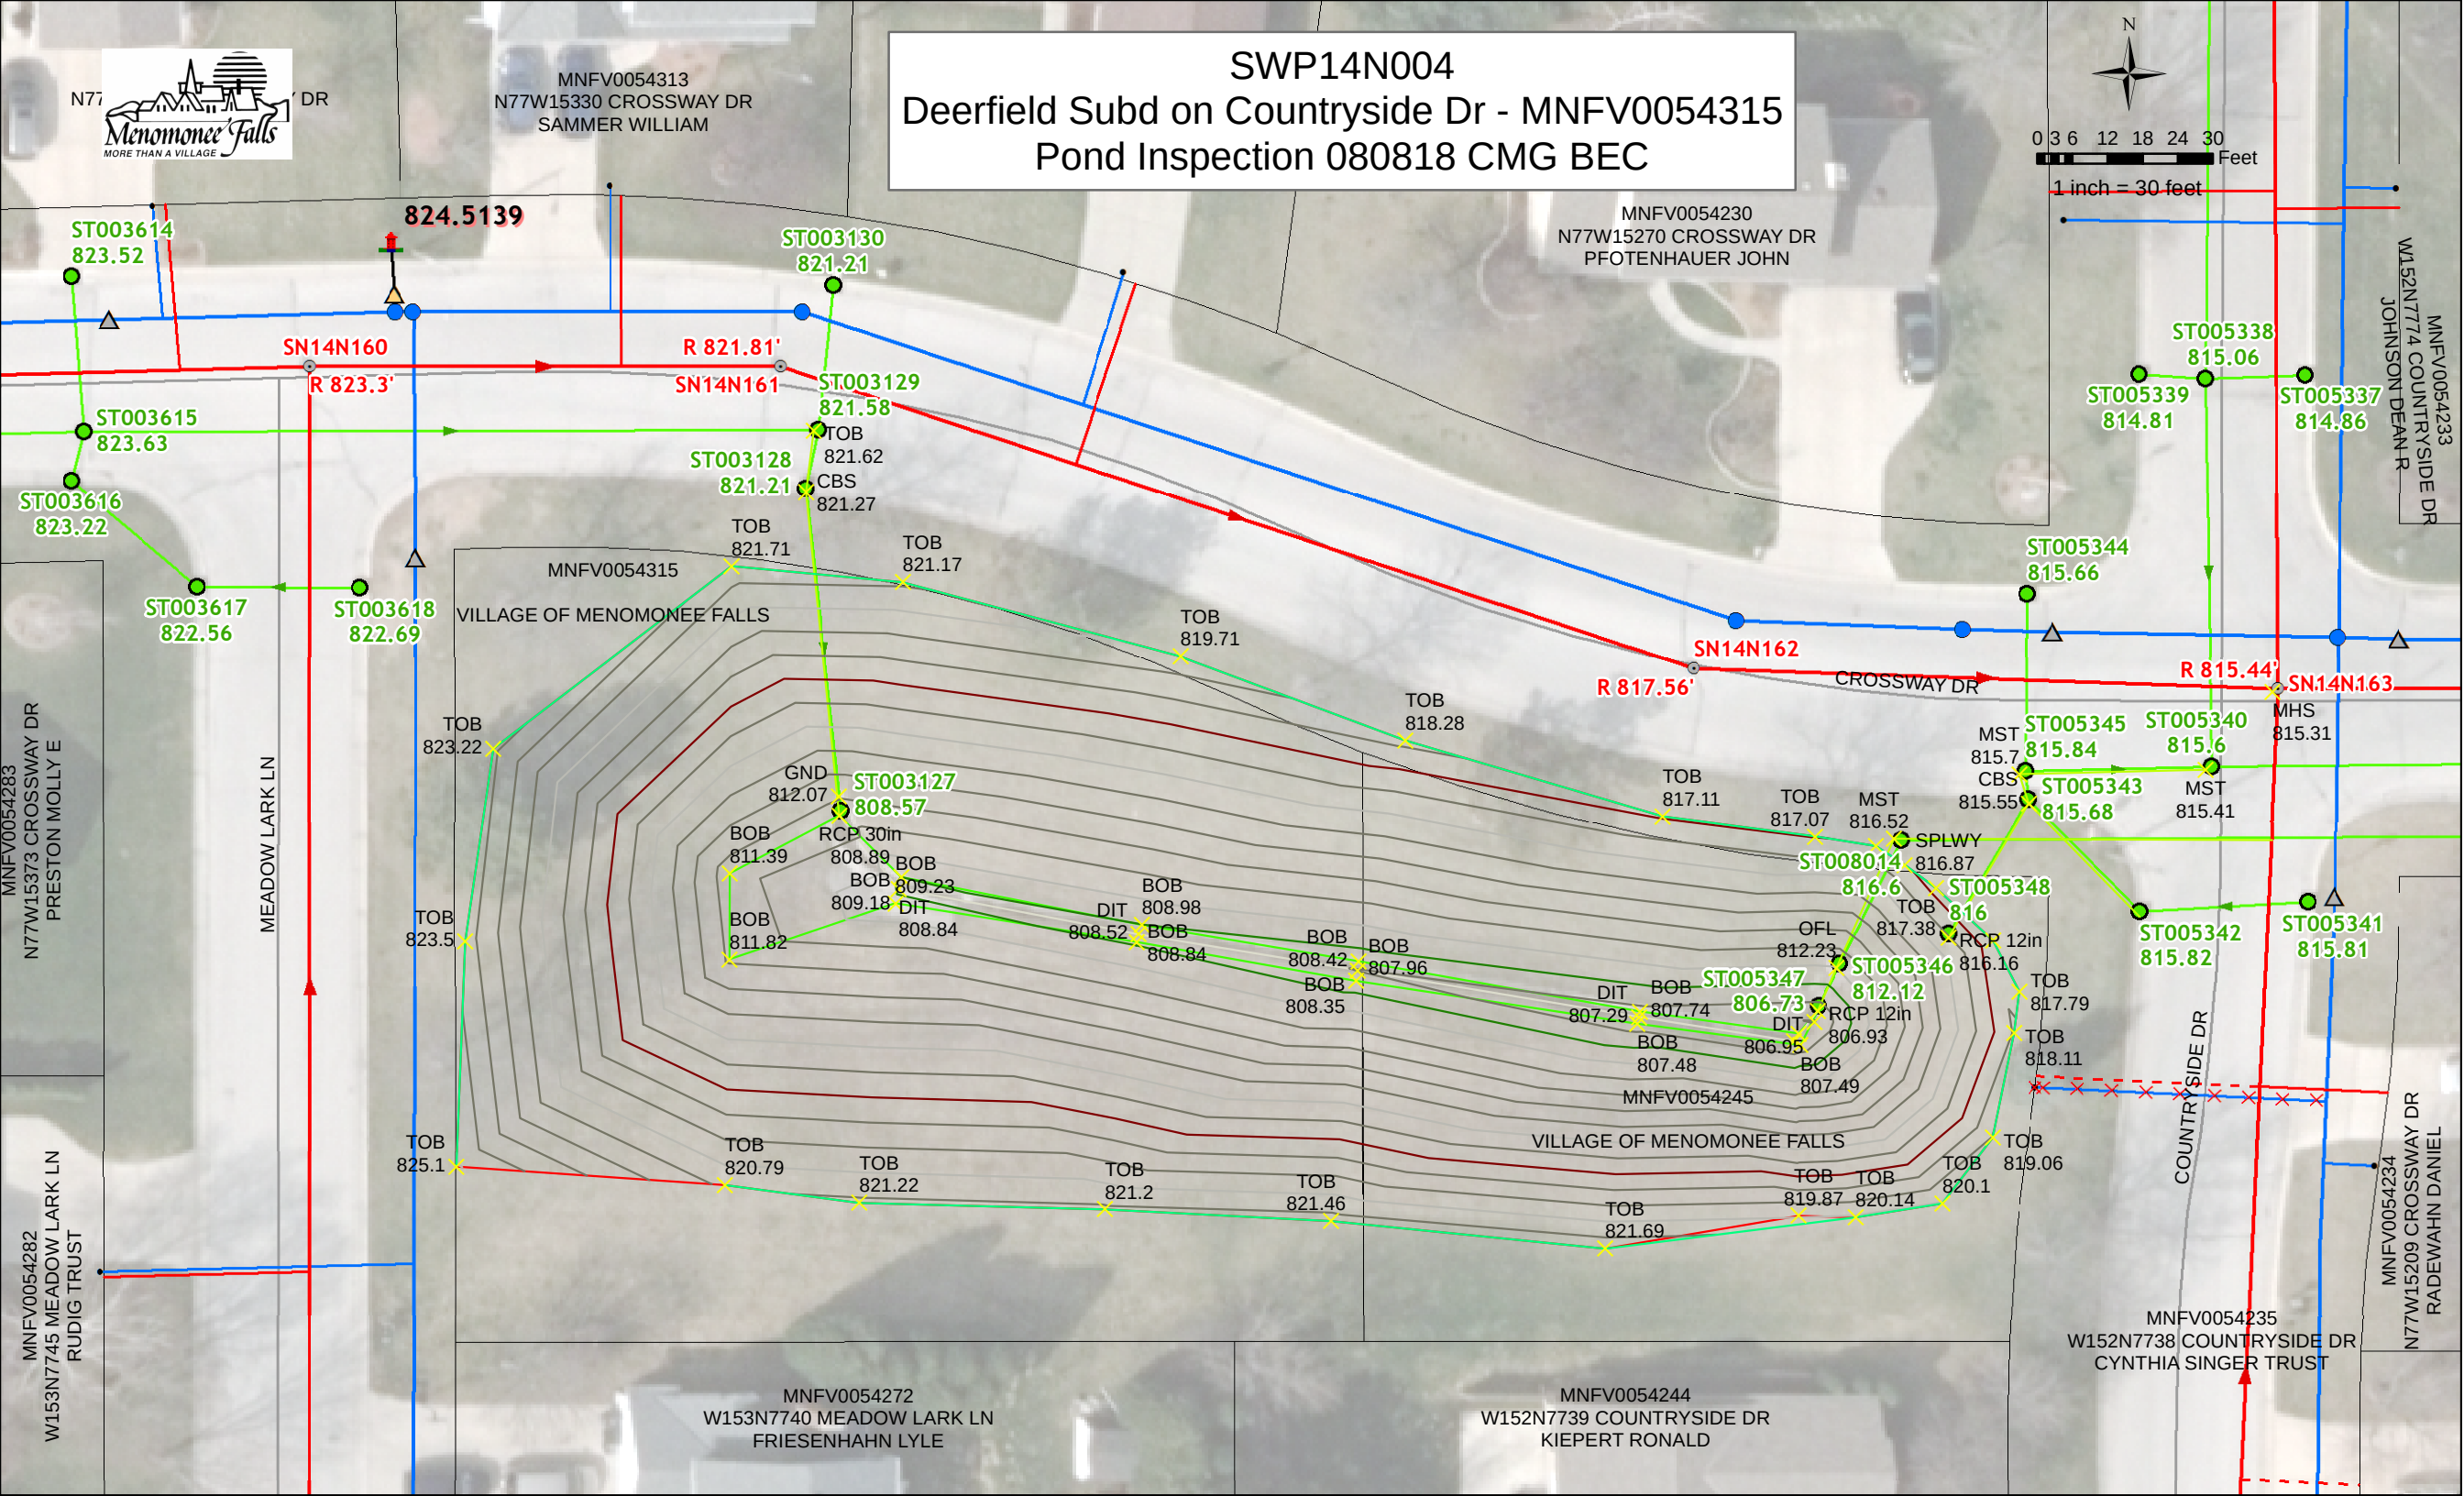
SWP14N004  
Deerfield Subd on Countryside Dr - MNFV0054315  
Pond Inspection 080818 CMG BEC

$$H = 816.80 - 808.90 = 7.90 \text{ FT}$$

$$A_1 = 0.029 \text{ AC}$$

$$A_2 = 0.335 \text{ AC}$$

$$V = \left( \frac{H}{3} \right) (A_1 + A_2 + \sqrt{A_1 A_2})$$

$$V = \left( \frac{7.90 \text{ FT}}{3} \right) (0.029 \text{ AC} + 0.335 \text{ AC} + \sqrt{0.029 \text{ AC} \times 0.335 \text{ AC}})$$

$$V = 2.836 \text{ AC FT} \checkmark \text{ on 3/16/18}$$
