## STORMWATER MANAGEMENT FACILITIES OPERATION AND INSPECTION REPORT

Quarter Section 15 NE Name of Business/Subdivision HUNTER'S RIDGE ESTATES III  
Property Tax ID Number 0057288 Address of Property \_\_\_\_\_  
\_\_\_\_\_  
\_\_\_\_\_

Description: SWP15N006  
P-0066B, U-0272

# Hunter's Ridge Estates (Pilgrim & Crossway) Retention Pond - SWP15N006

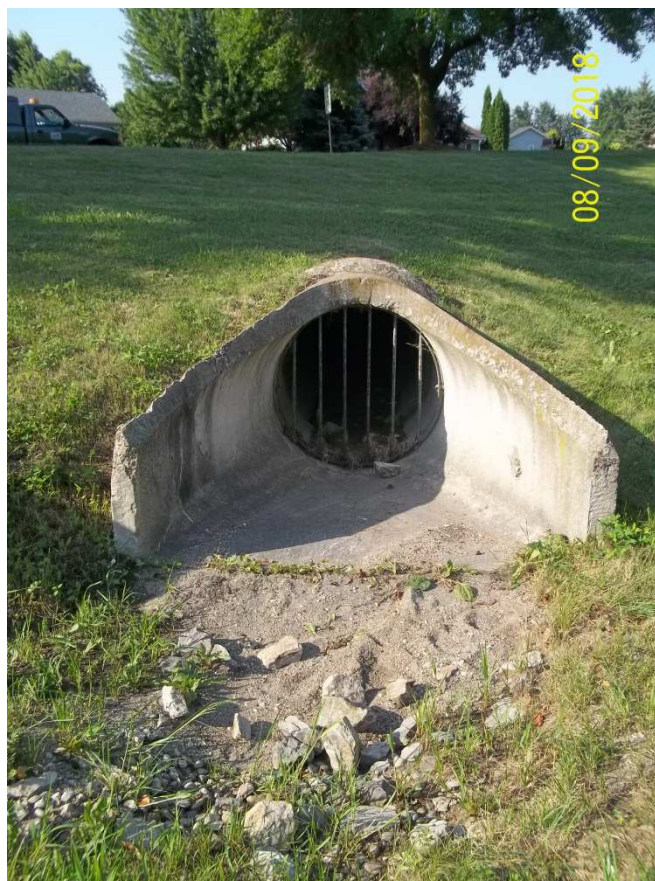
## Outlet ST012724

| Compliance Verification | Design | Actual | Compliant<br>Yes    No | | Comments | |
|---|---|---|---|---|---|---|
| Outfall 1 (ST12724) | RCP - 42" | | SOUTH EMBANKMENT | | RCP IN GOOD CONDITION | |

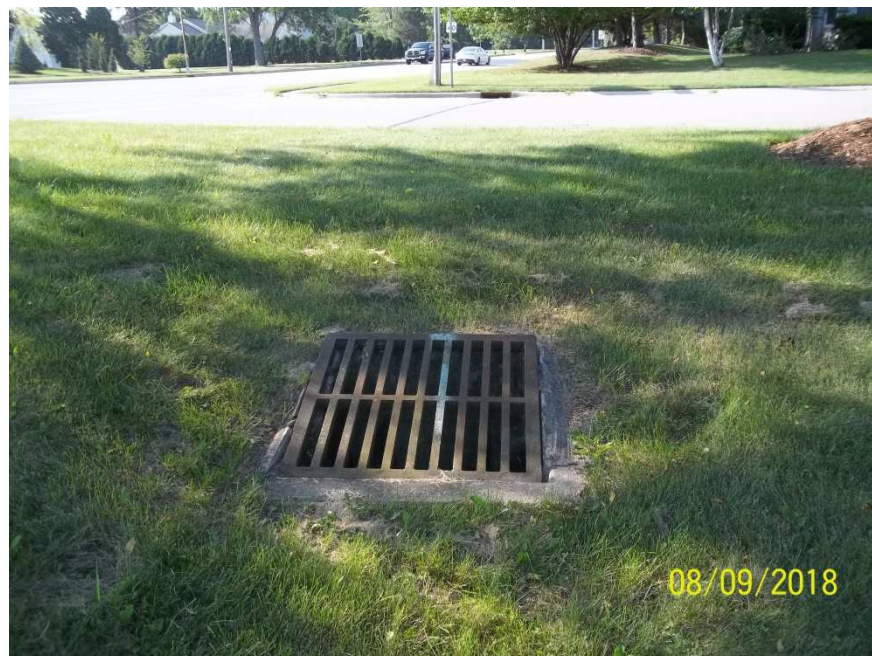
Overflow ST012722

| Compliance Verification | Design (Non-AsBuilt) | Actual (GPS) | Compliant Yes | No | Comments (Condition of Structure) |
|---|---|---|---|---|---|
| Opening Diameter (inches) (ST012722) | 30" X 30" | 30" X 30" | | | REINFORCED CONCRETE/CAST IRON GRATE |

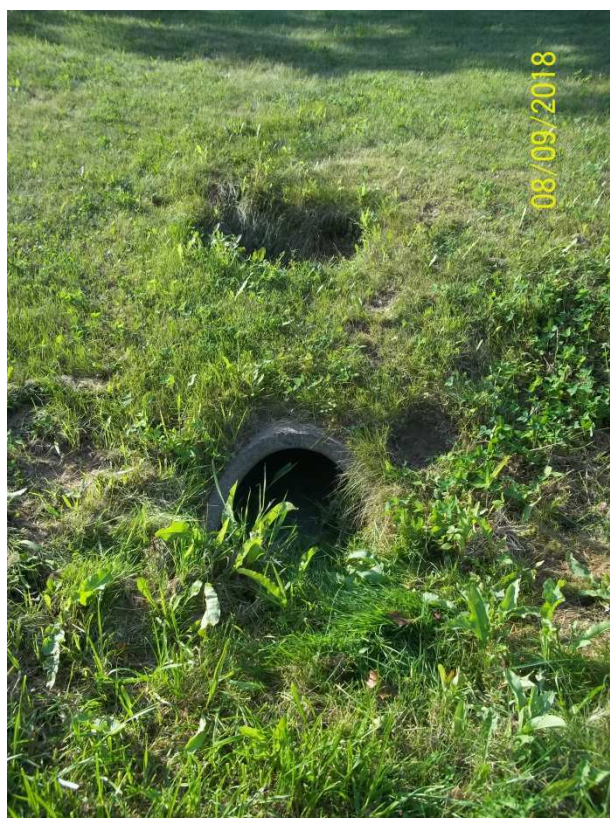
Inlet ST012723

| Compliance Verification | Design (Non-AsBuilt) | Actual (GPS) | Compliant Yes | No | Comments (Condition of Structure) |
|---|---|---|---|---|---|
| Opening Diameter (inches) | 10" RCP | 12" RCP | - | - | 12" RCP IN GOOD CONDITION, REPAIR GAP/SINK HOLE IN JOINT |

| Compliance Verification | Design | Actual | Compliant<br>Yes    No | | Comments | |
|---|---|---|---|---|---|---|
| Unauthorized Plantings, trees, or woody vegetation | - | N | REPAIR JOINT GAP/SINK HOLE @ OUTLET PIPE | | | |

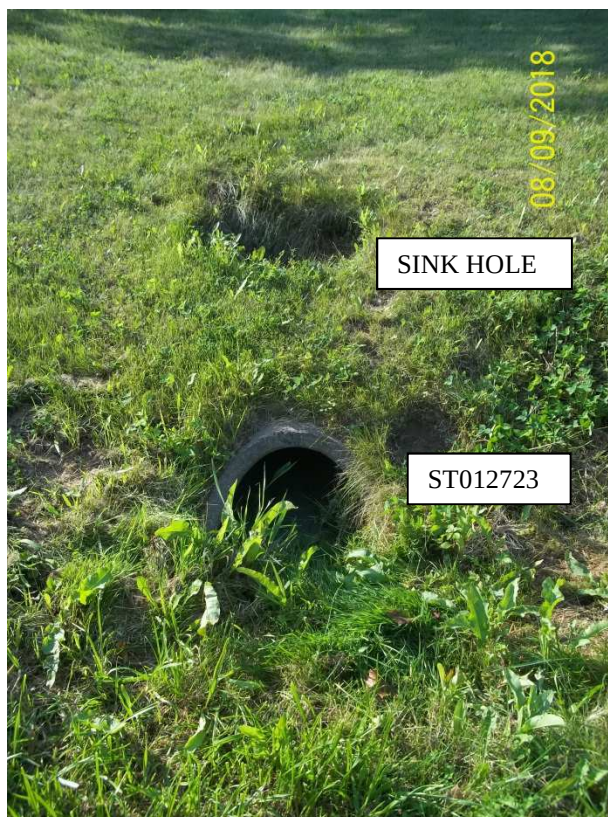
## Repairs Needed (8/2018)

- 1) Fix top of RCP
- 2) Fill Sink Hole

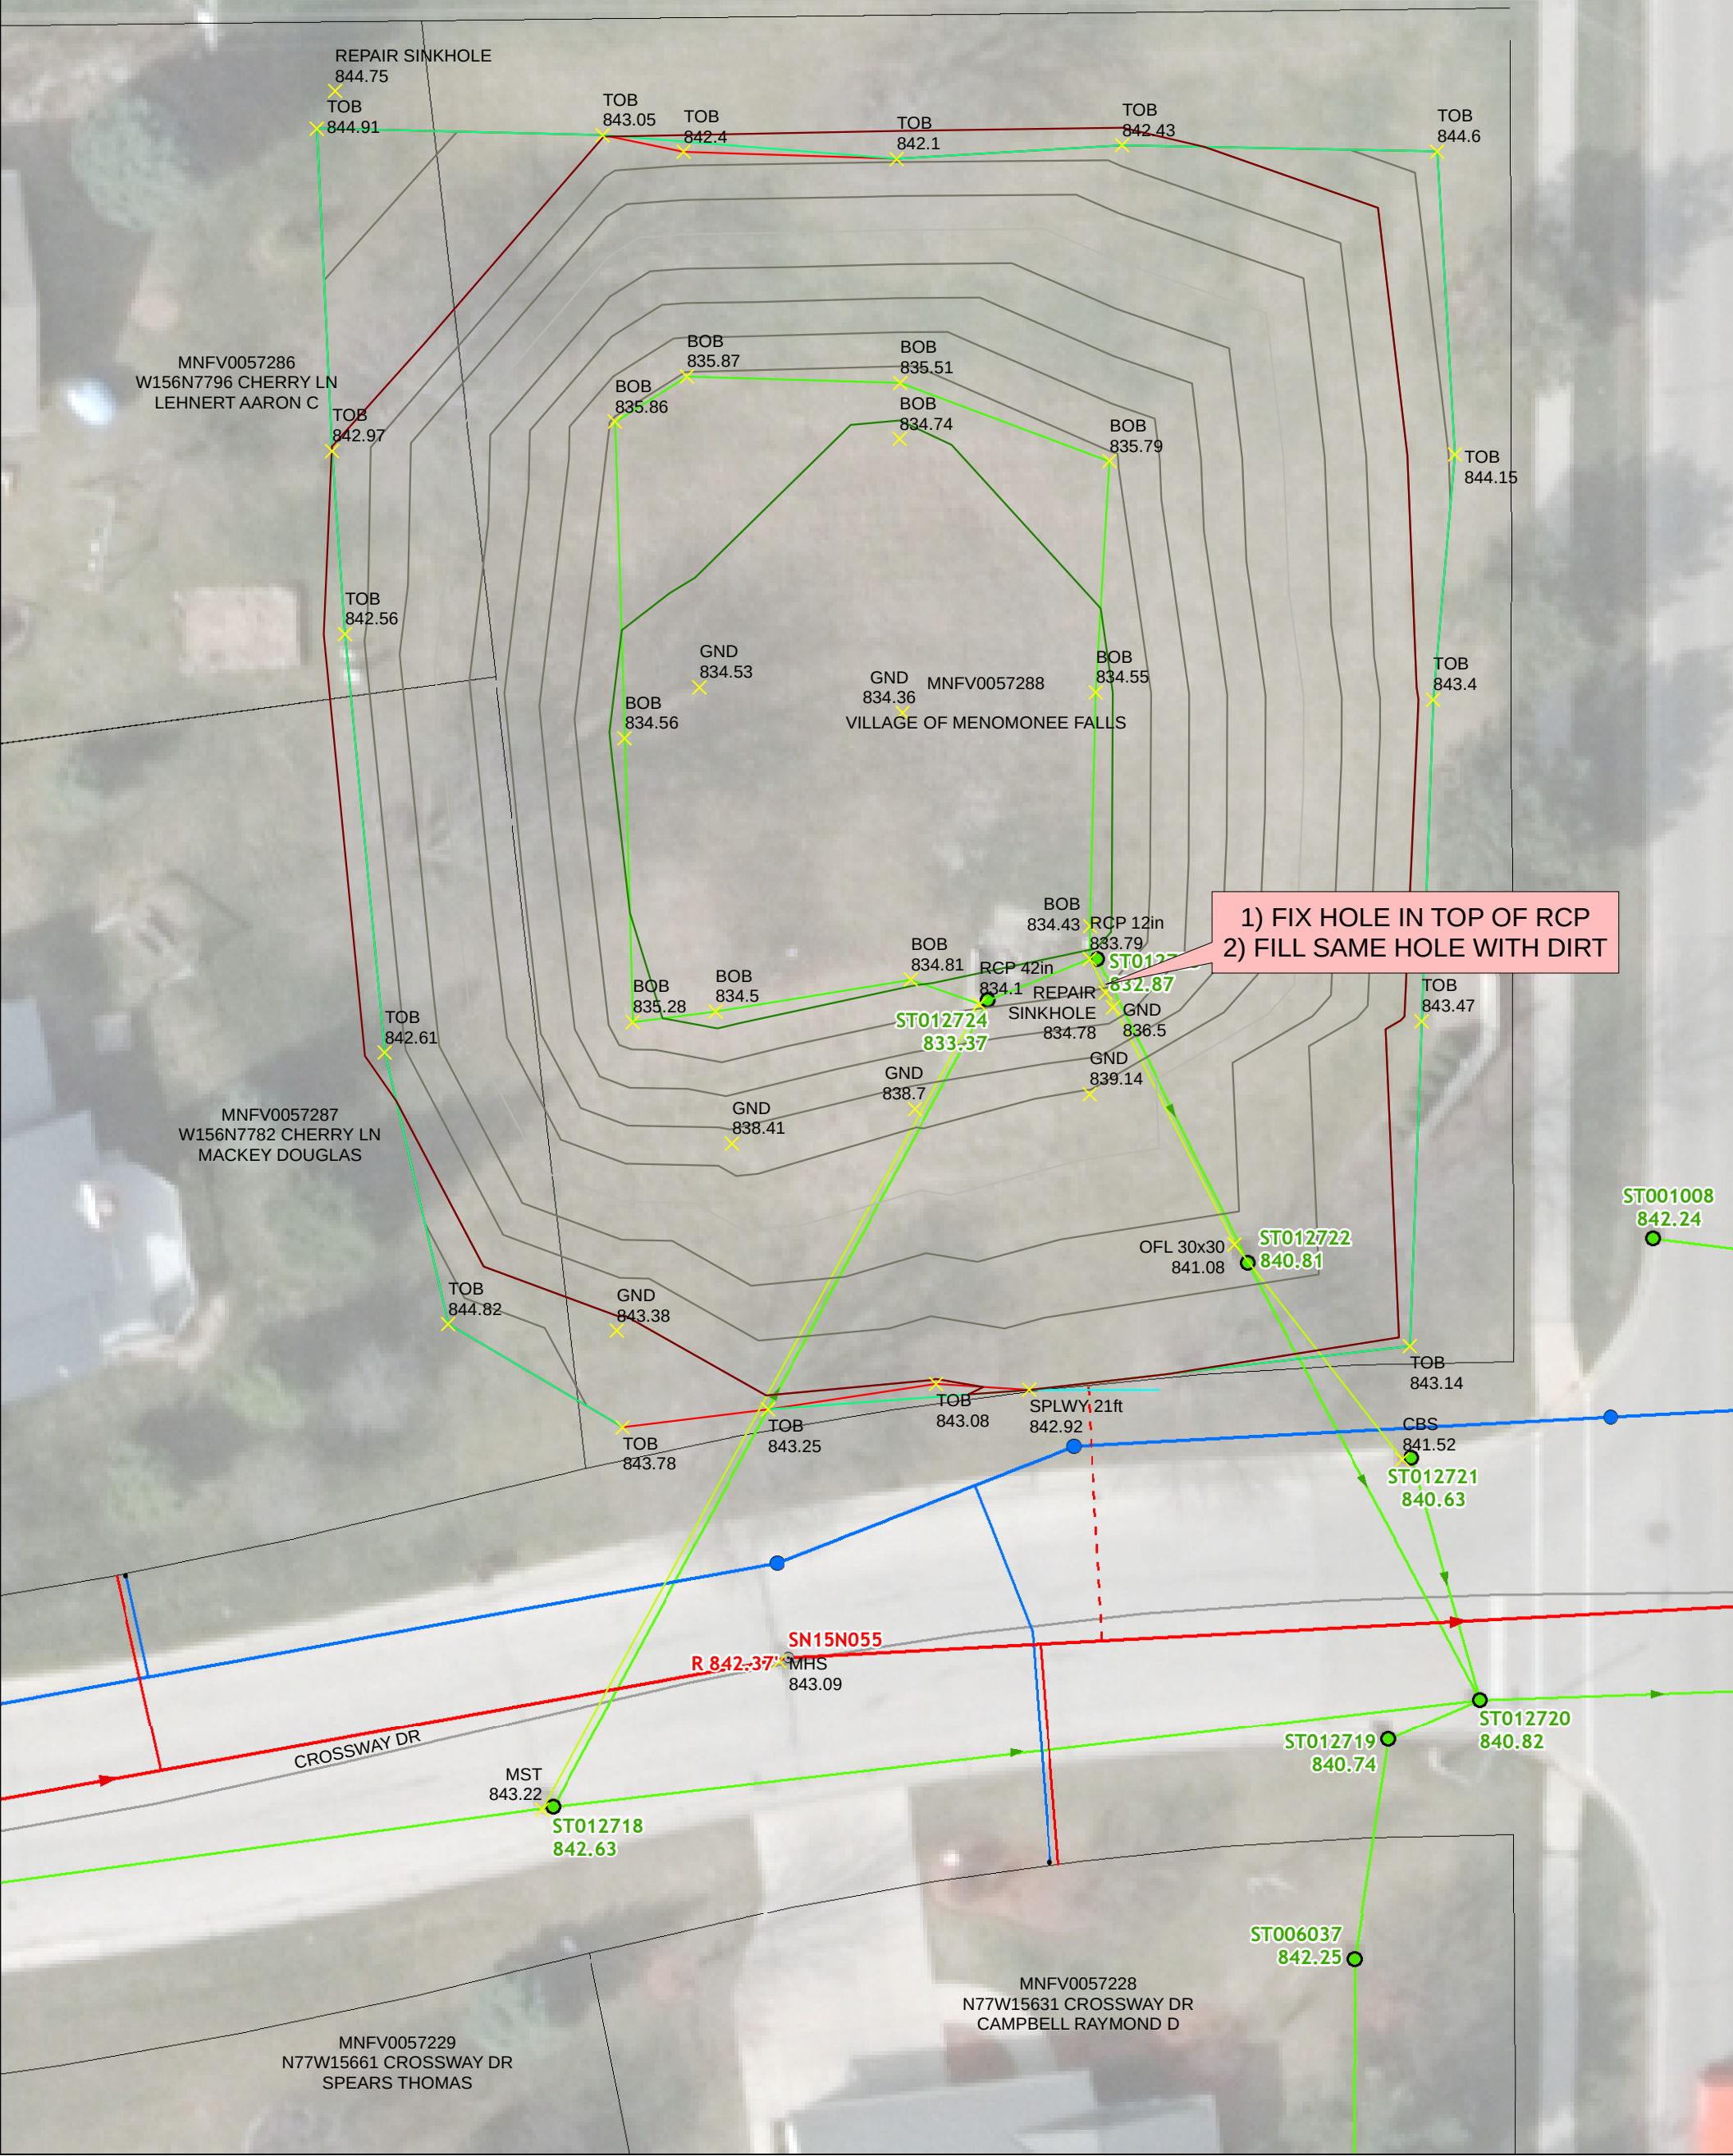
$$H = 843.00 - 834.75 = 8.25'$$

$$A_1 = 0.0865 \text{ AC}$$

$$A_2 = 0.451 \text{ AC} \quad \text{Pilgrimage Crossway}$$

$$V = \left( \frac{H}{3} \right) (A_1 + A_2 + \sqrt{A_1 + A_2})$$

$$V = \left( \frac{8.25 \text{ FT}}{3} \right) (0.087 \text{ AC} + 0.451 \text{ AC} + \sqrt{0.087 \text{ AC} + 0.451 \text{ AC}})$$

$$V = 3.495 \text{ AC FT} \quad \checkmark \quad \text{CNG} \quad 8/16/18$$
