## STORMWATER MANAGEMENT FACILITIES OPERATION AND INSPECTION REPORT

| Quarter Section | 11 NW | Name of Business/Subdivision | VMF COMMUNITY CENTER |

Description: SWP11N002

# Margaret Rd Retention Pond (West) - SWP11N002

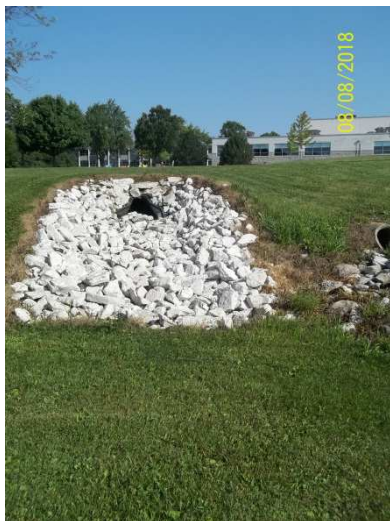
Outlet ST015054

| Compliance Verification | Design | Actual | Compliant<br>Yes    No | | Comments | |
|---|---|---|---|---|---|---|
| Outfall 3 (ST015054) | CORRUGATED PVC – 12" | | NORTHWEST CORNER | | GOOD CONDITION | |

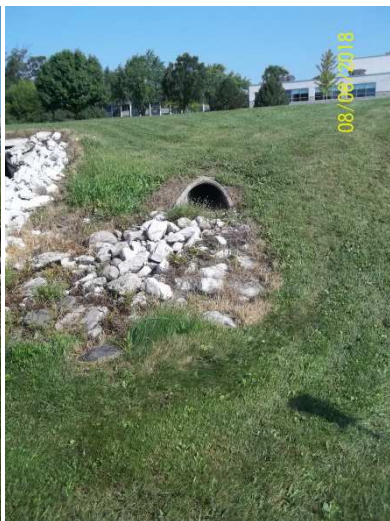
Outlet ST011221

| Compliance Verification | Design | Actual | Compliant<br>Yes    No | | Comments | |
|---|---|---|---|---|---|---|
| Outfall 1 (ST011221) | RCP - 12" | | NORTHWEST CORNER | | RCP IN GOOD CONDITION, RIPRAP IN END SECTION | |

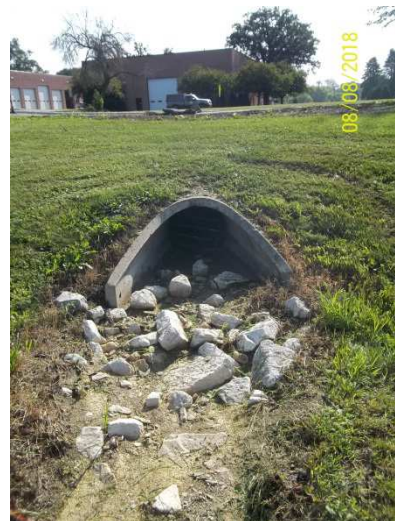
Outlet ST011227

| Compliance Verification | Design | Actual | Compliant<br>Yes    No | | Comments | |
|---|---|---|---|---|---|---|
| Outfall 2 (ST011227) | RCP – 24" | | EAST EMBANKMENT | | RCP IN GOOD CONDITION, RIPRAP IN END SECTION | |

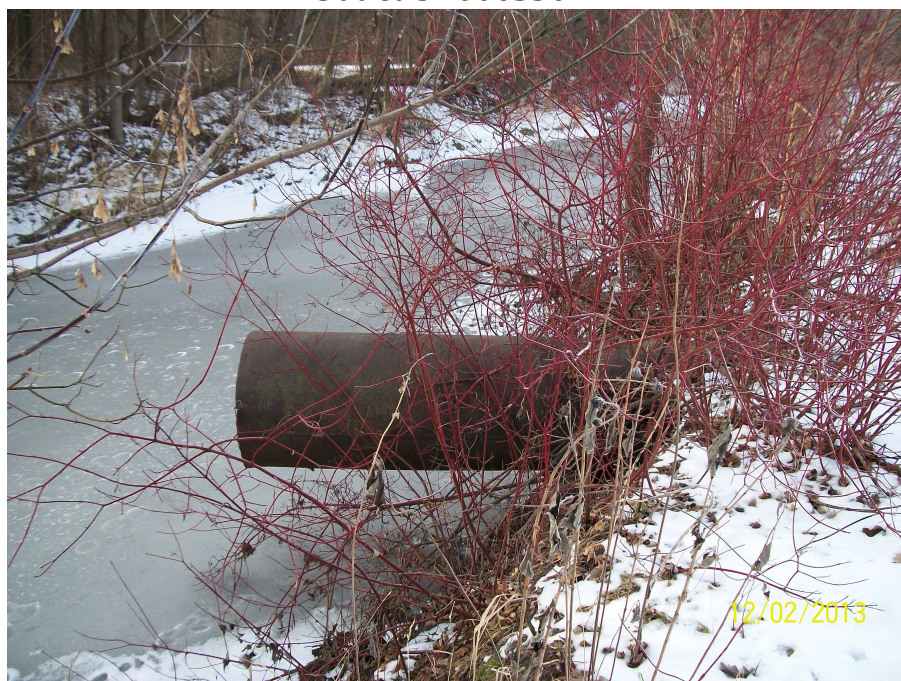
### Outlet ST006390

| Compliance Verification | Design (Non-AsBuilt) | Actual (GPS) | Compliant Yes No | | Comments (Condition of Structure) |
|---|---|---|---|---|---|
| Opening Diameter (inches) | NOT LISTED | 15" | - | - | 15" RCP IN GOOD CONDITION |

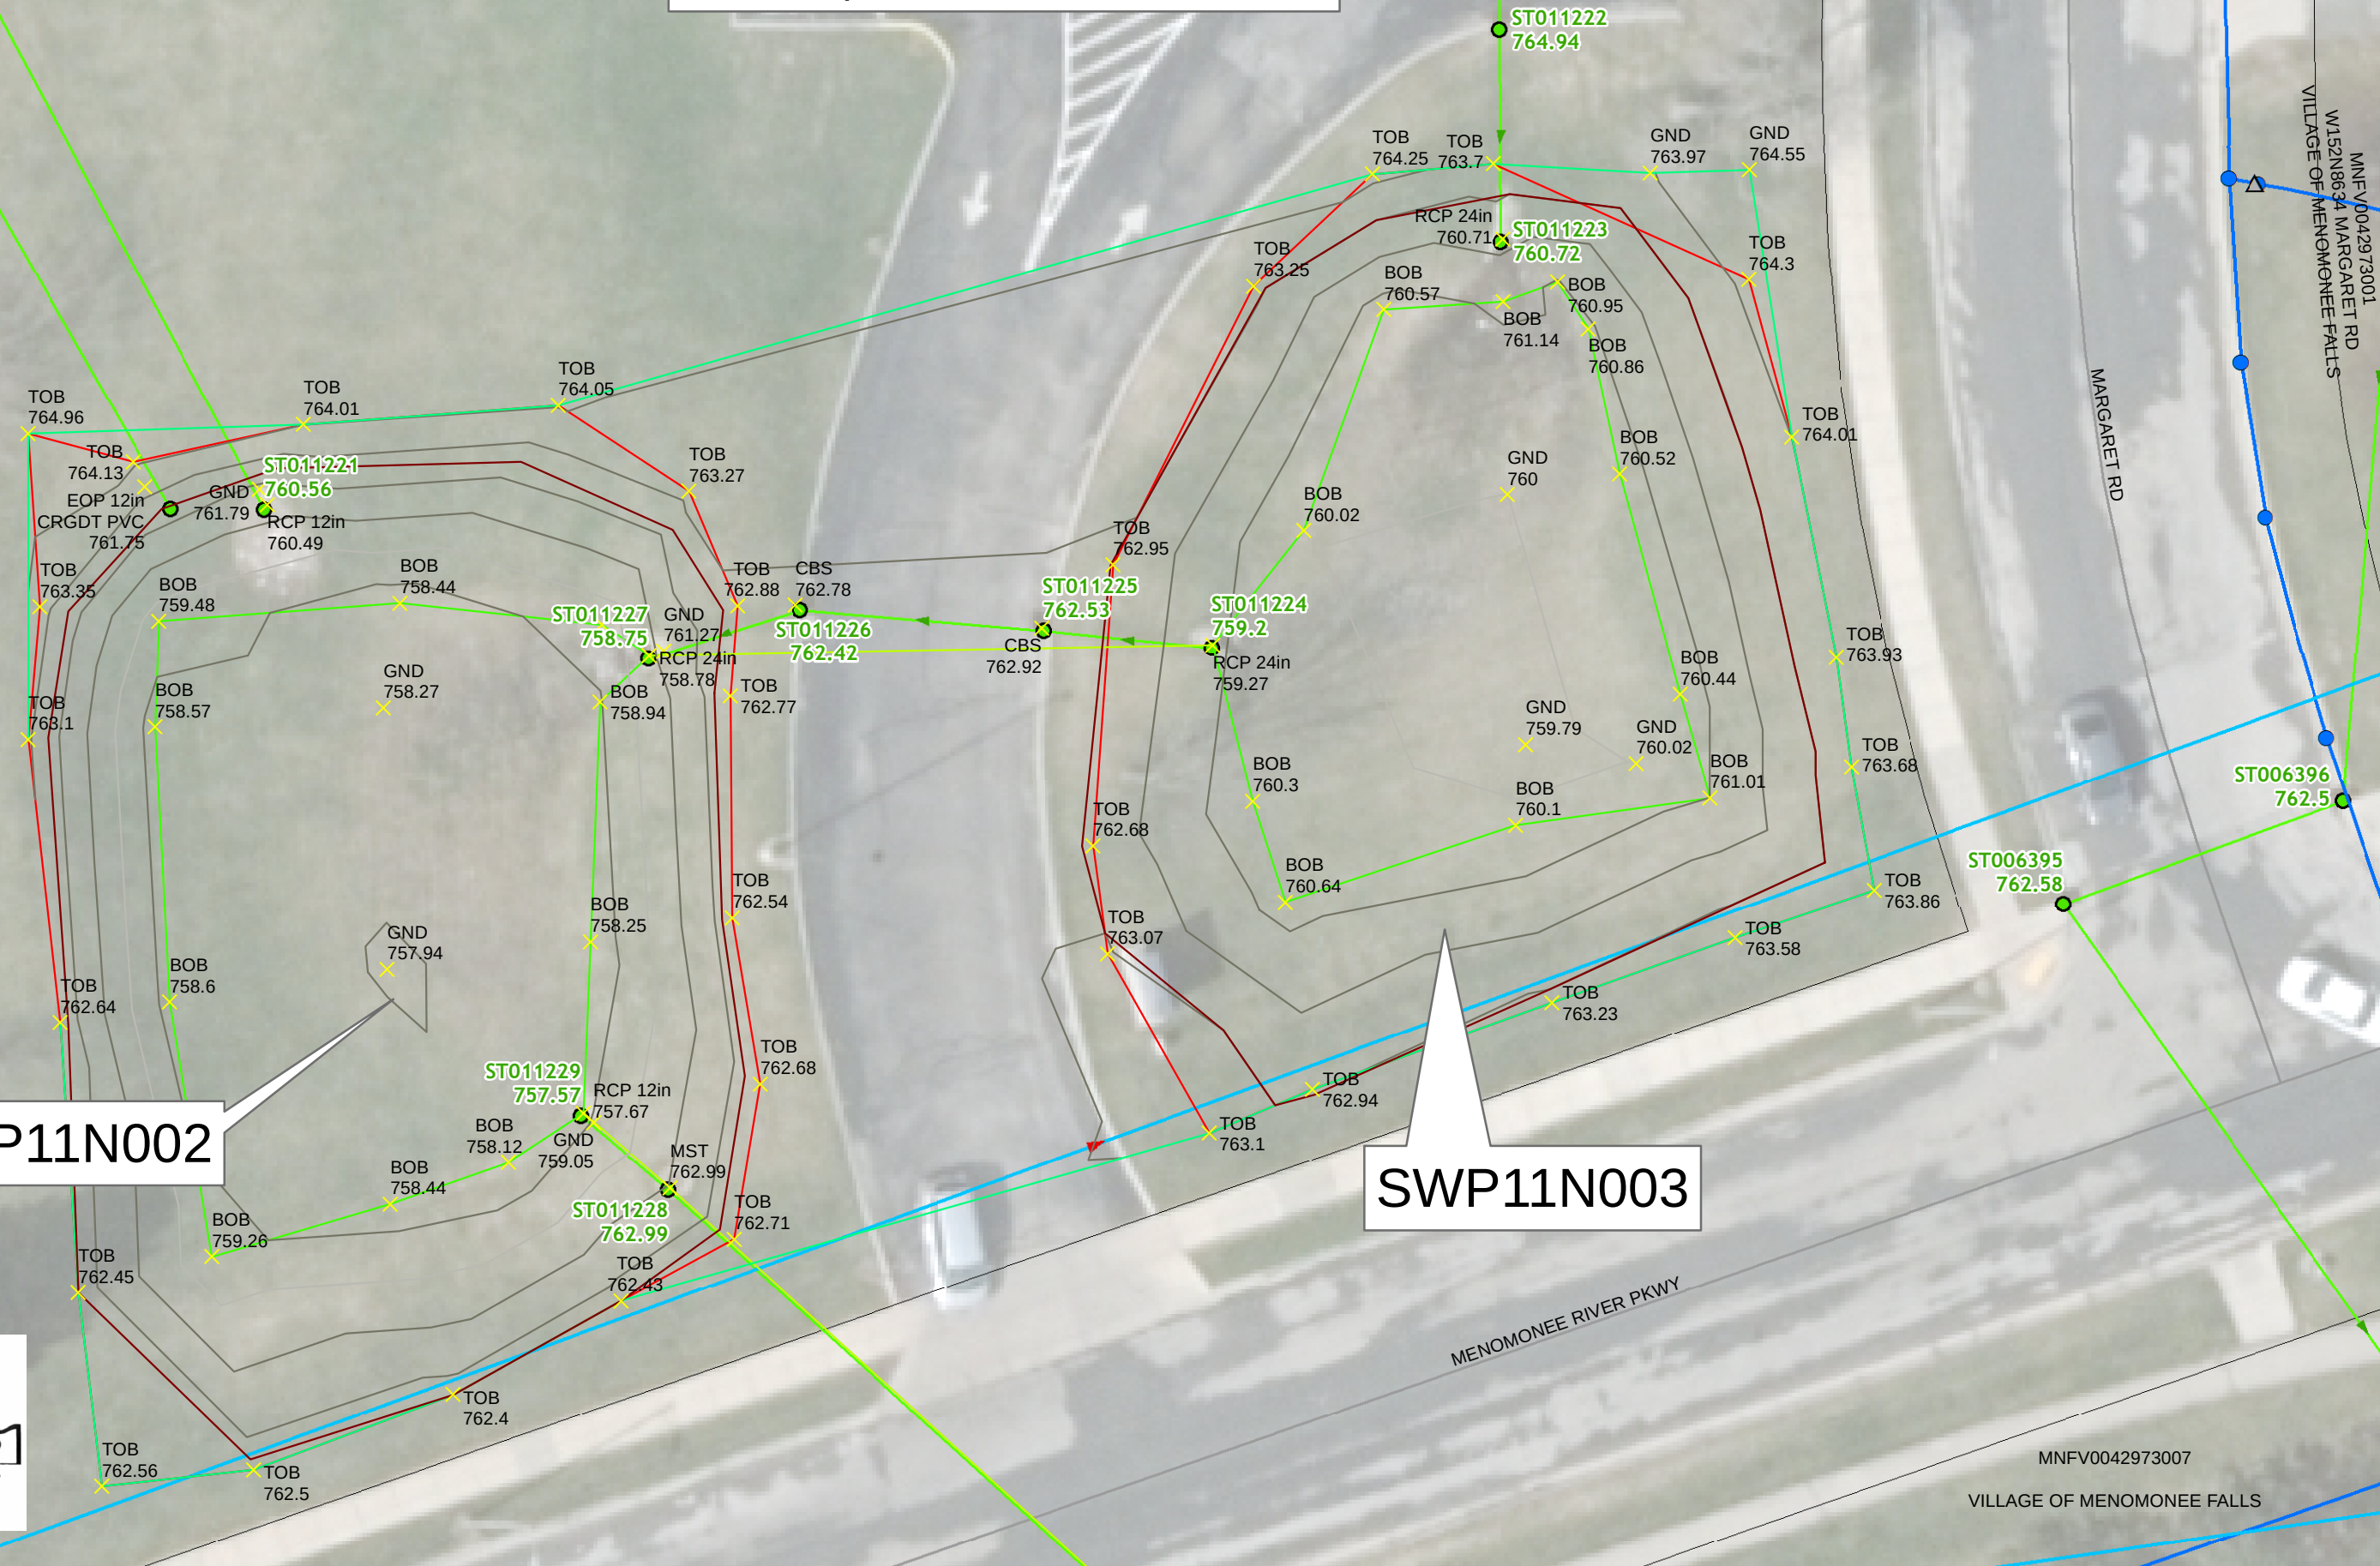
11N002

$$H = 762.42 - 758.40 = 4.02 \text{ FT}$$

$$A_1 = 0.085 \text{ AC}$$

$$A_2 = 0.195 \text{ AC}$$

$$V = \left( \frac{H}{3} \right) (A_1 + A_2 + \sqrt{A_1 A_2})$$

$$V = 1.084 \text{ AC FT} \quad \checkmark \quad \text{cms} \quad 8/15/18$$
